## **Springburn Winter Gardens**

## **Structural Appraisal and Condition Report**

For:  
**Glasgow City Council**

**June 2021**

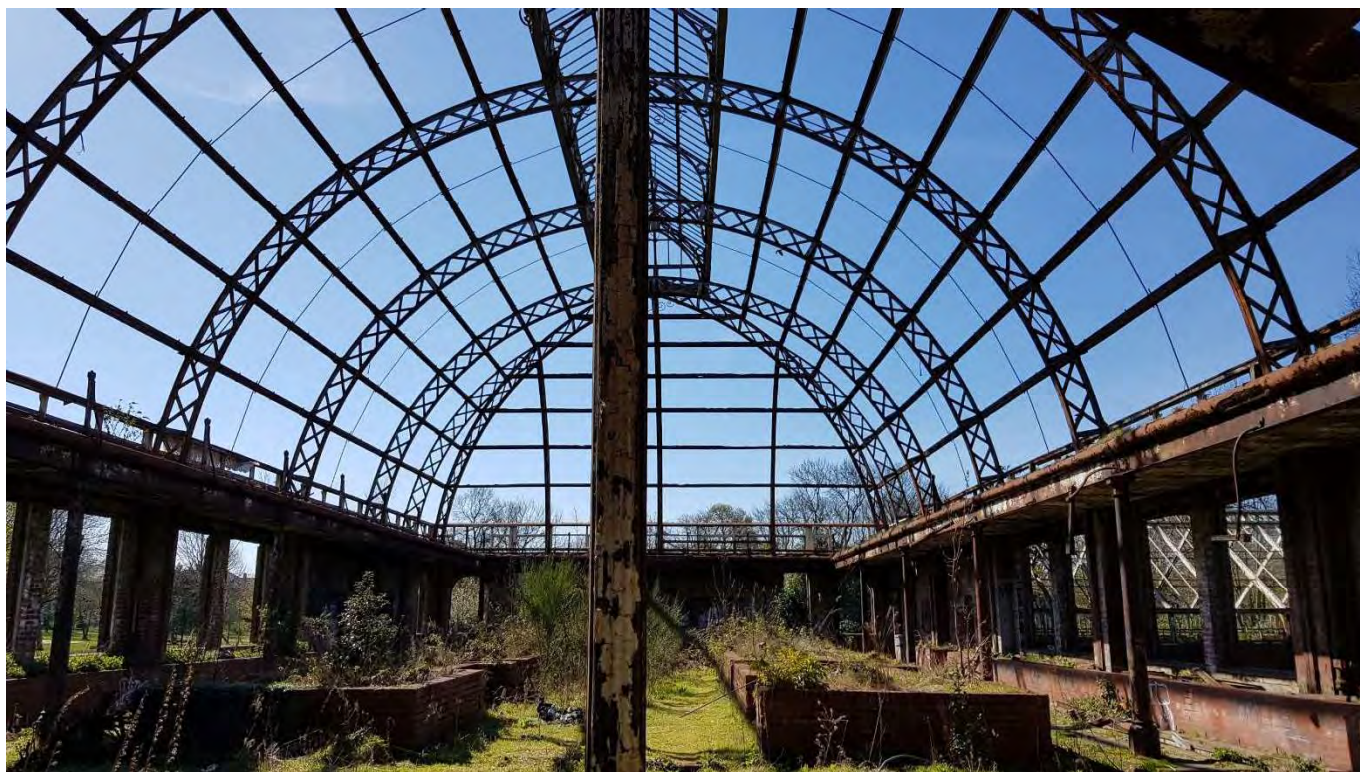
1 – View of Main Hall looking south

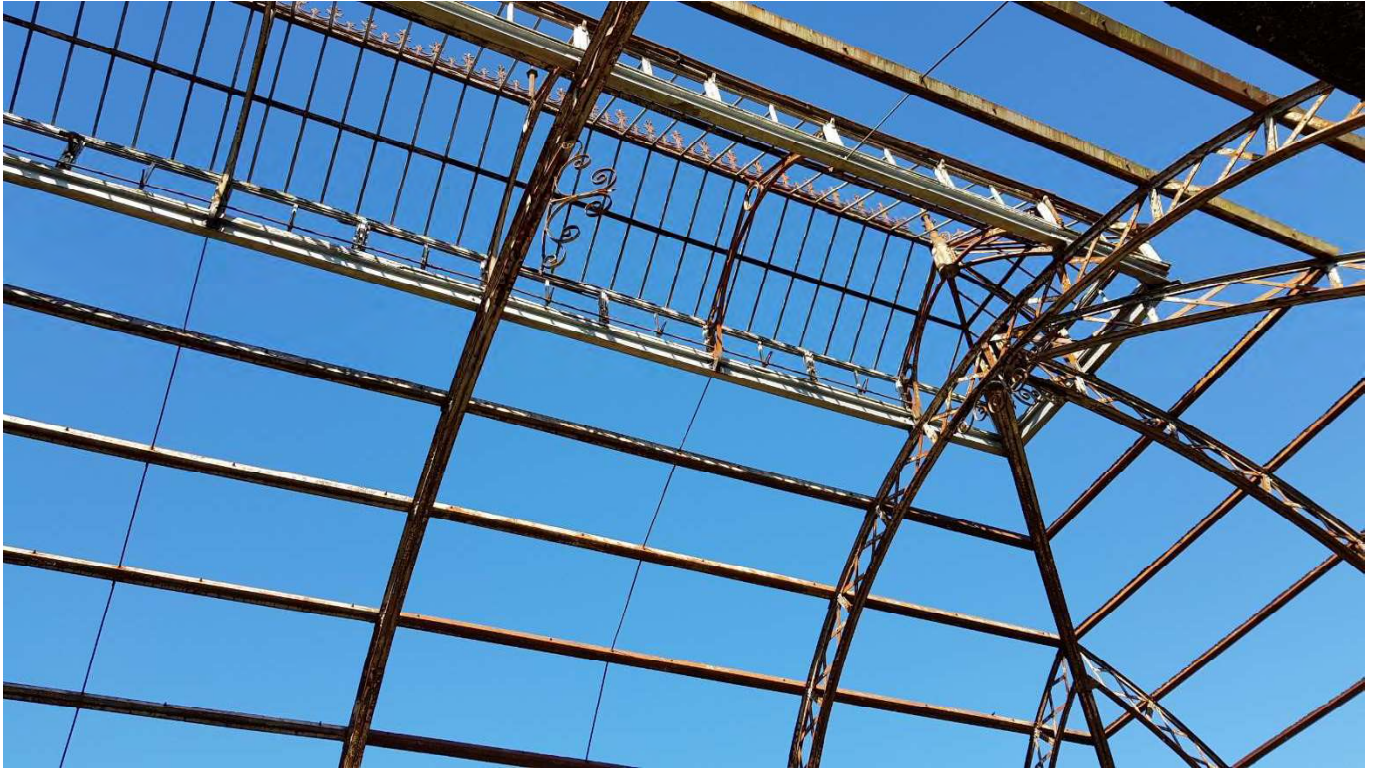
3 – View of 'hanging' bracket (looking north-west) and recently repaired cupola ringbeam

The corroded steelwork around the base of the cupola has already been strengthened or replaced as part of a partial repair contract. One of the hanging scroll-work brackets suspended from the cupola is now hanging by what appears to be a single bolt, and will need to be removed as part of the initial clearance works.

The steel beams supporting the Lantern have already been fully replaced but a hanging steel scrollwork element needs to be removed to make the central space safe to access.

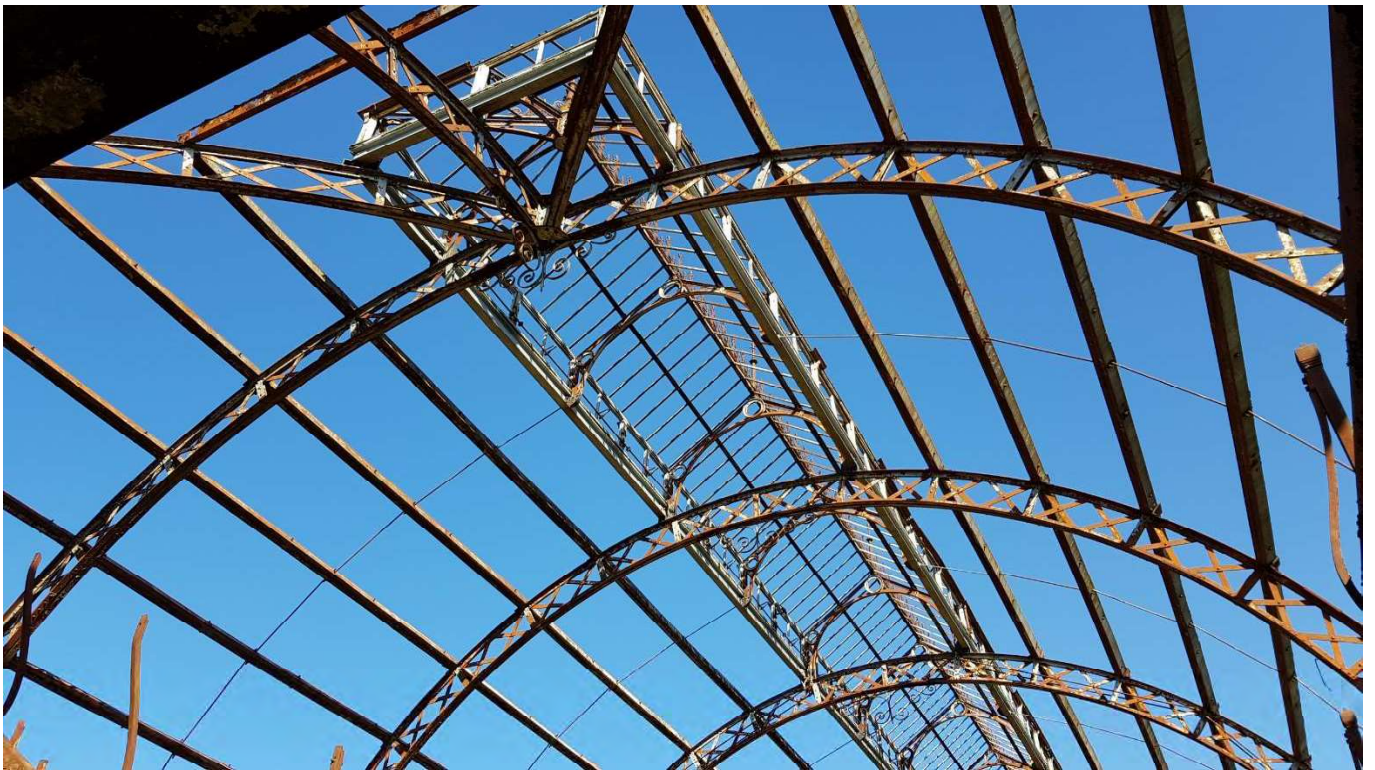
4 – View of Main Hall roof showing the relatively good condition of the purlins on running north-south

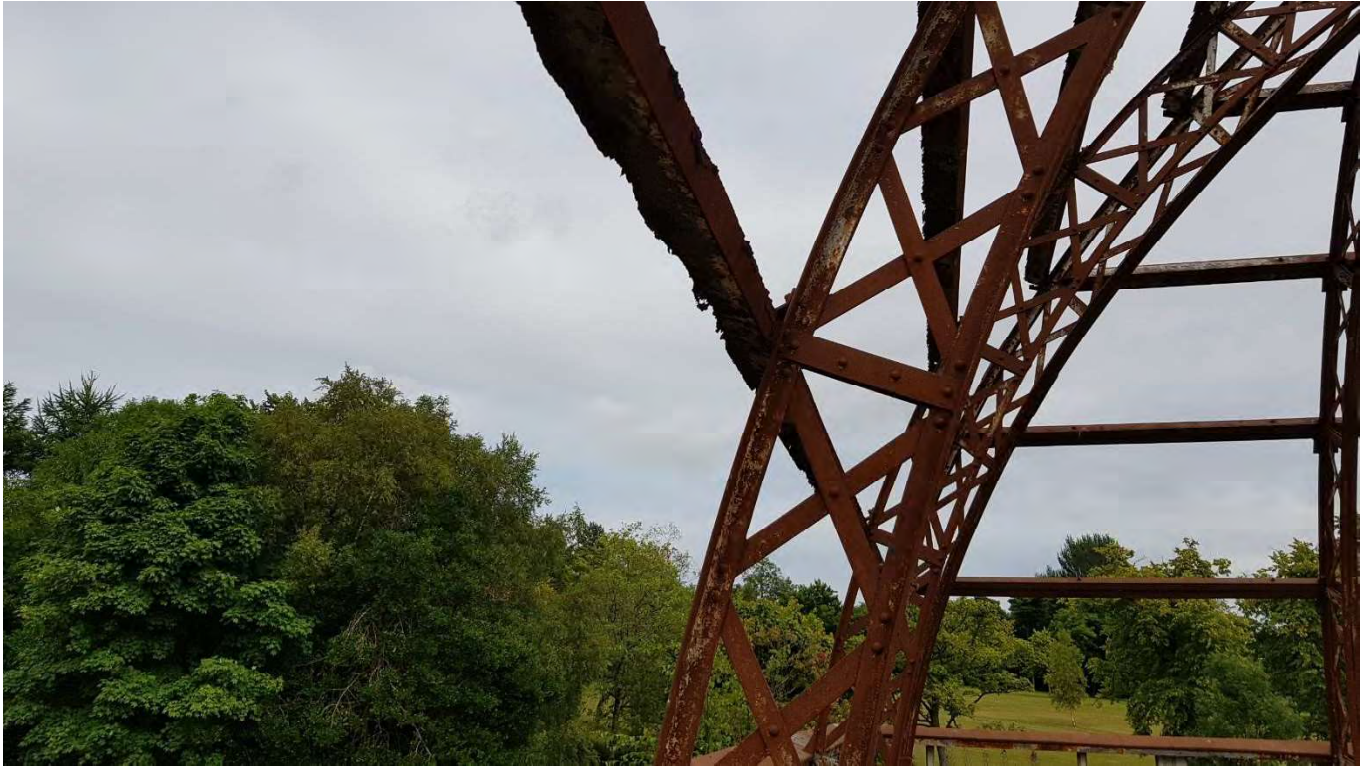
5 – North elevation purlin deterioration showing severe section loss to single purlins on the north and south main elevation frames

All existing purlins should be removed and replaced with a like-for-like section. If historic Rolled Steel Channels are not able to be sourced it may be acceptable to substitute for modern equivalents. An assessment should be made as to whether the RSC purlins on the east and west elevations are original and whether they need to be replaced.

Existing corroded purlins on the north and south end elevations should be checked by crane basket to confirm fixity and whether they are a risk going forward for public access. Allow for replacement of the end bay purlins as part of the public access works.

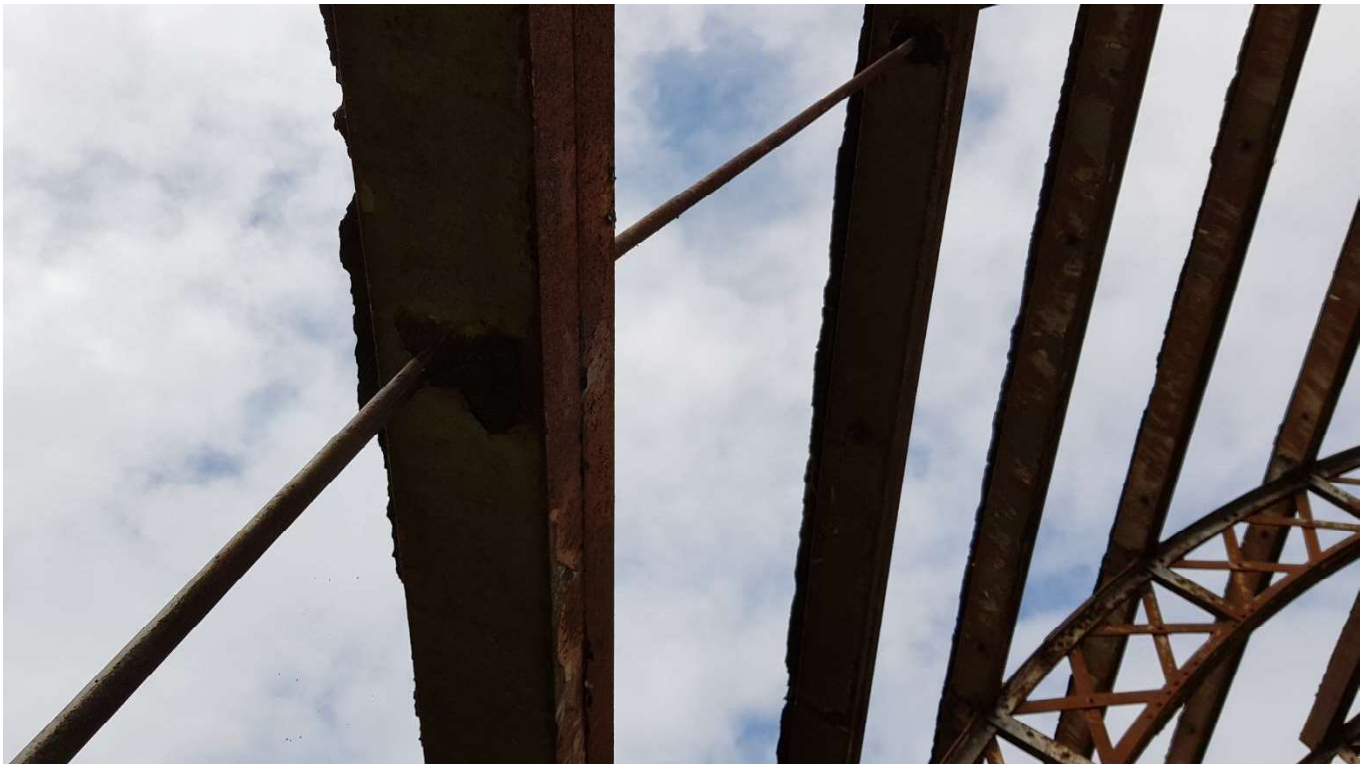
6 – Similar to Photo 5, the corrosion of the main purlins on the north elevation is severe, but the anti-sag rods appeared to be in reasonable condition

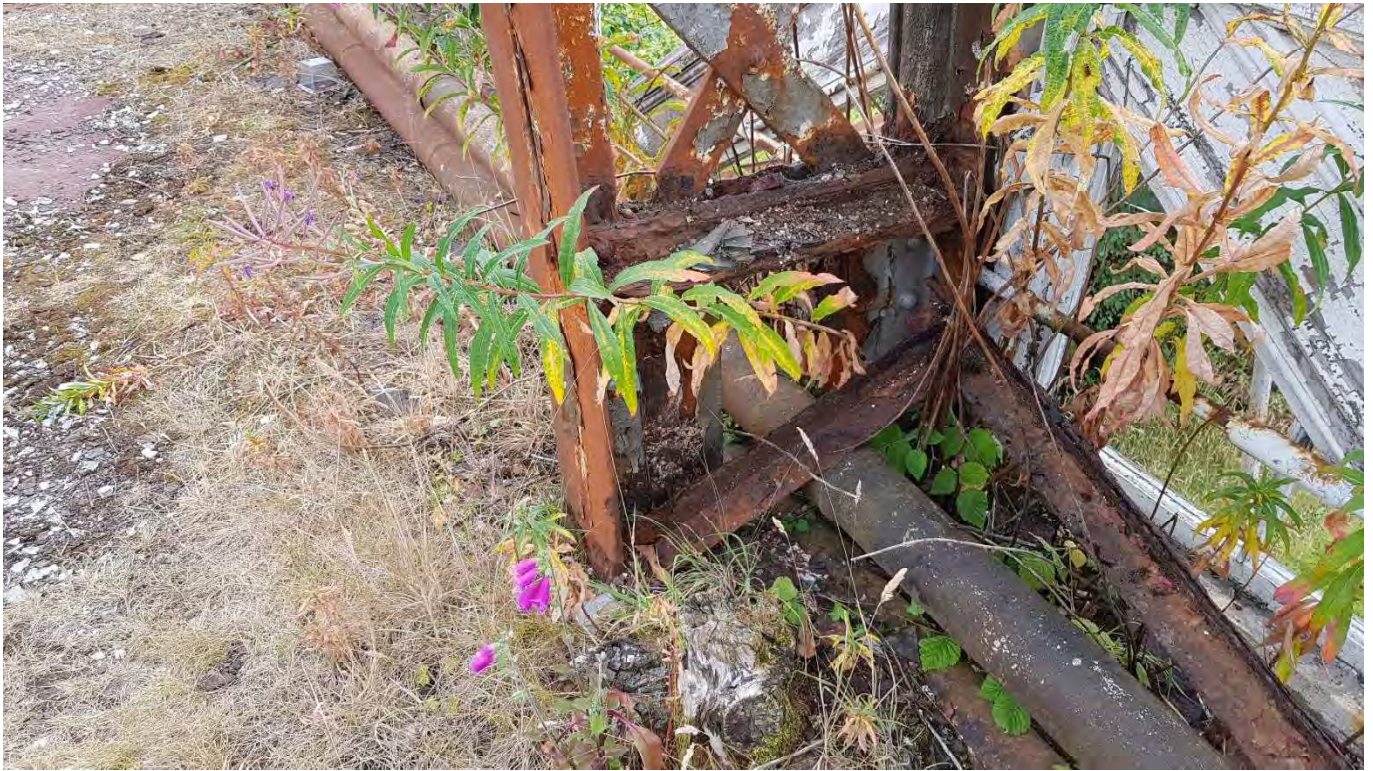
7 – Base of one of the lattice frames on the west elevation showing the localised corrosion of the lower level angles

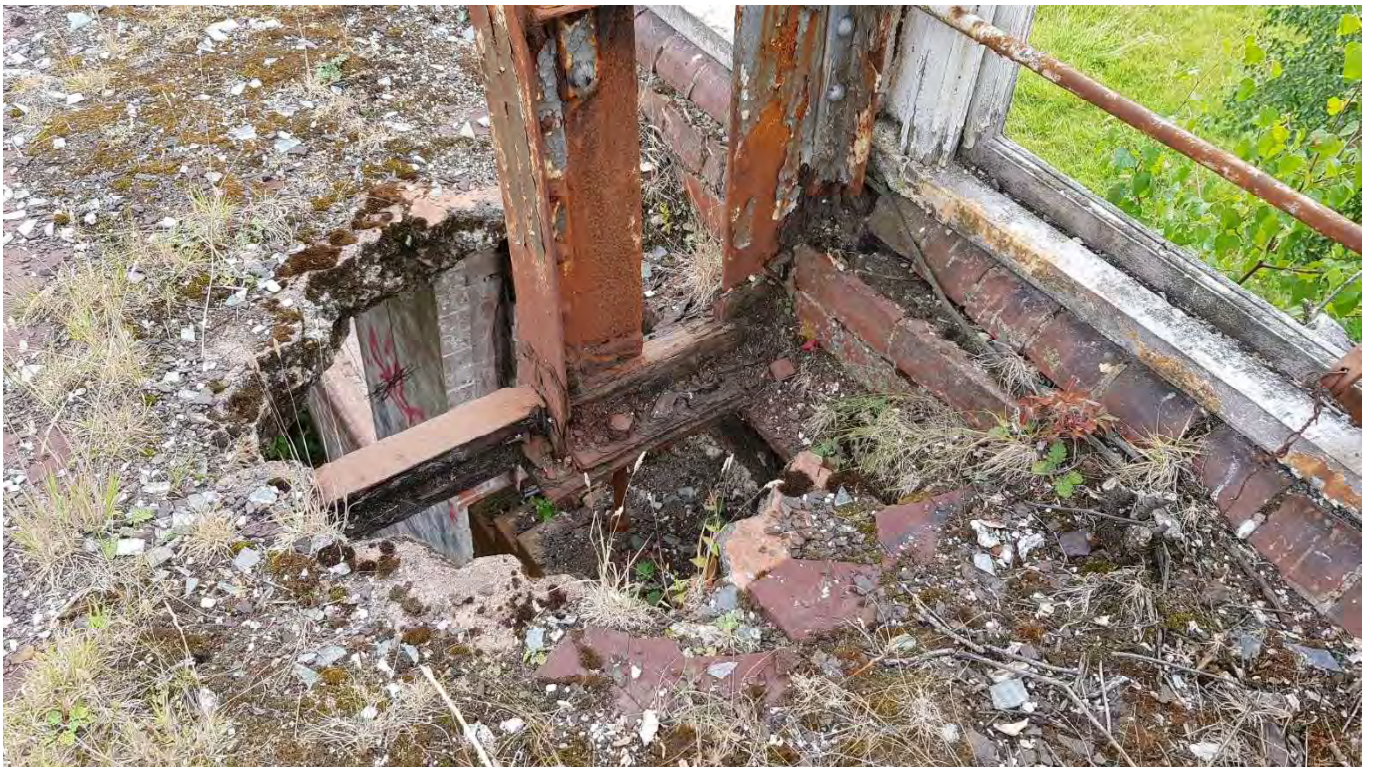
8 – The opened-up lattice frame base to the south-west of the Main Hall, showing some delamination and loss of rivets/bolts at slab level

Below Gallery level the steel should wire brushed and painted with a suitable corrosion inhibiting coating. Allowance should be made at this time for strengthening the columns by bolting 200x90x30 PFCs either side of the flange and bolting through. This will enhance the compressive and bending capacity of each column. A further assessment of the columns should be made when they are fully exposed.

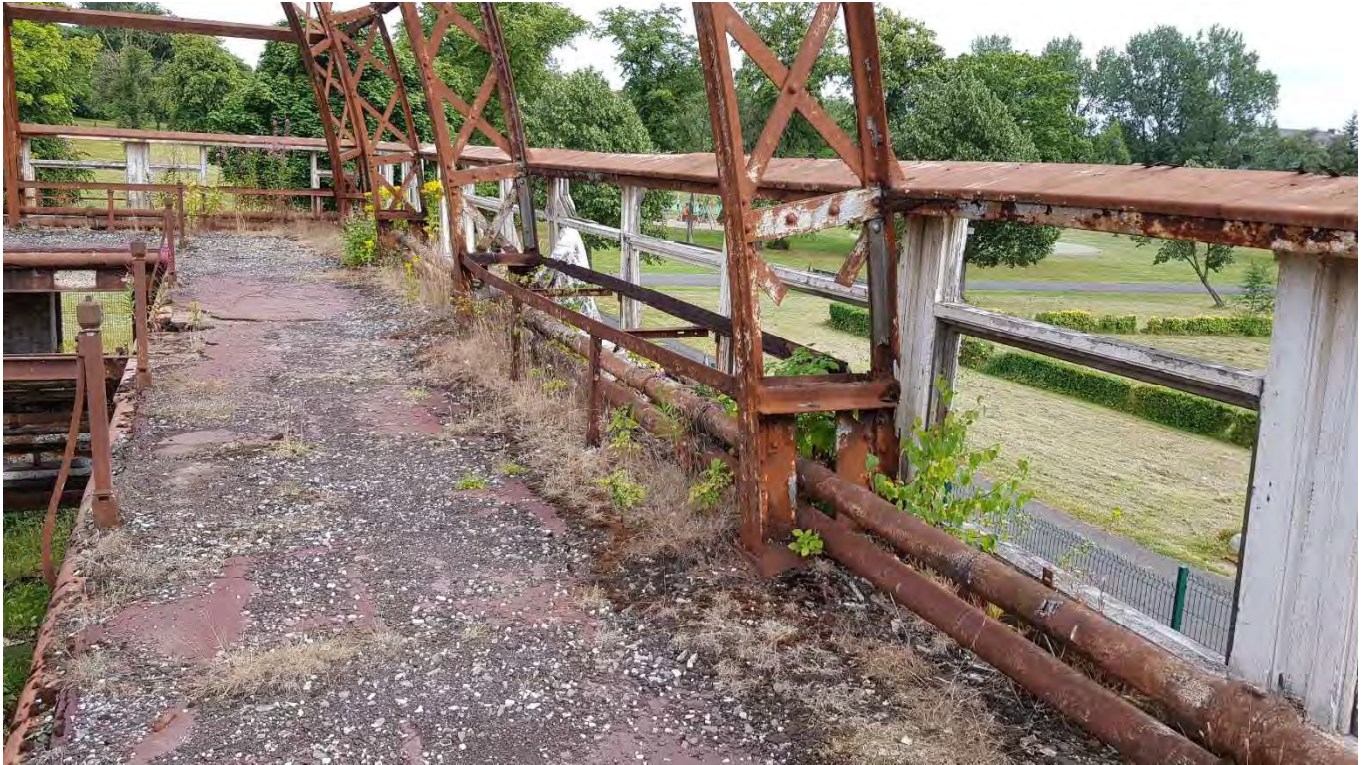
9 – View along the south gallery showing the condition of the floor surface and missing cross members in the main lattice frame

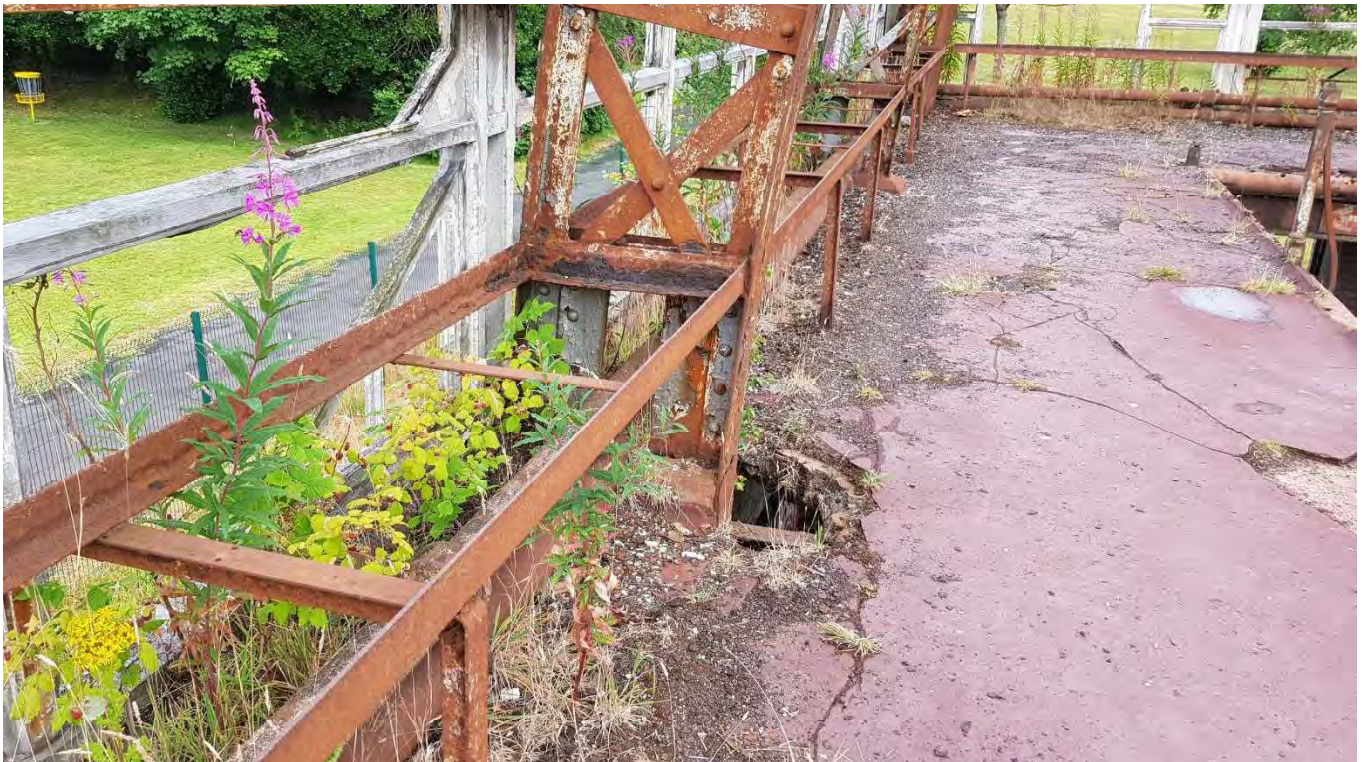
10 – View along north balcony with cracked finishes to slab and the original table framing. Some original paint finishes are still shown on the steelwork

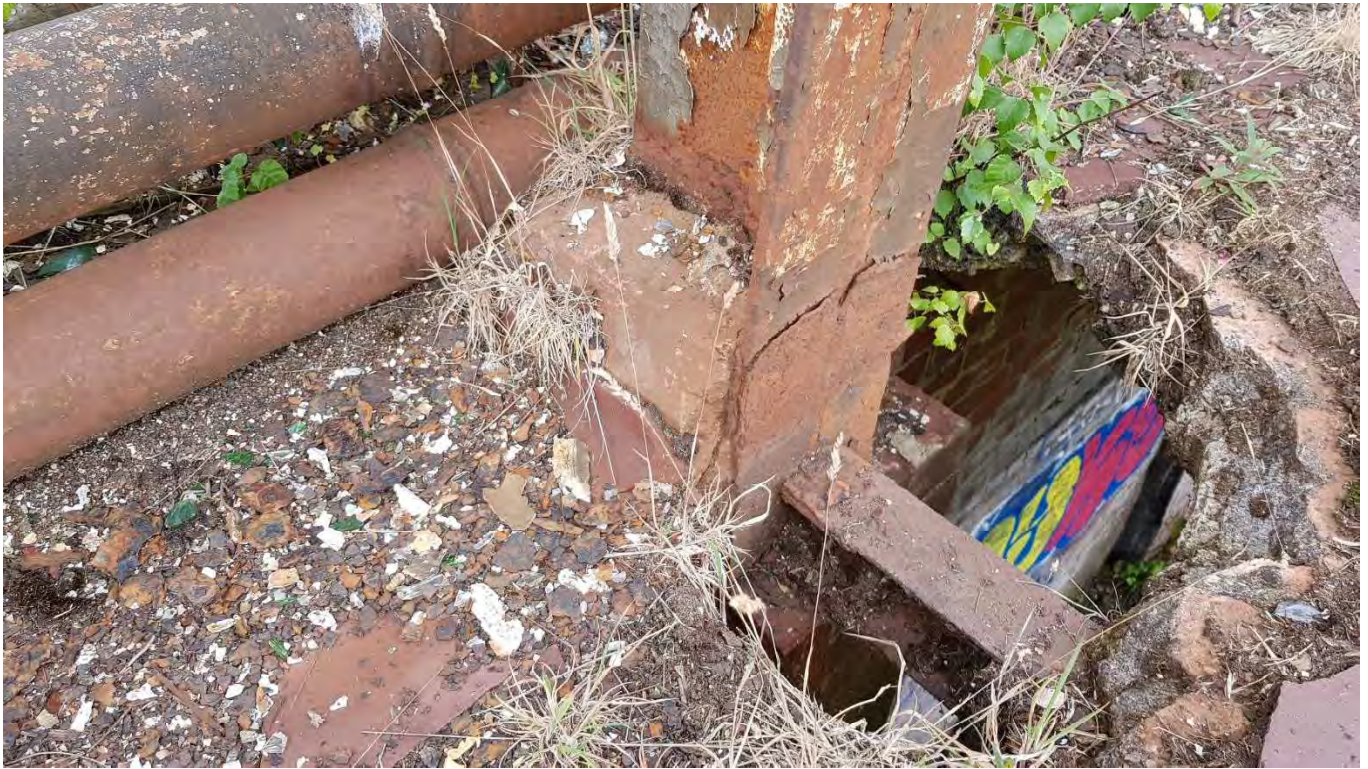
11 – Close-up view at base of main frame showing the steel is intact but has delaminated and needs some attention

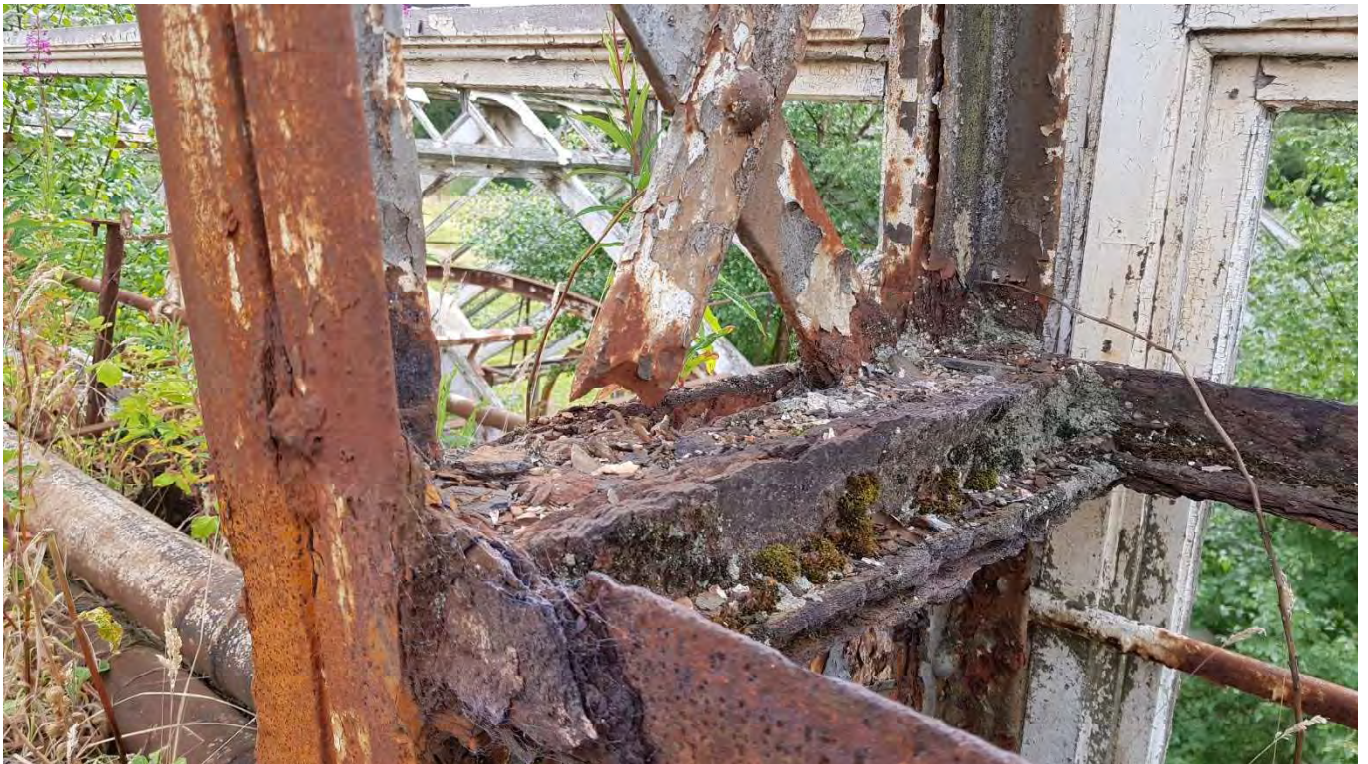
12 – View of one of the worst corroded angle frame connections with severe deterioration of the steelwork locally

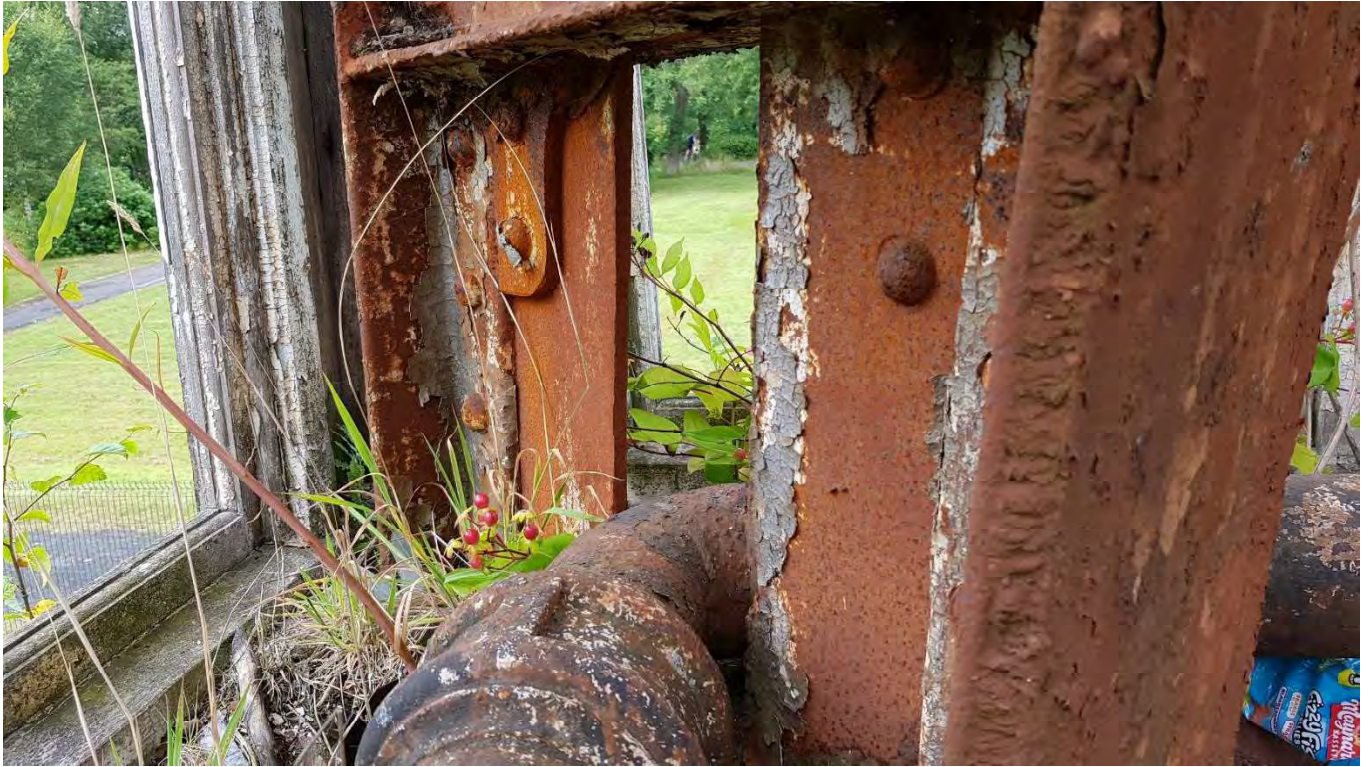
13 – View below the lower steelwork in the north-west corner with intact rivets and only surface corrosion

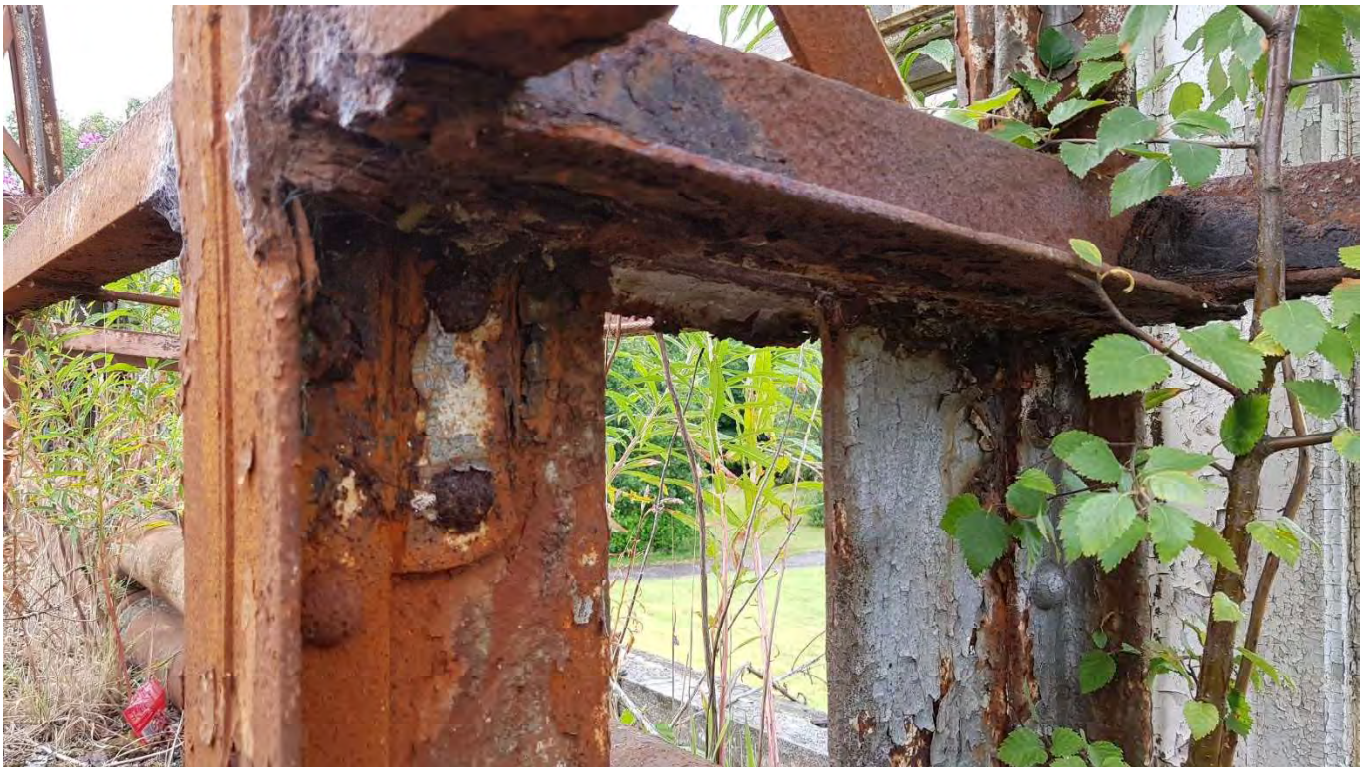
14 – Close-up view of lower frame connection with more deterioration to rivets

There is uncertainty on whether the riveted connections have deteriorated resulting in a loss of strength. Allowance should be made for enhancing the connections by riveting or, if acceptable, spot welding.

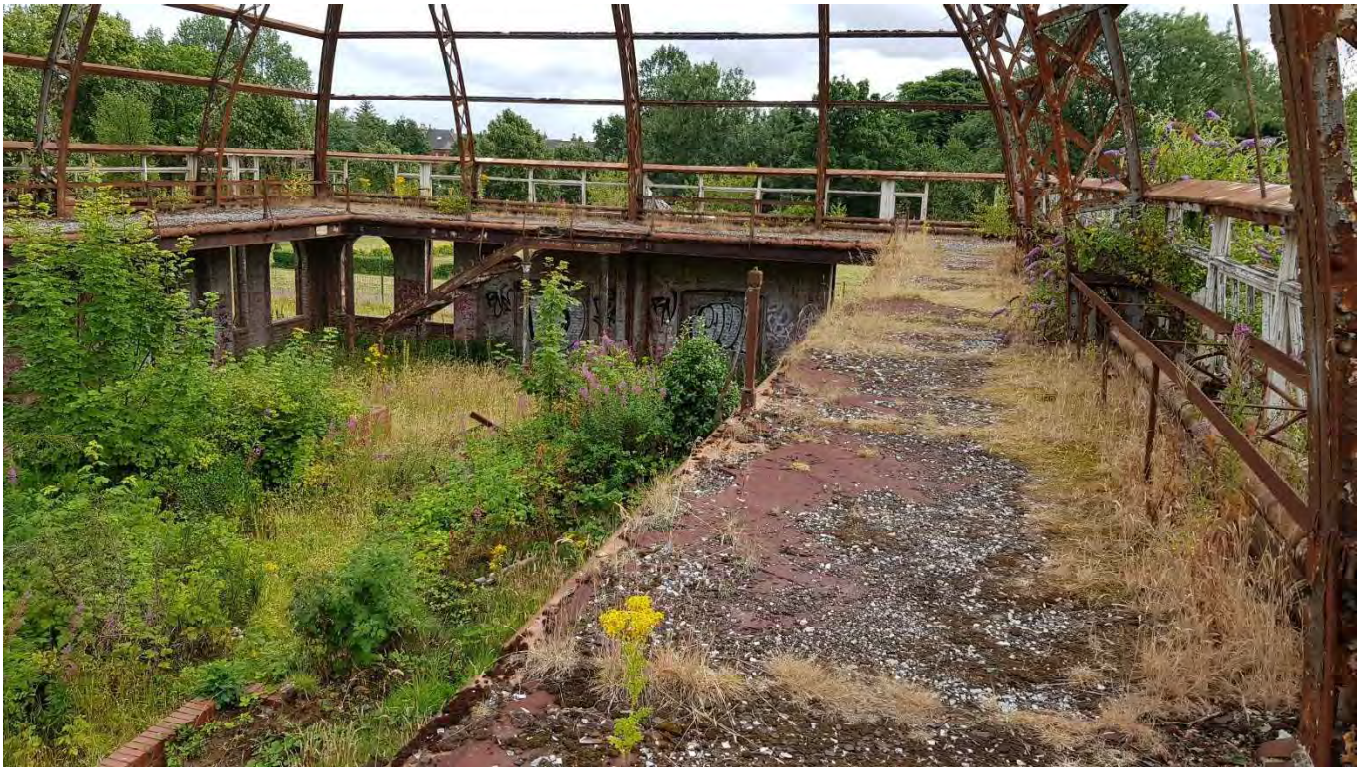
15 – View along west balcony looking south

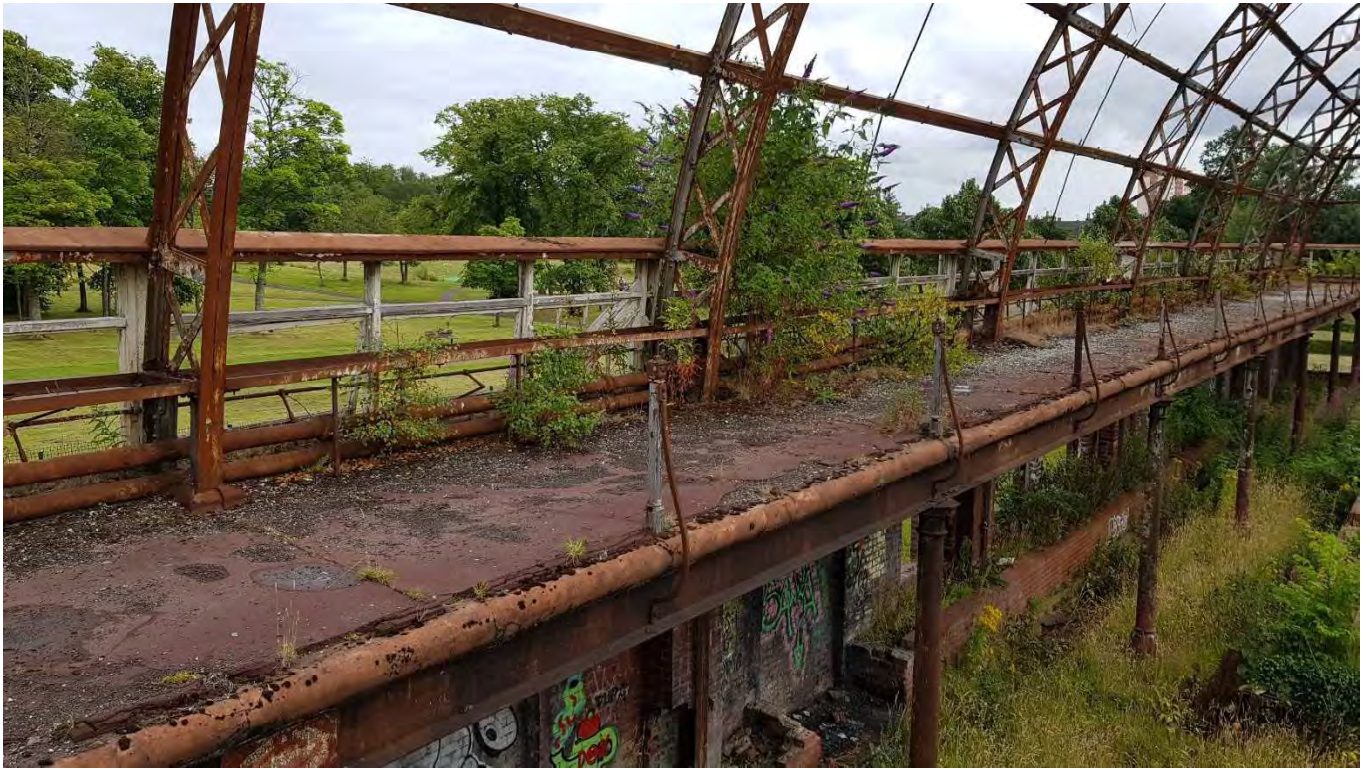
17 – West balcony showing missing balustrading and failed top surface

The steel and ironwork to the stairs should be wire brushed and reused with new timber treads installed. The Gallery balustrade should be wholly replaced using the few remaining balusters as a template.

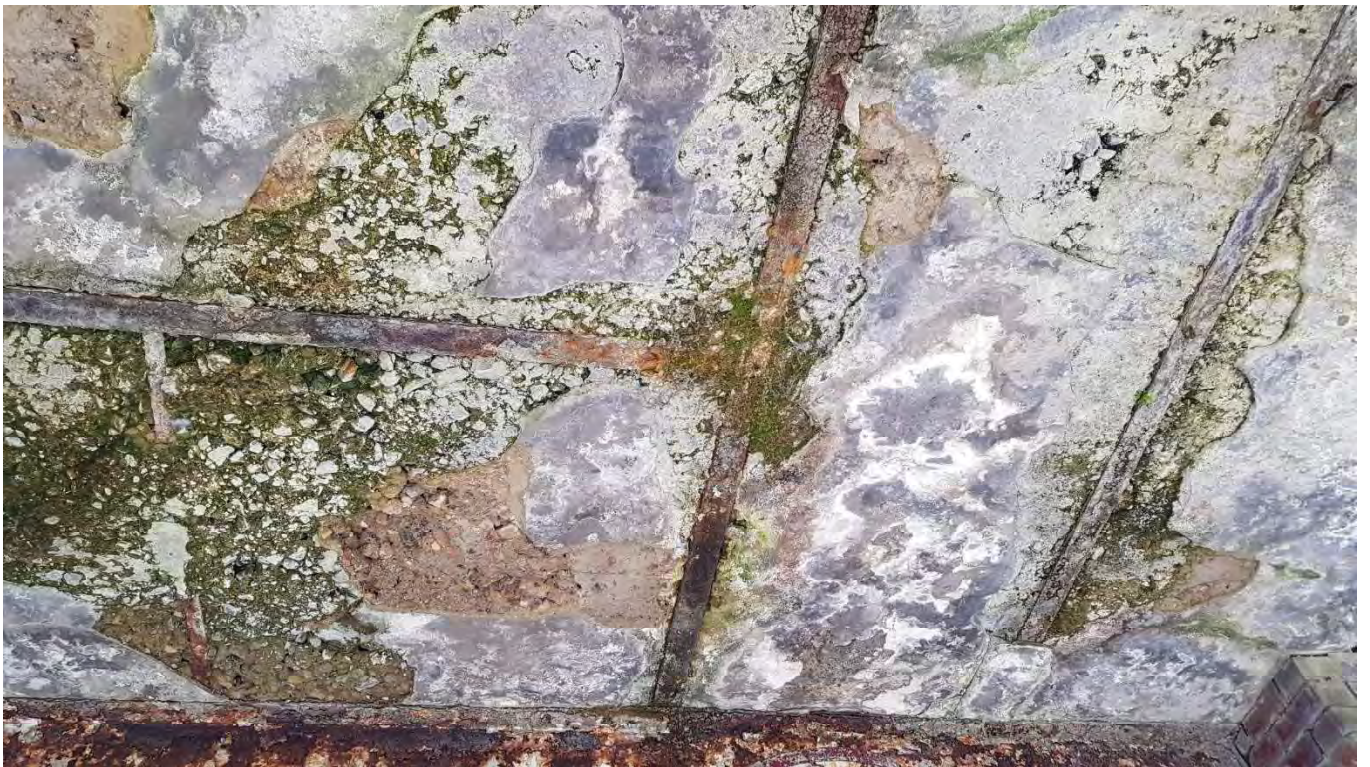
18 – View of underside of balcony showing filler joists with some corrosion and some spalling of the concrete infill, but the structure appeared intact

The filler joists should be wire brushed and painted with a suitable corrosion inhibitor.

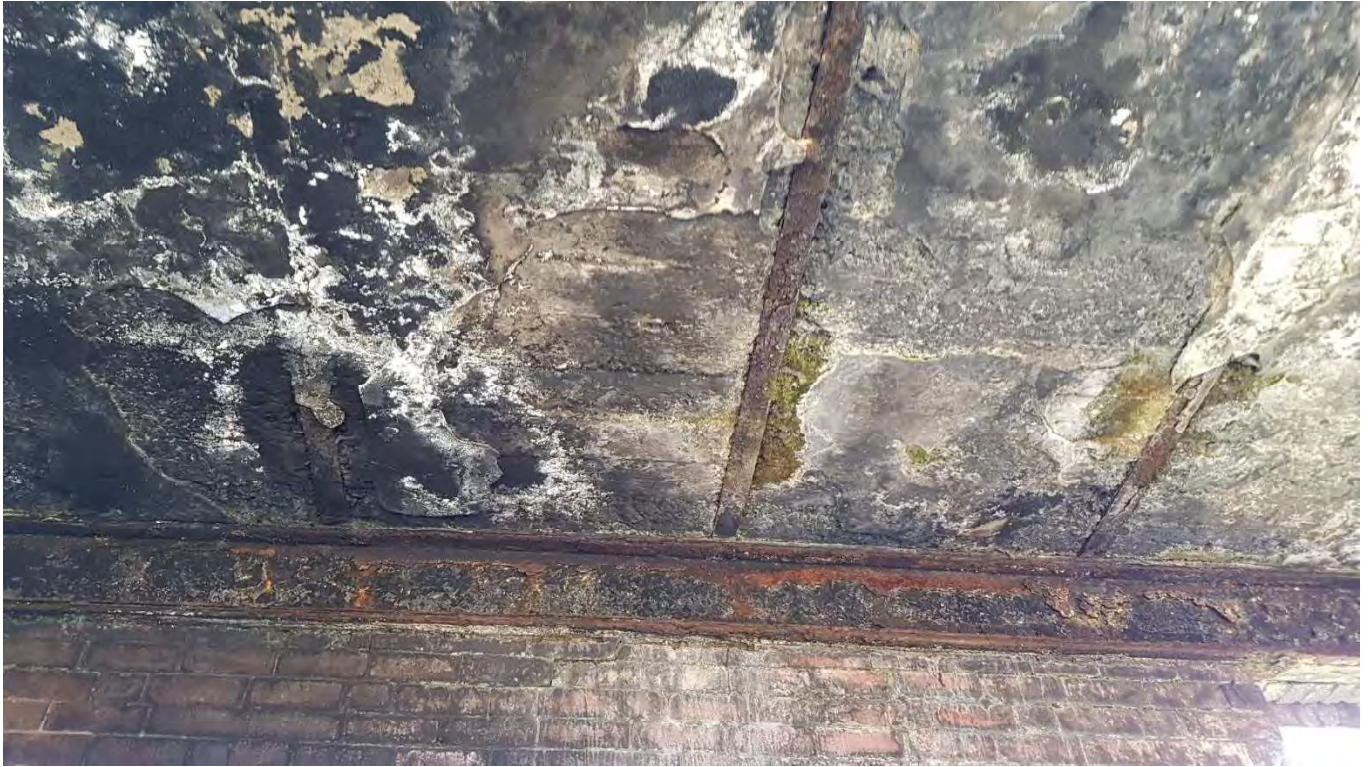
19 – Underside of balcony with corroded steel beam in the wall and some spalling in the slab

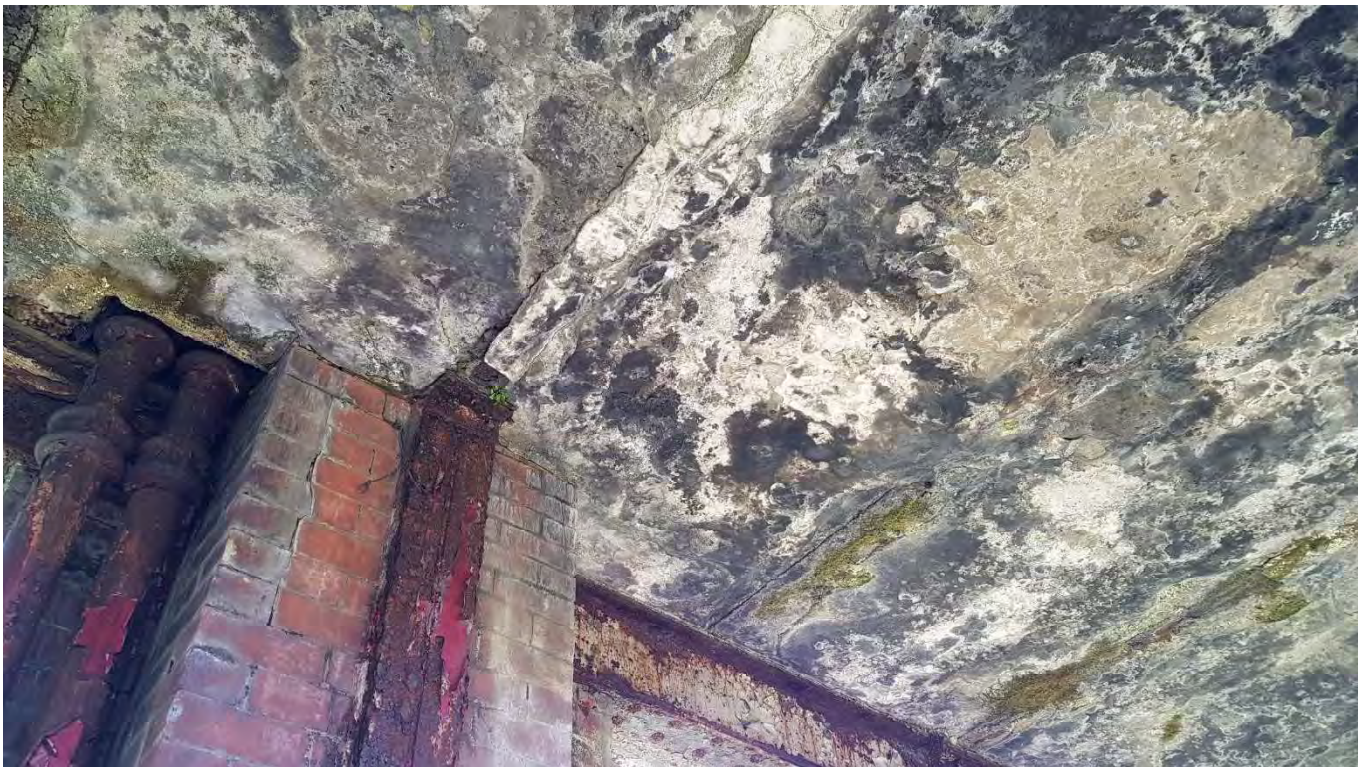
20 – Underside view of balcony at column location showing intact but deteriorating concrete

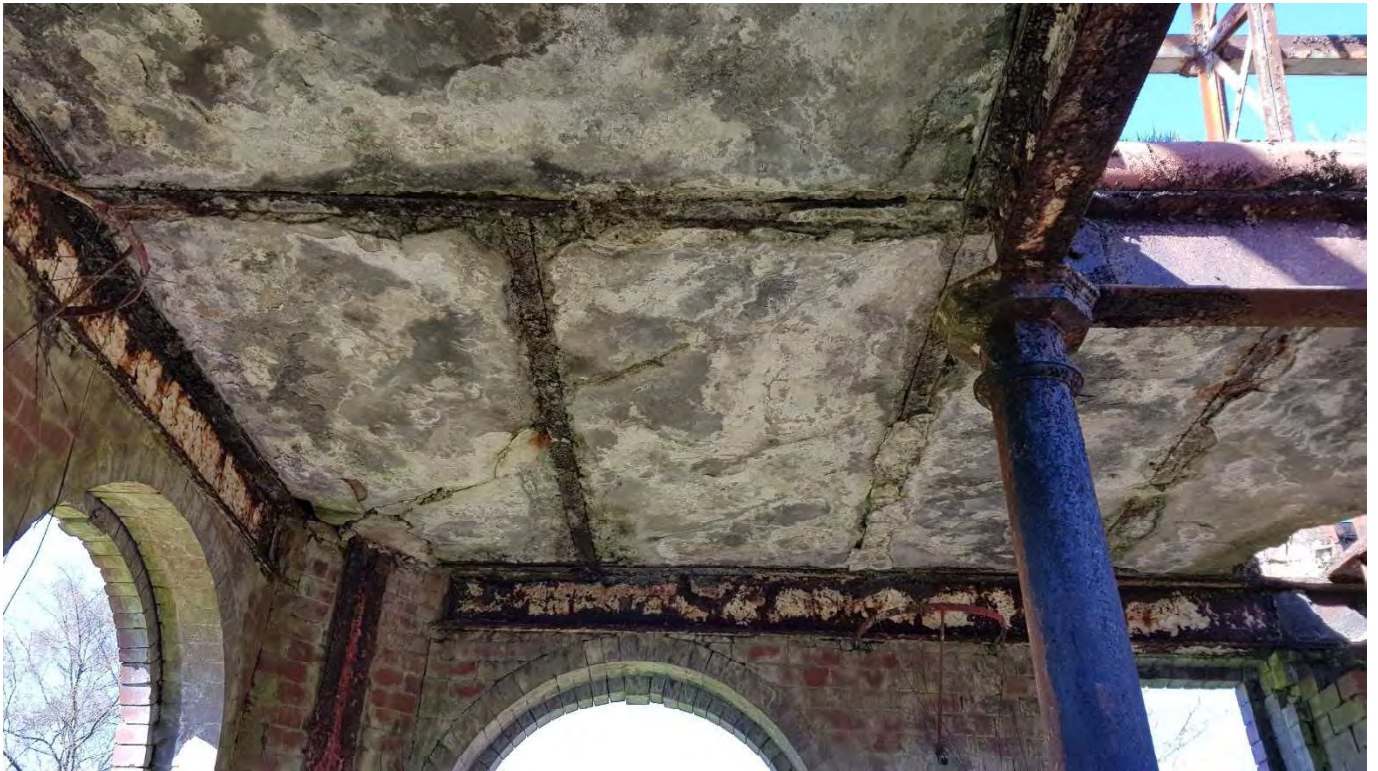
21 – Underside view of balcony slab and steel edge beams and cast iron column. Edge beams still have paint remnants and although surface deterioration on filler joists and concrete, all can be repaired

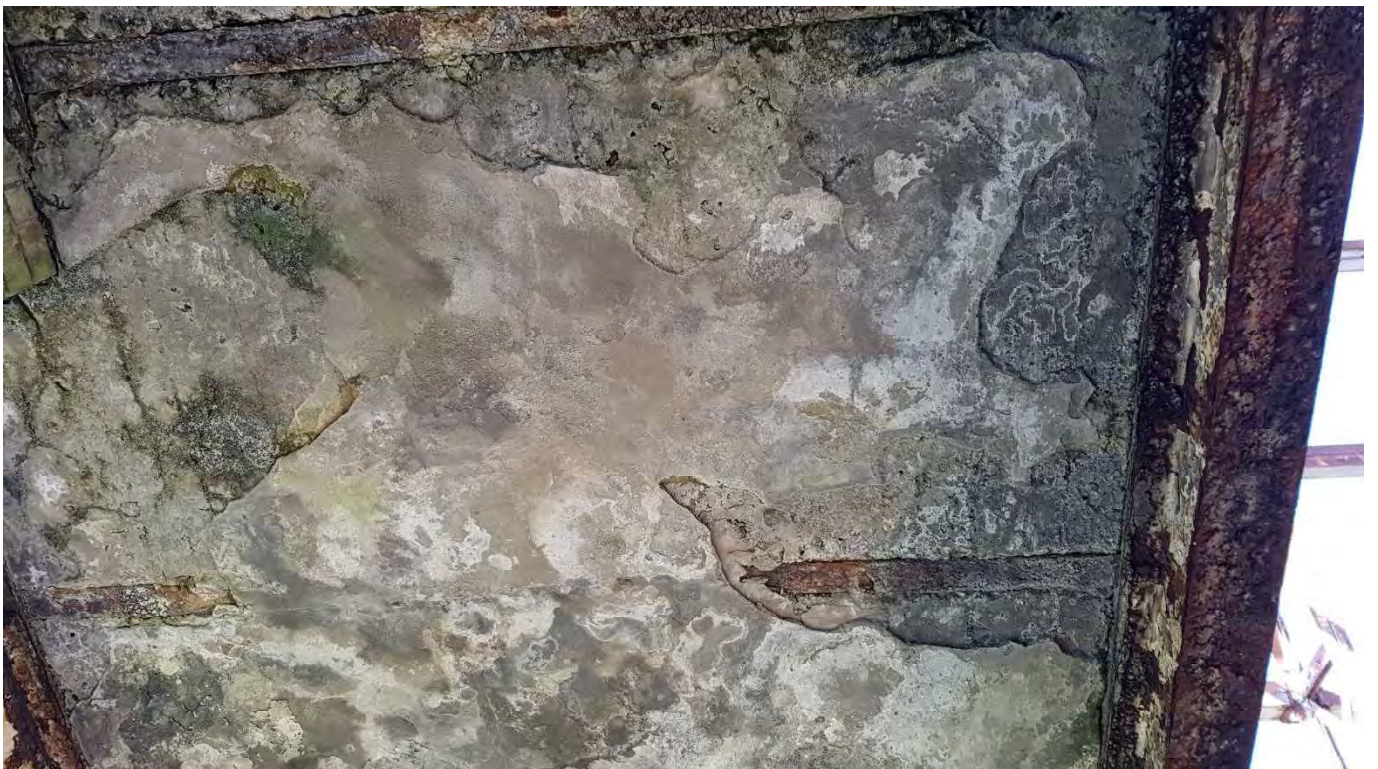
22 – Underside view of slab with more intact finishes and corroded steel support beam

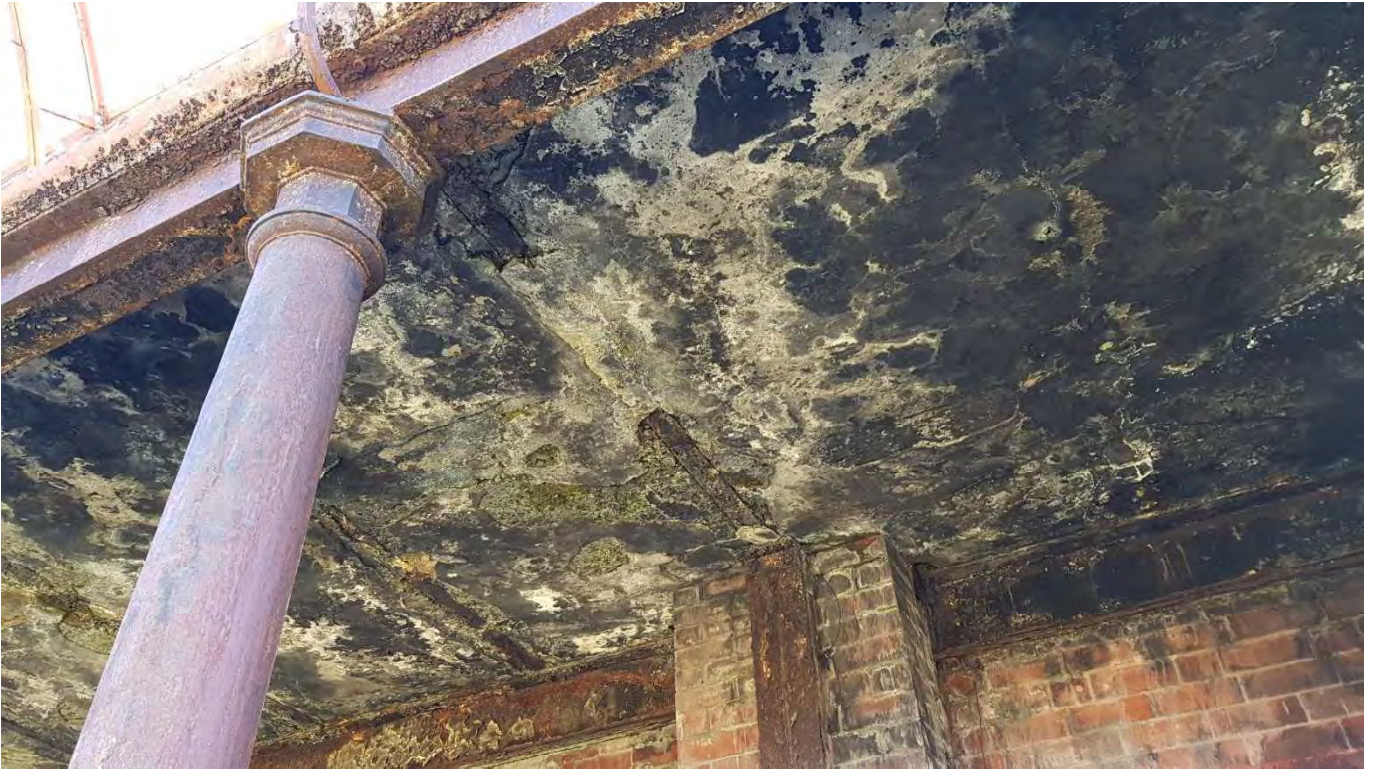
23 – Cast iron column is in good condition but the slab and filler joists will need some attention, as will the main stanchion base half-embedded in the pier
