## **Springburn Winter Gardens**

## **Structural Appraisal and Condition Report**

For:  
**Glasgow City Council**

**June 2021**

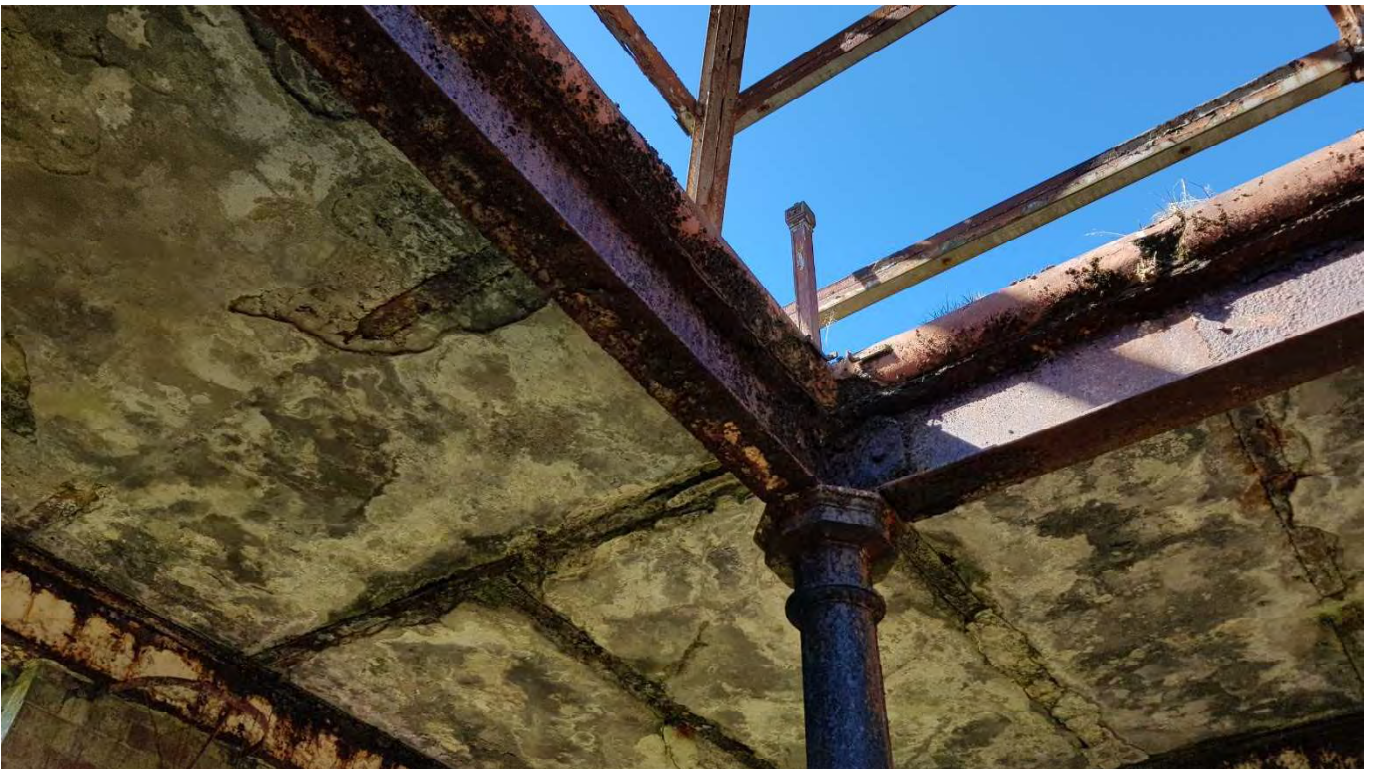
24 – Corroded steel beams at the corner which will need re-painted, but are intact

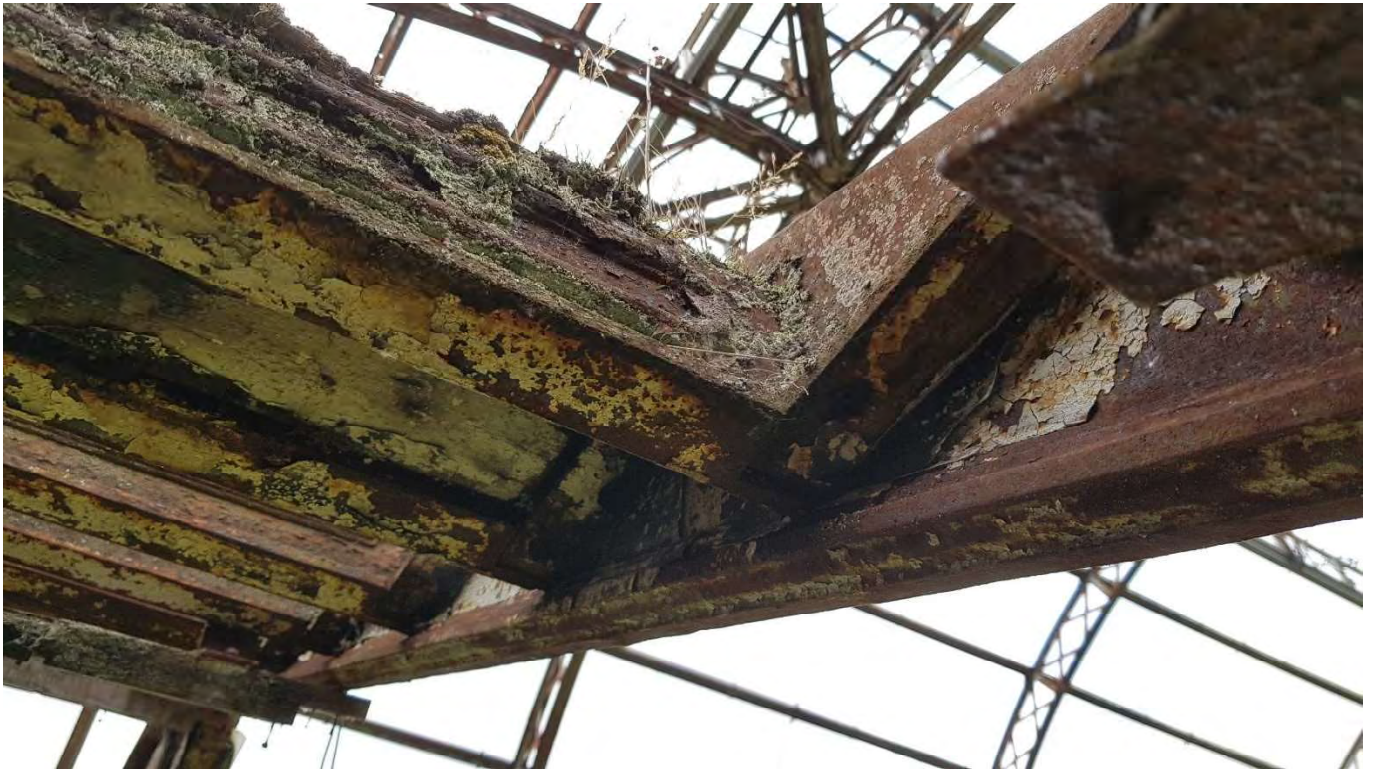
25 – Steel stairs have been damaged but the remaining steel is in reasonable condition and they could be repaired

The steel and ironwork to the stairs should be wire brushed and reused with new timber treads installed. The Gallery balustrade should be wholly replaced using the few remaining balusters as a template.

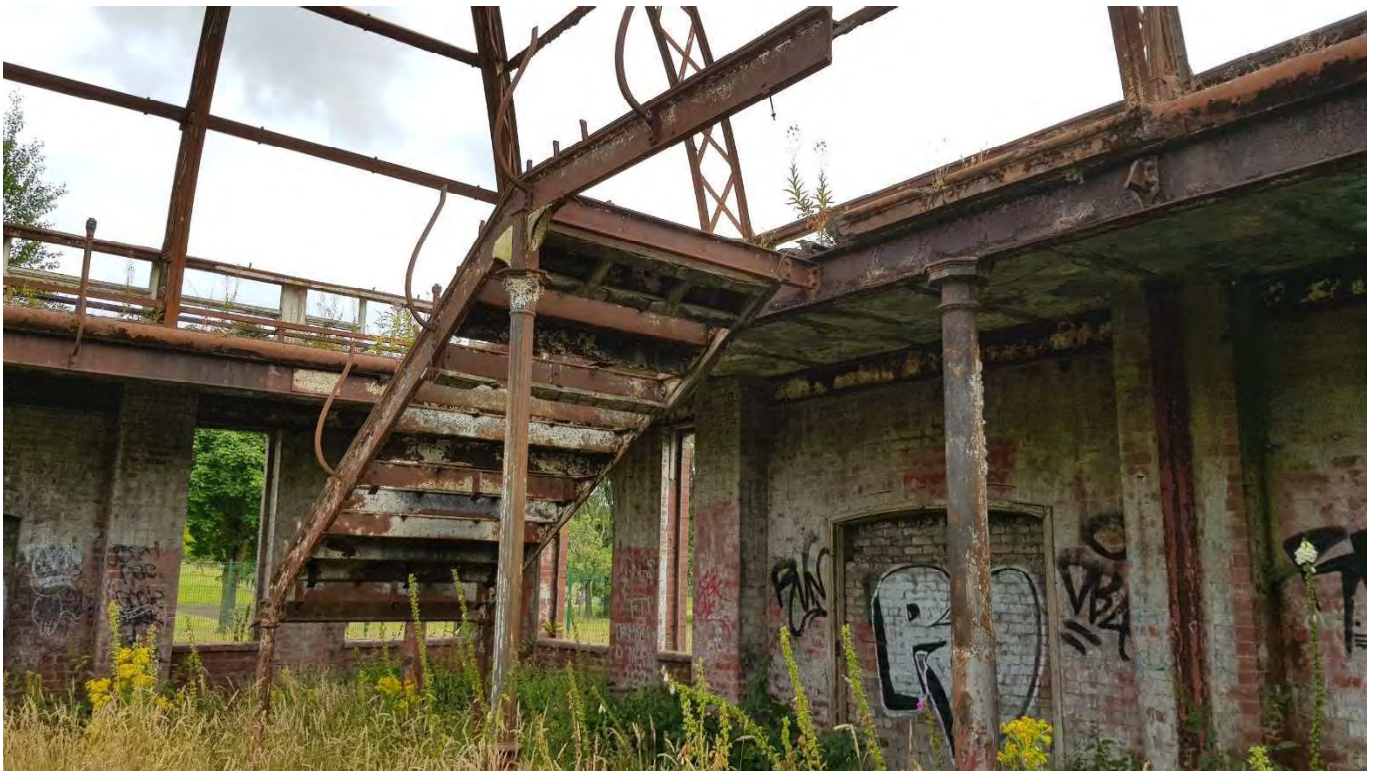
26 – View of steel stairs to south

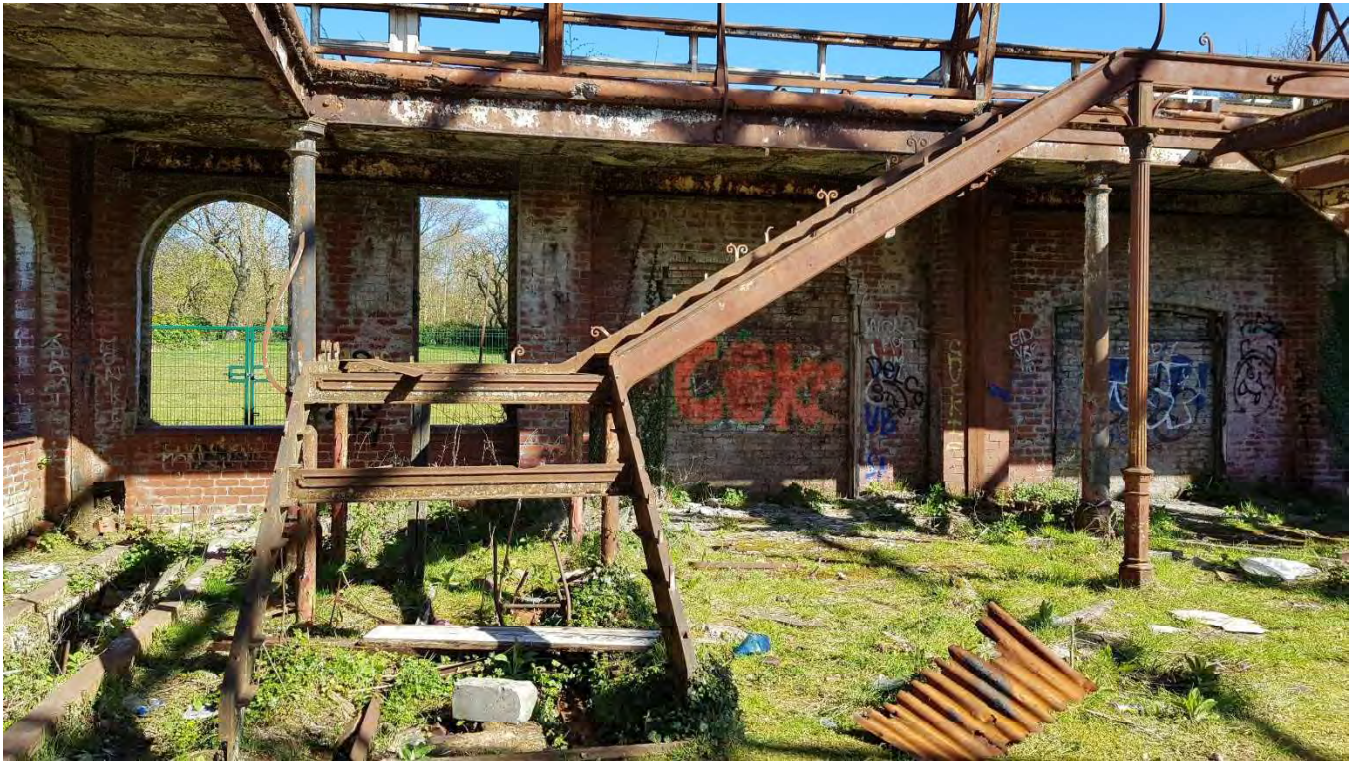
27 – View of steel stairs to north, which again can be repaired

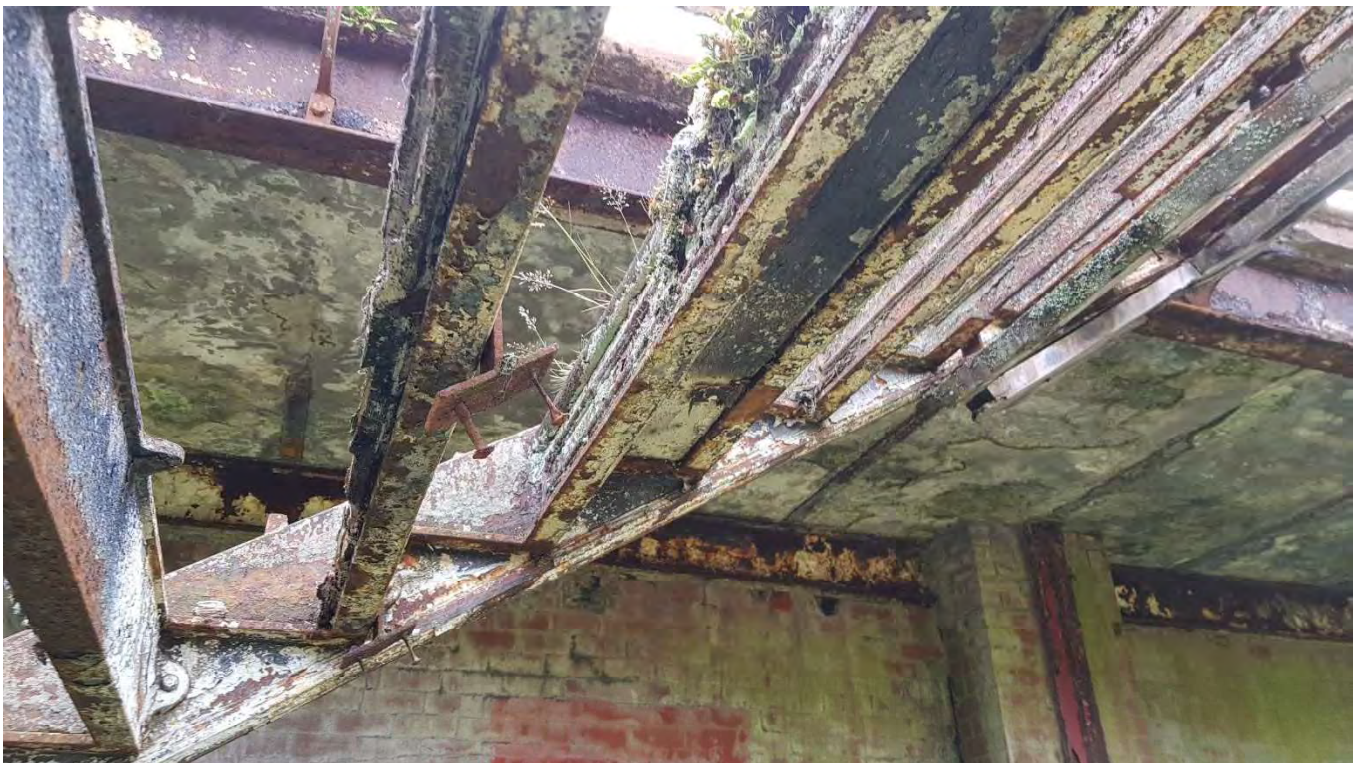
28 – Close-up of steel stairs showing surface deterioration but intact joints

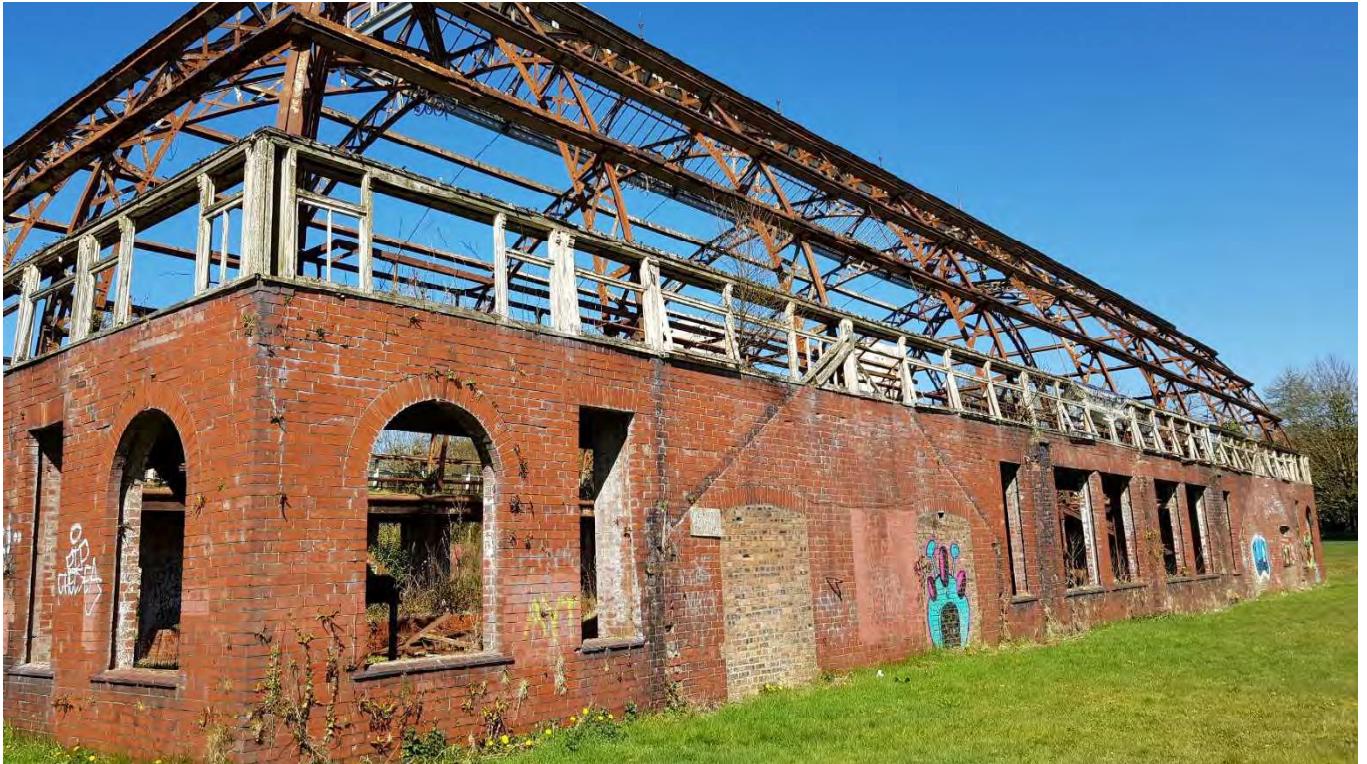
29 – View of east elevation showing previous openings bricked-up and the vestige of eastern glasshouses. Vegetation growth has rooted in the masonry mortar joints and will need to be removed

Ensure that no further deterioration due to vegetation growth within the cavities by applying a herbicide and regularly cutting back.

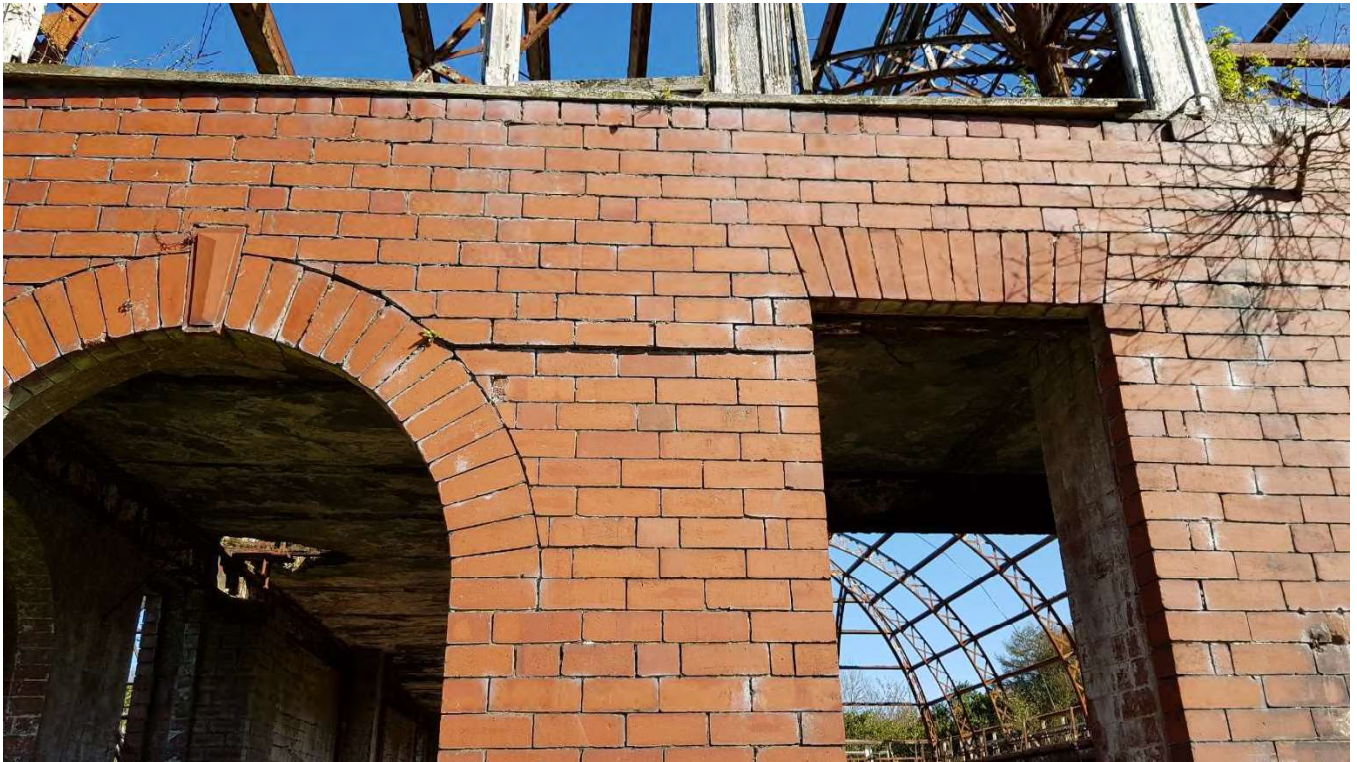
31 – Close-up of some root damage and dislocation of a course of masonry

Where root growth of vegetation has taken hold and caused movement of the masonry, the outer leaf of brickwork should be carefully taken down locally (generally over the top quarter of the wall) and set aside for refurbishment and reuse. All roots within the cavity should be removed prior to reinstatement of the bricks and full pointing carried out to weatherproof the masonry.

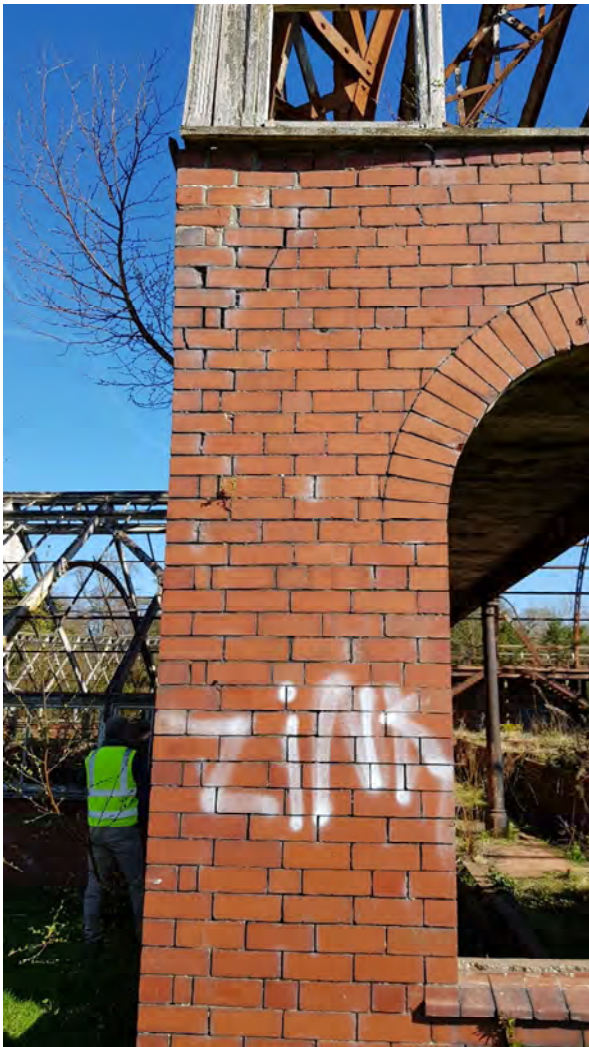
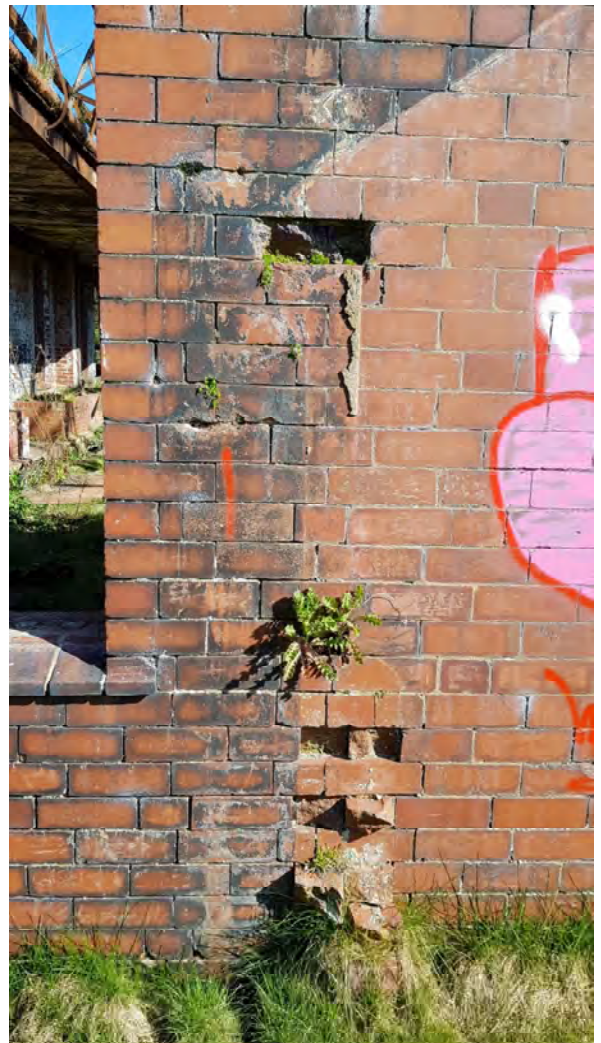
32 & 33 – View of south-west corner vegetation and cracking/movement and some missing bricks

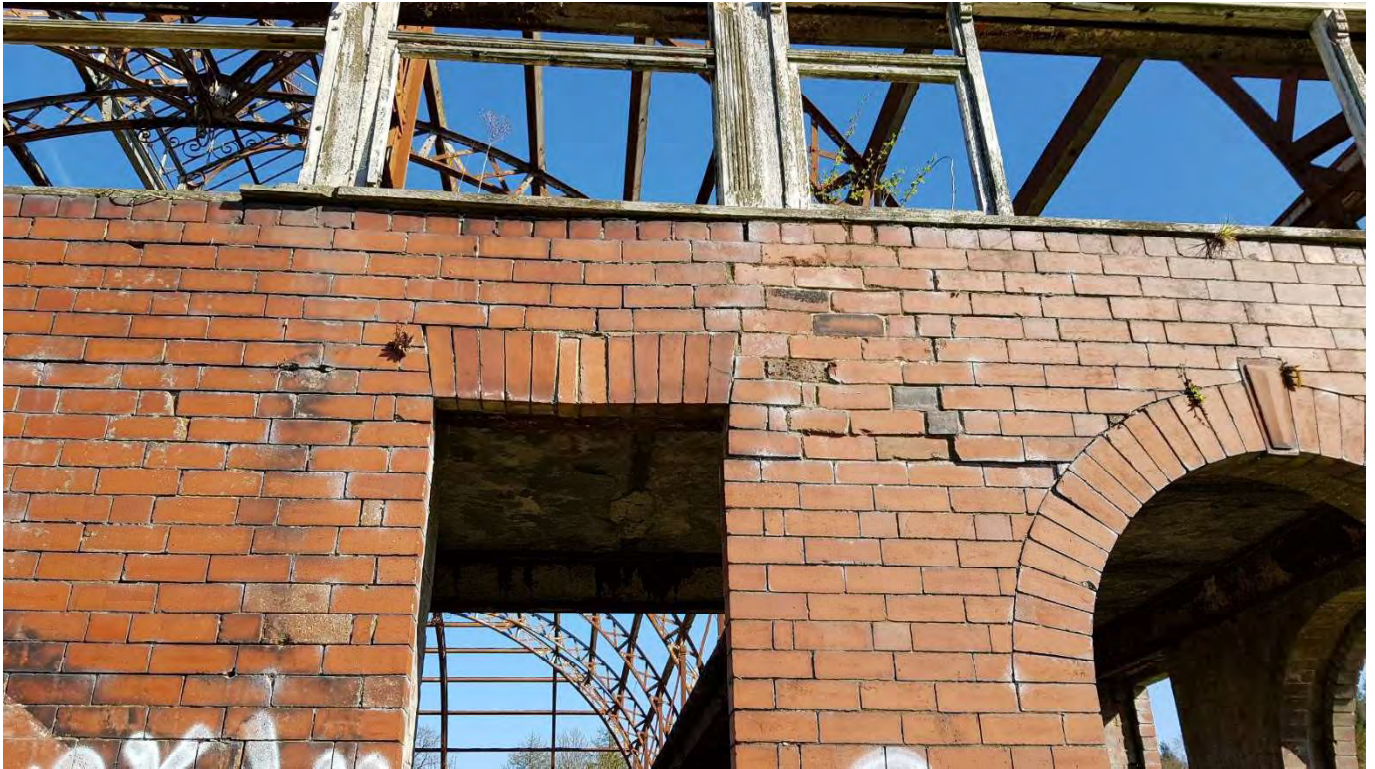
34 – Movement of masonry and failure of flat arch requiring some re-building and repointing

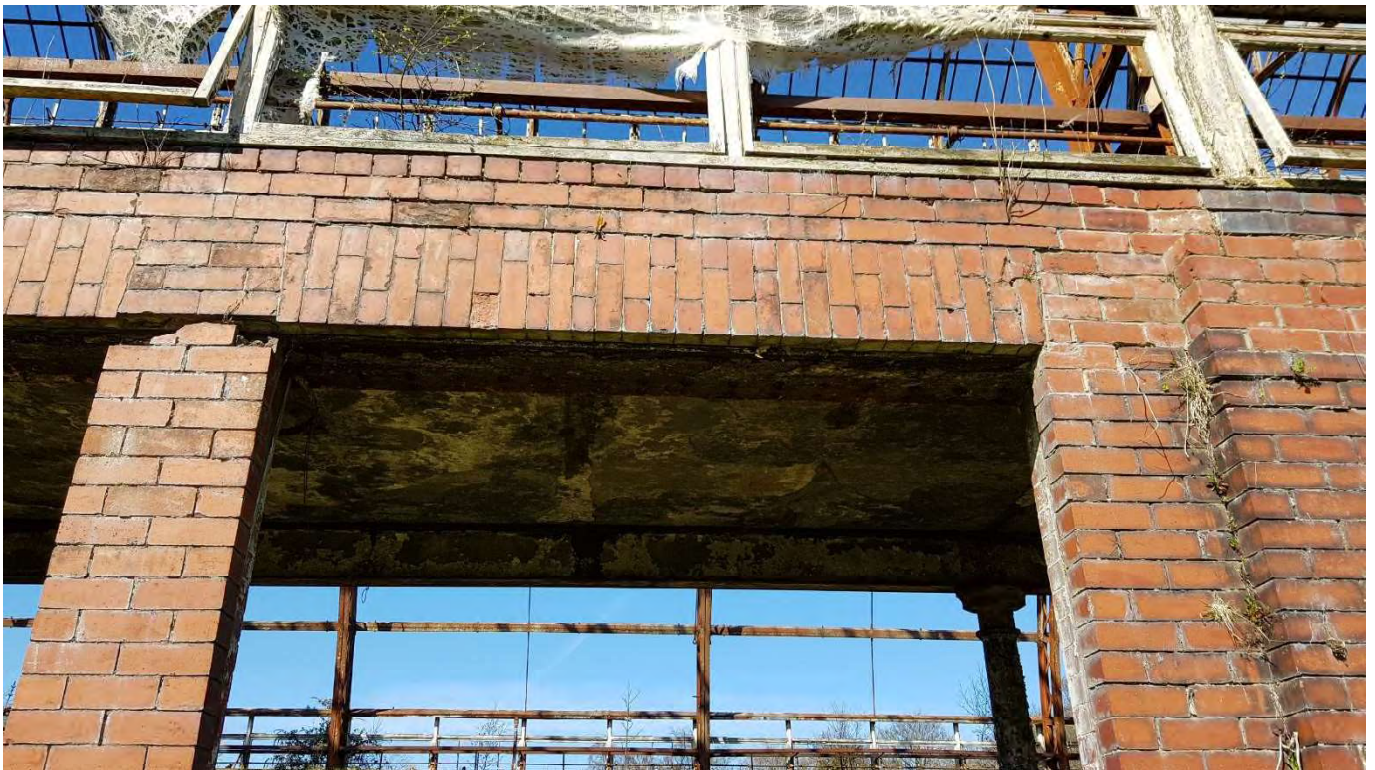
35 – Main flat arch with steel lintel behind showing localised jacking failure at the pier bearing

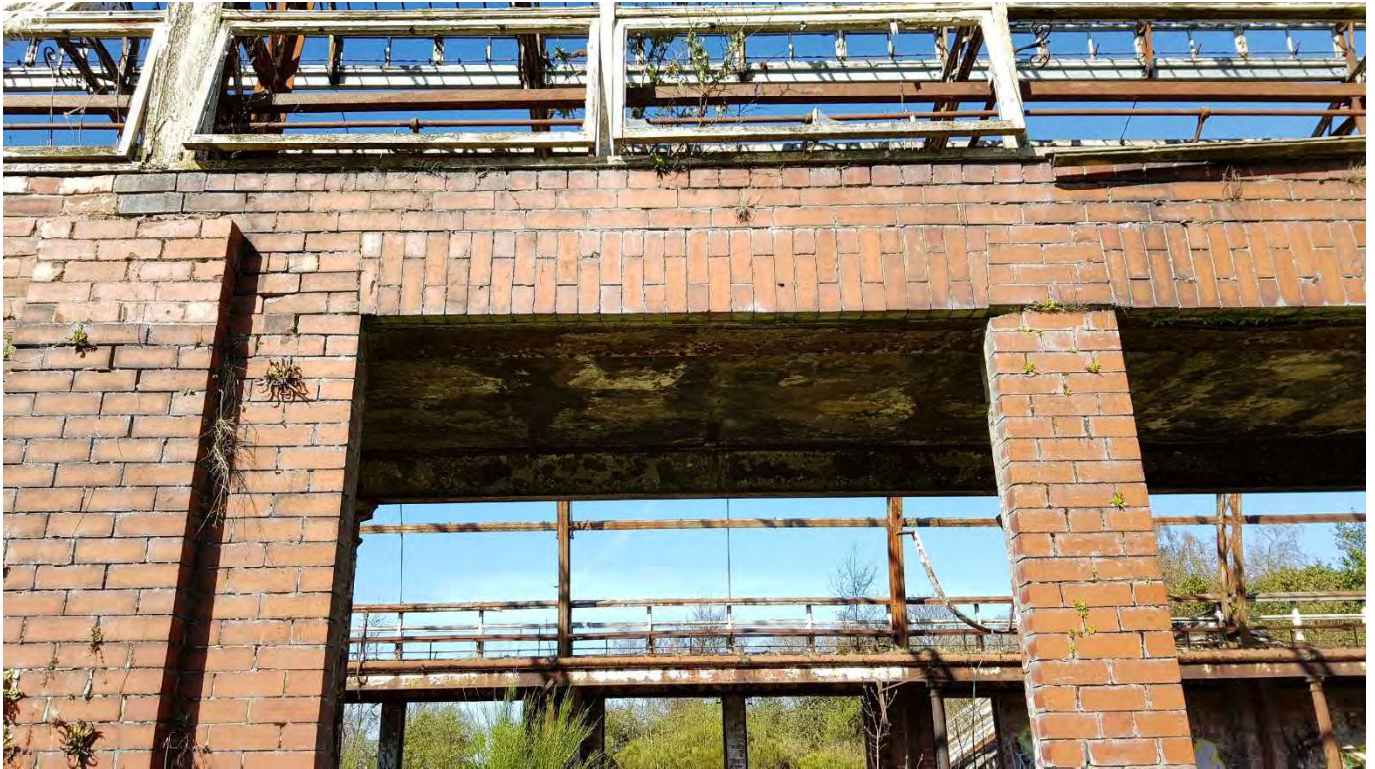
36 – Similar view showing the movement of bricks to the bearings of the main lintels

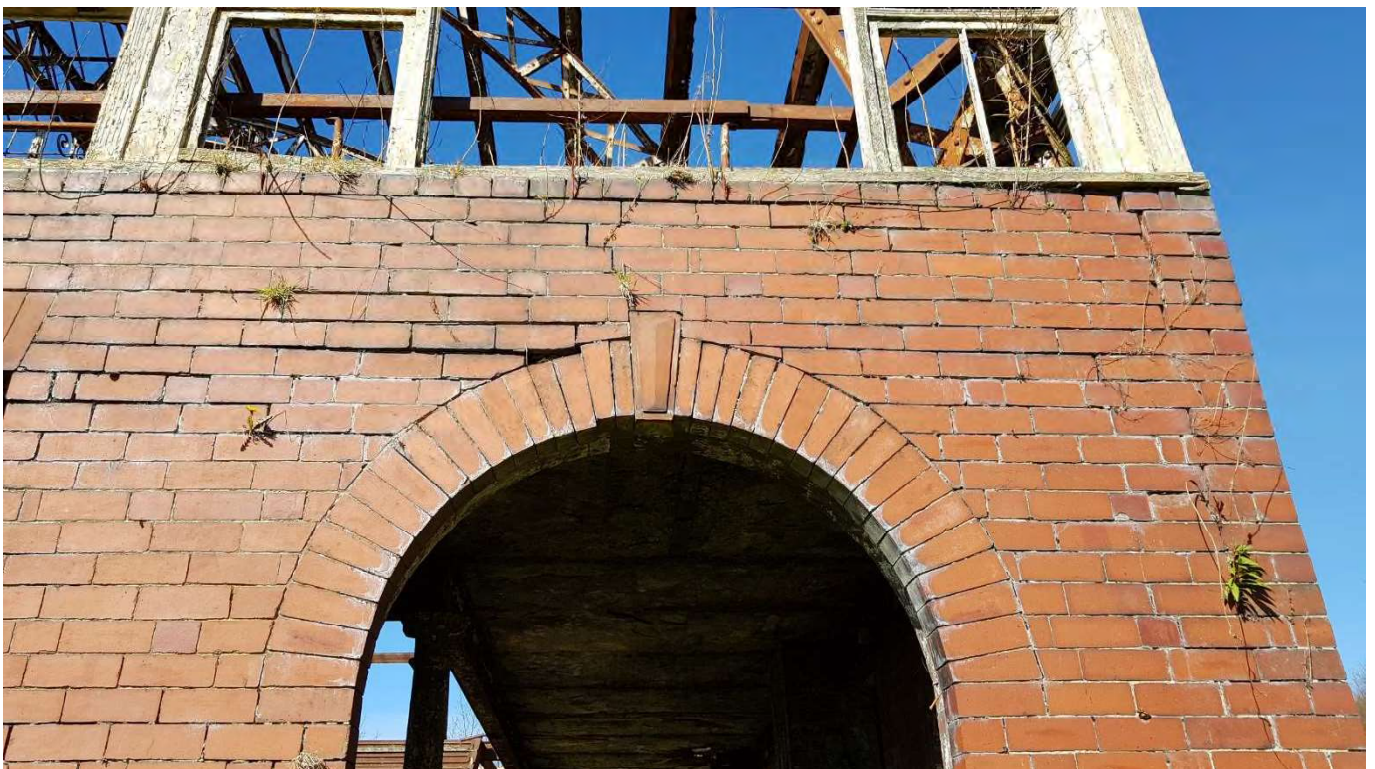
37 – Local arch slip failure due to vegetation growth and some expansion of the upper walling

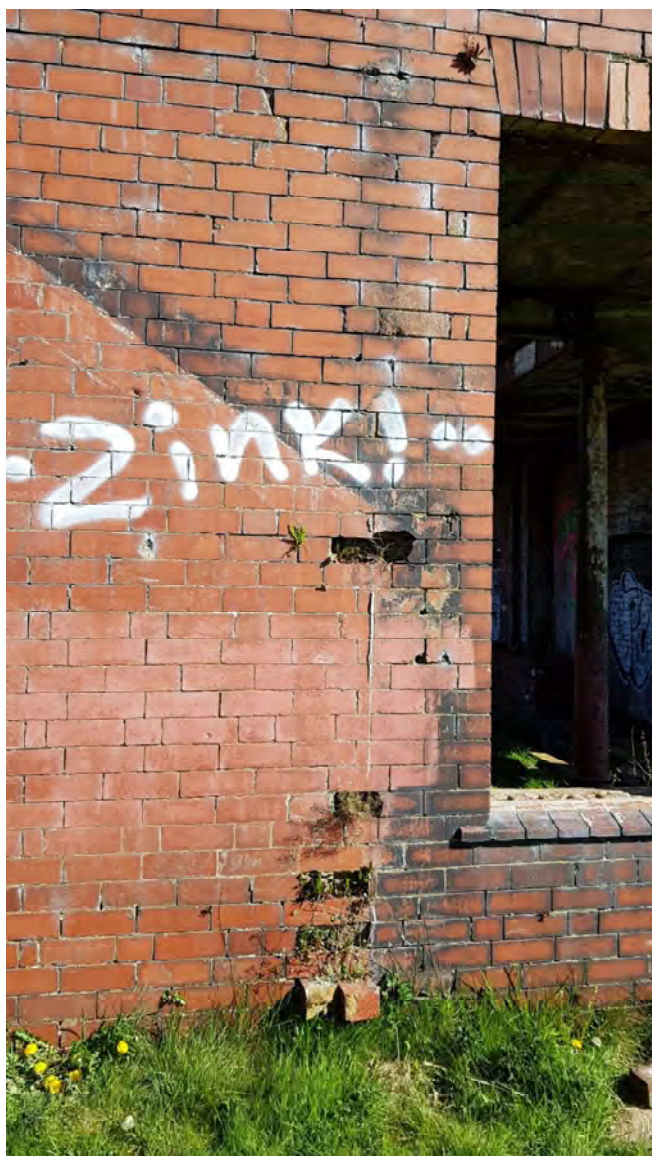
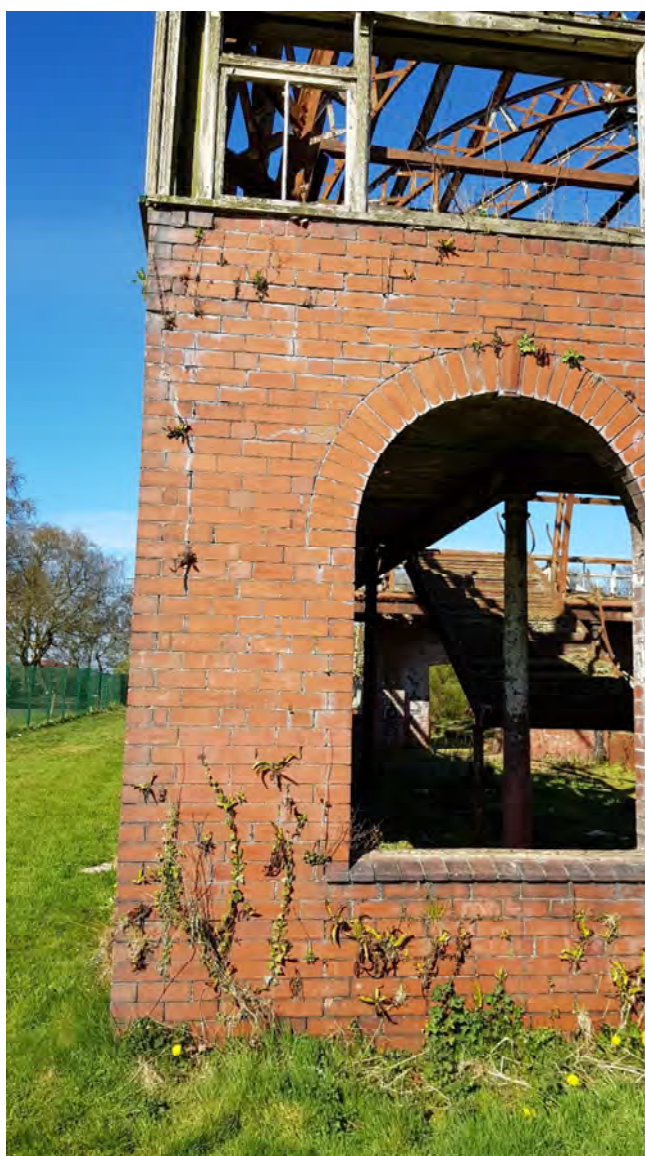
38 & 39 – Missing bricks and small cracks up masonry jamb and corner deterioration and movement of the upper panel

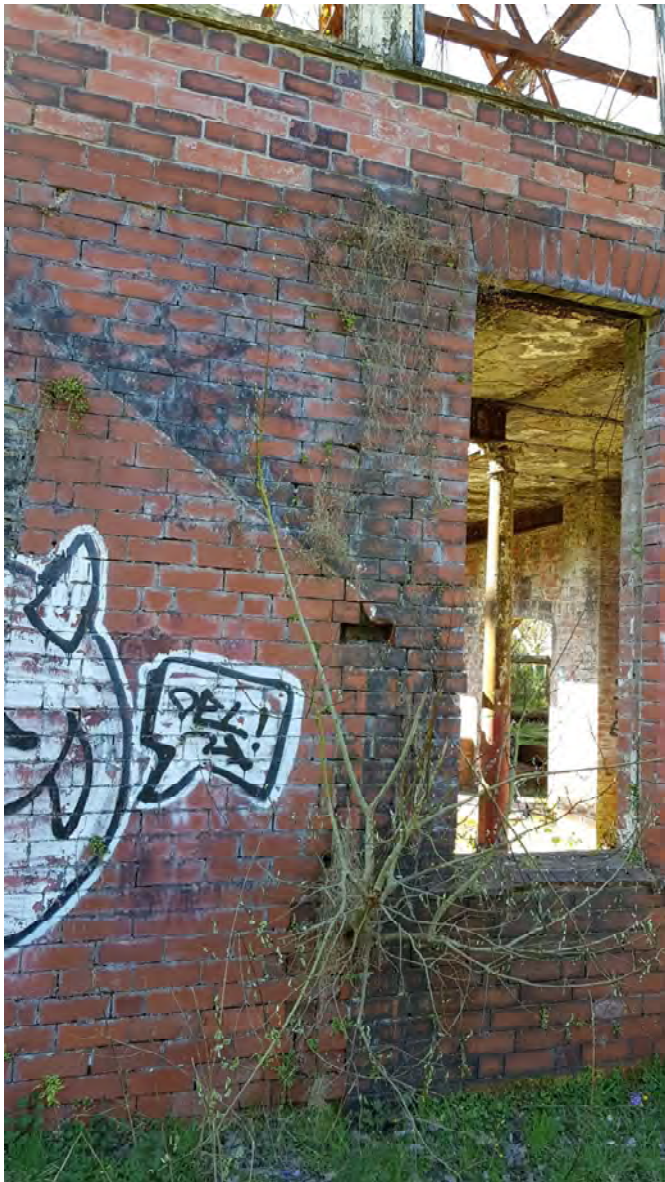
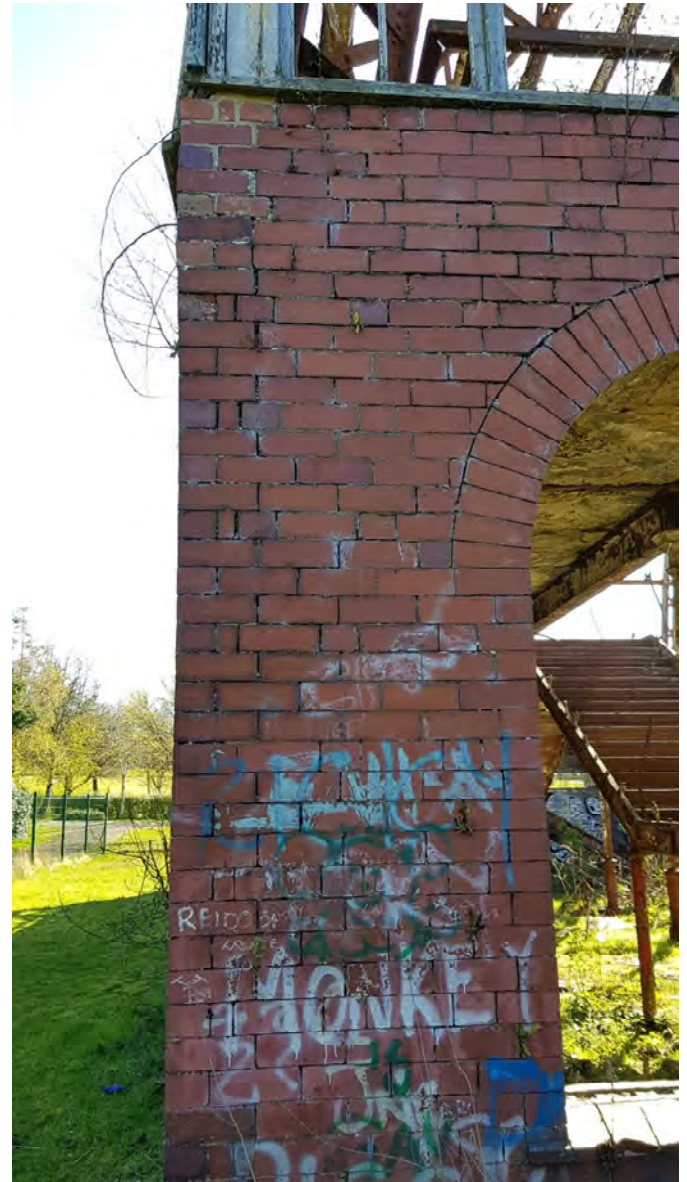
40 & 41 – Vegetation growth is causing severe damage to sections of masonry and removing water ingress and roots to limit water penetration and jacking of masonry is key for any repair

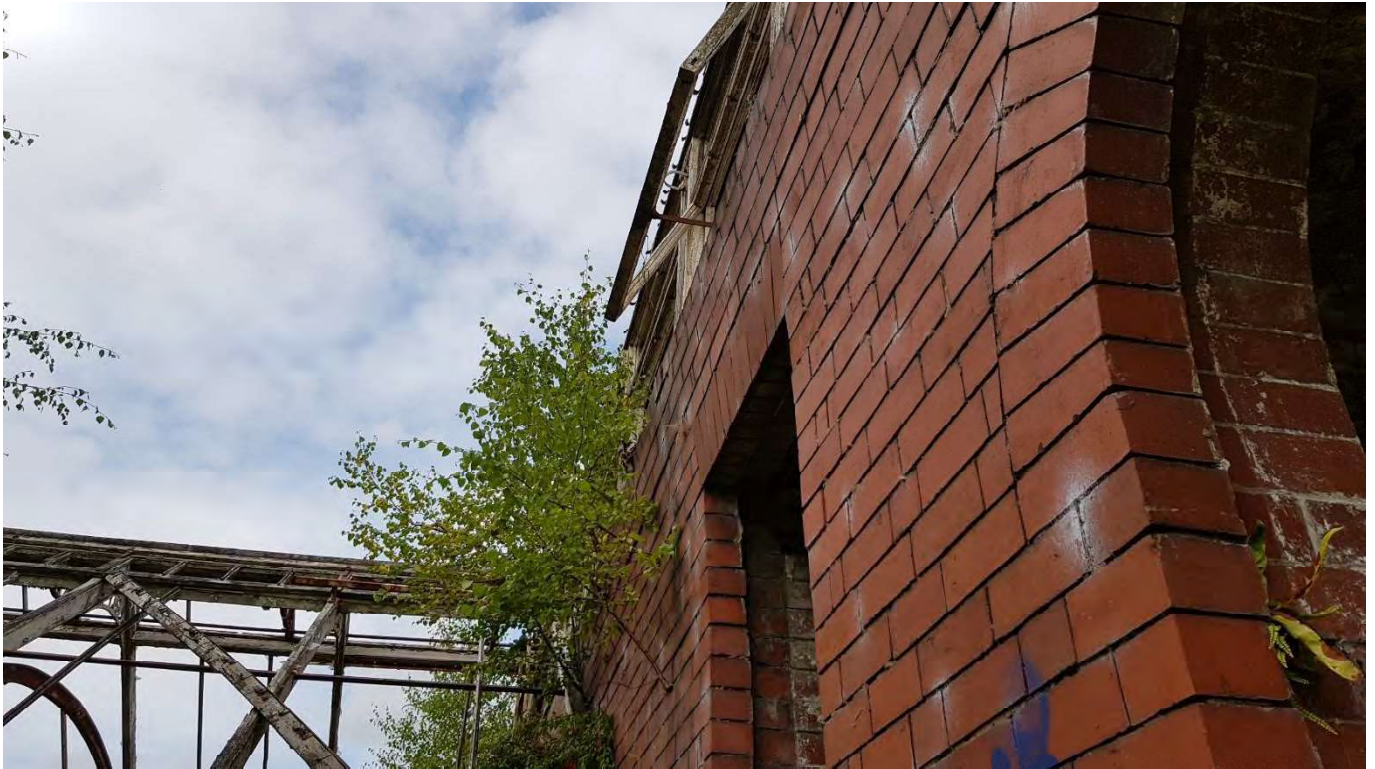
42 – View of south-west upper wall panel showing it 'prying' outwards locally – this will need re-set

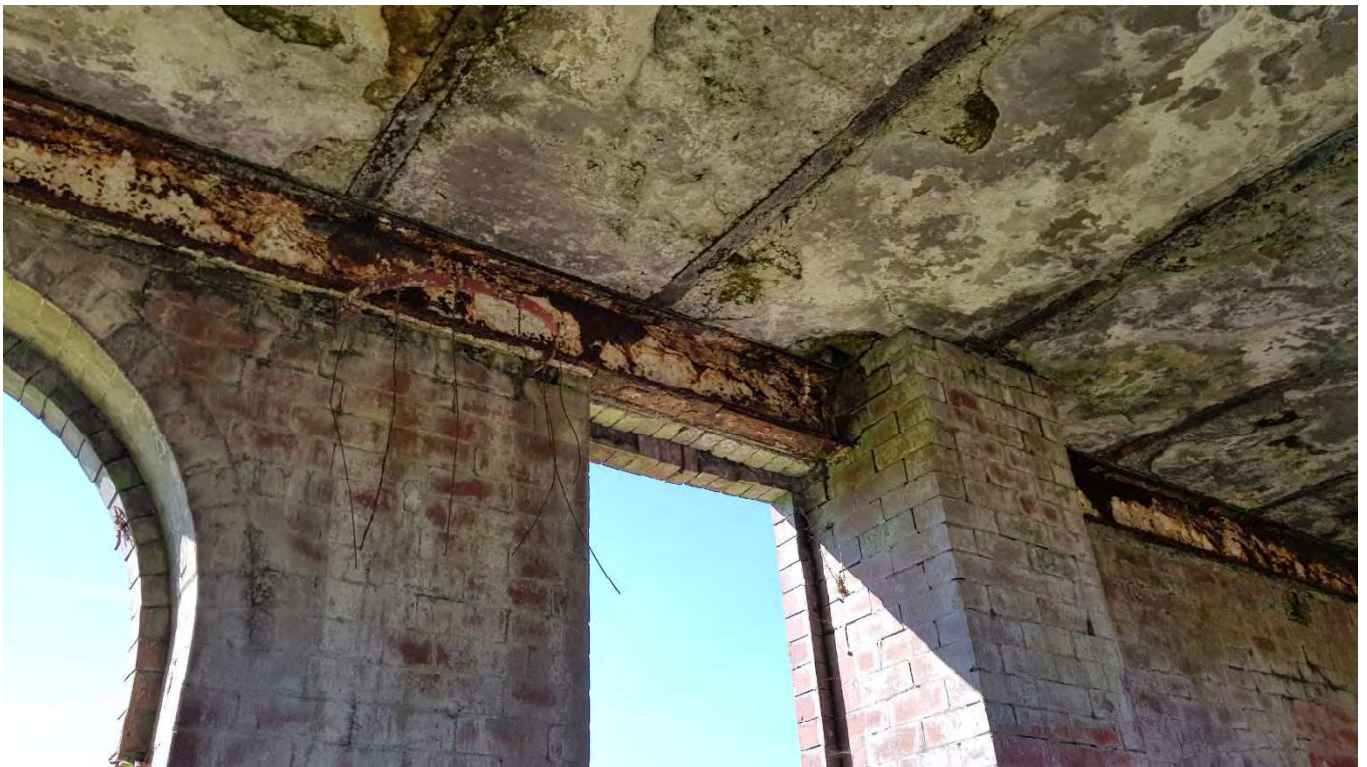
43 – Internal view of internal steel lintel beam showing some deterioration needing re-painted

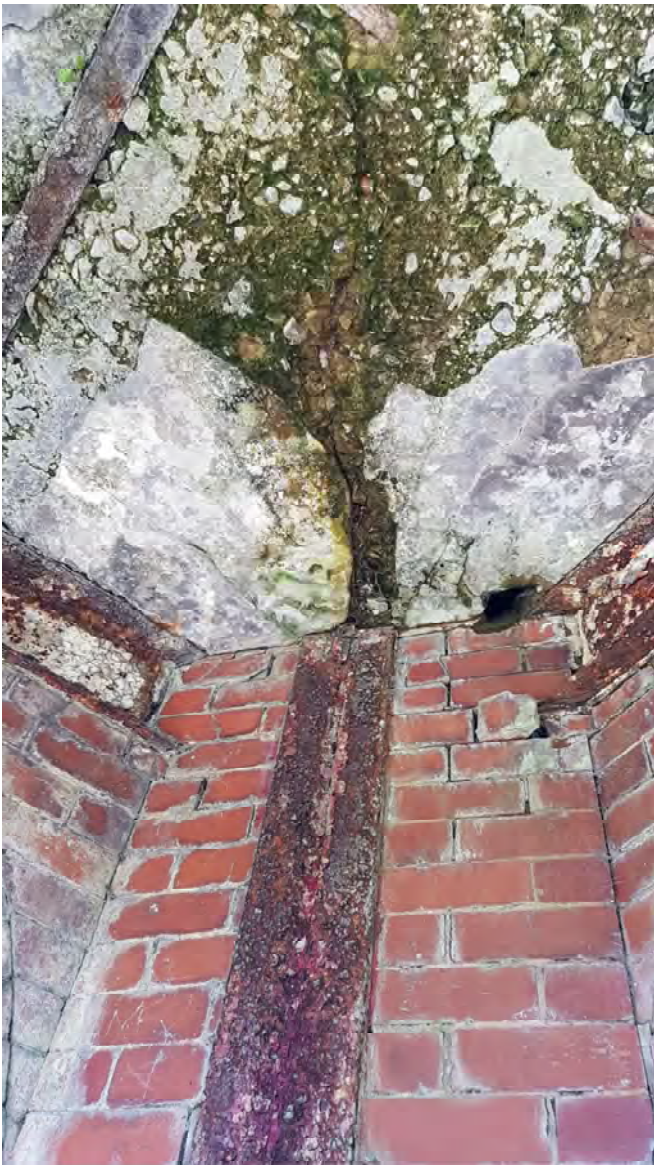
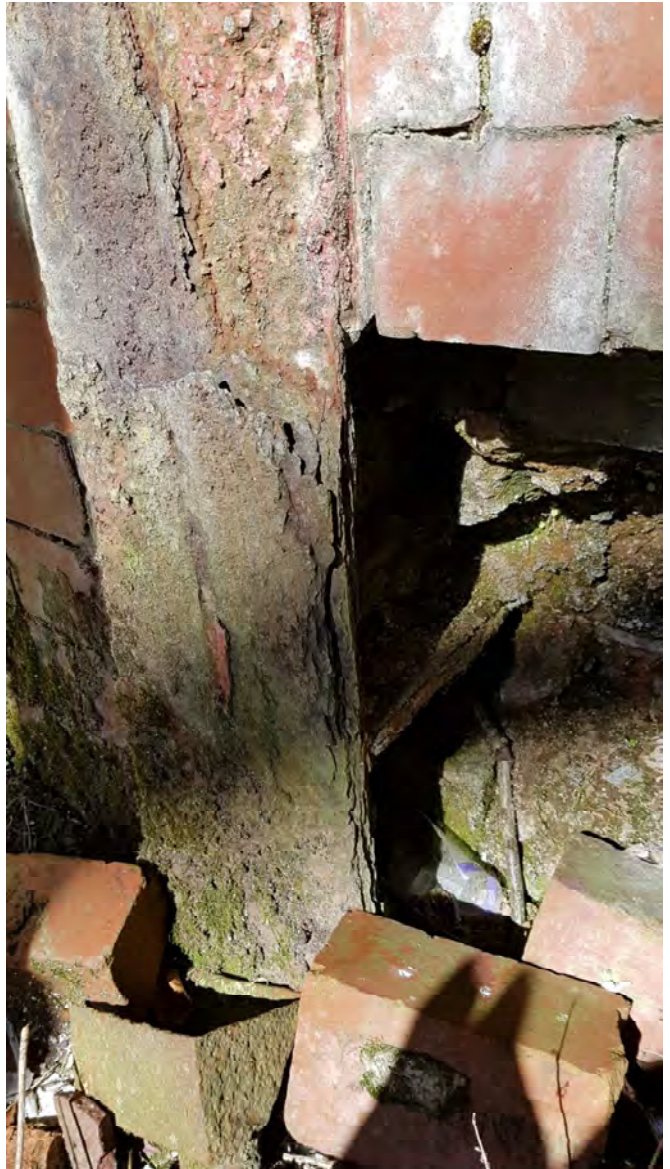
44 & 45 – Internal view of embedded stanchion and localised delamination at opened-up section

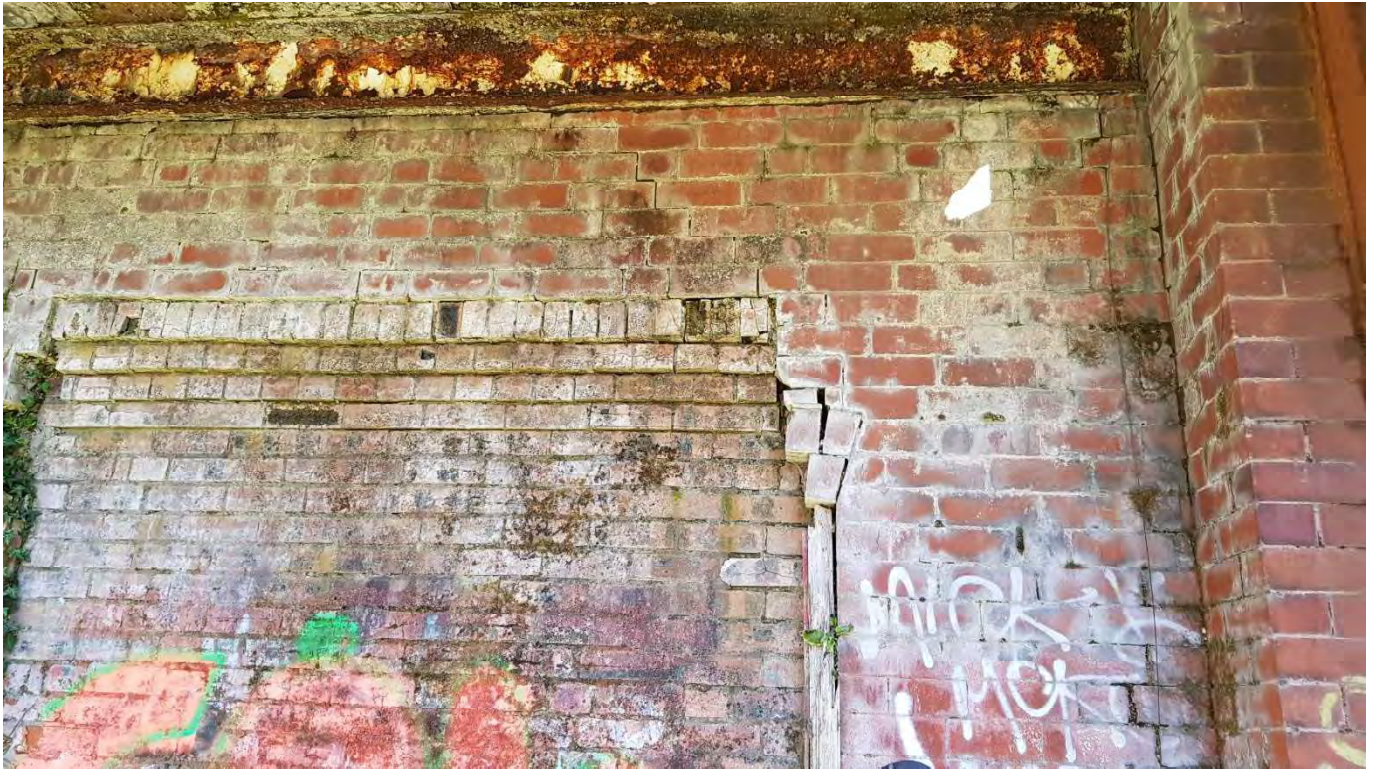
46 – Infill of original opening shows signs of failure near the bearing end

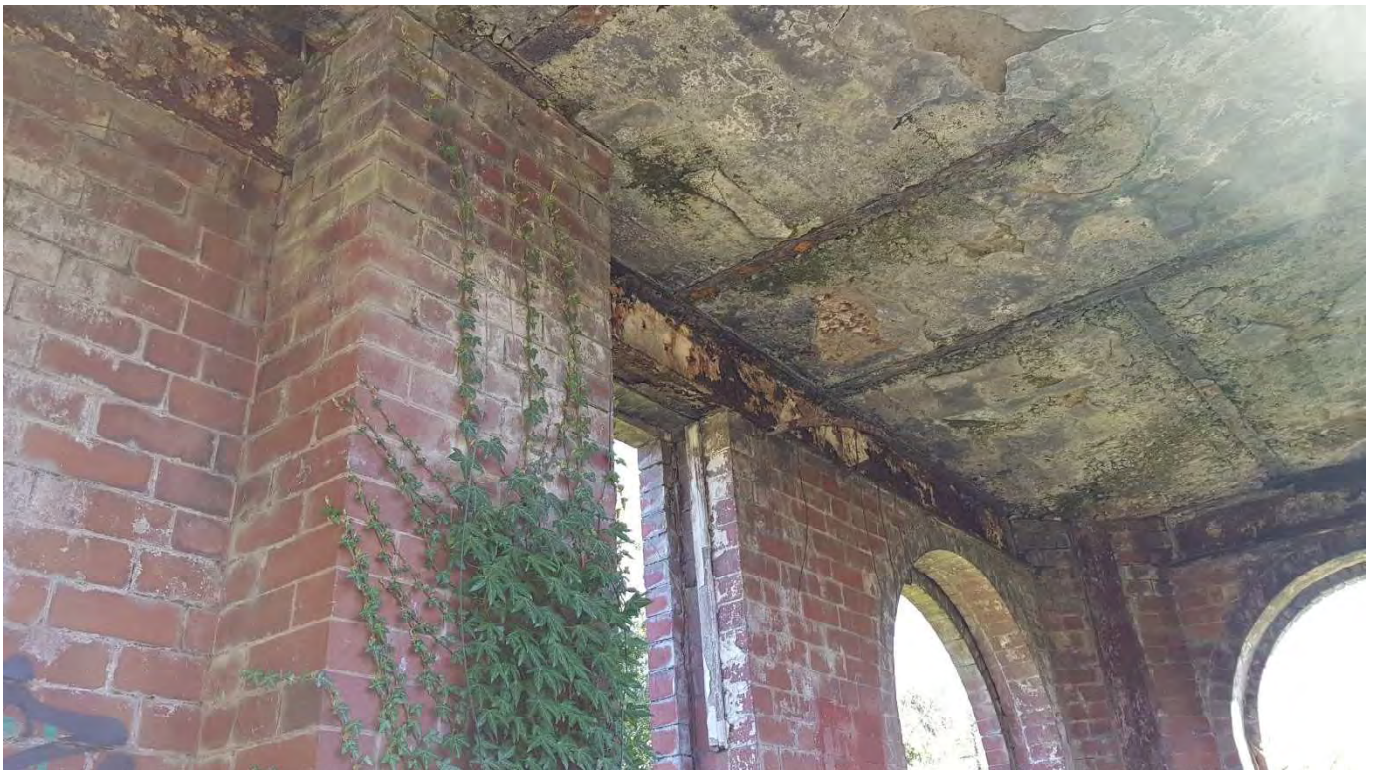
47 – Internal view of pier in good condition along with steel beams and filler joists
