## **Springburn Winter Gardens**

## **Structural Appraisal and Condition Report**

For:  
**Glasgow City Council**

**June 2021**

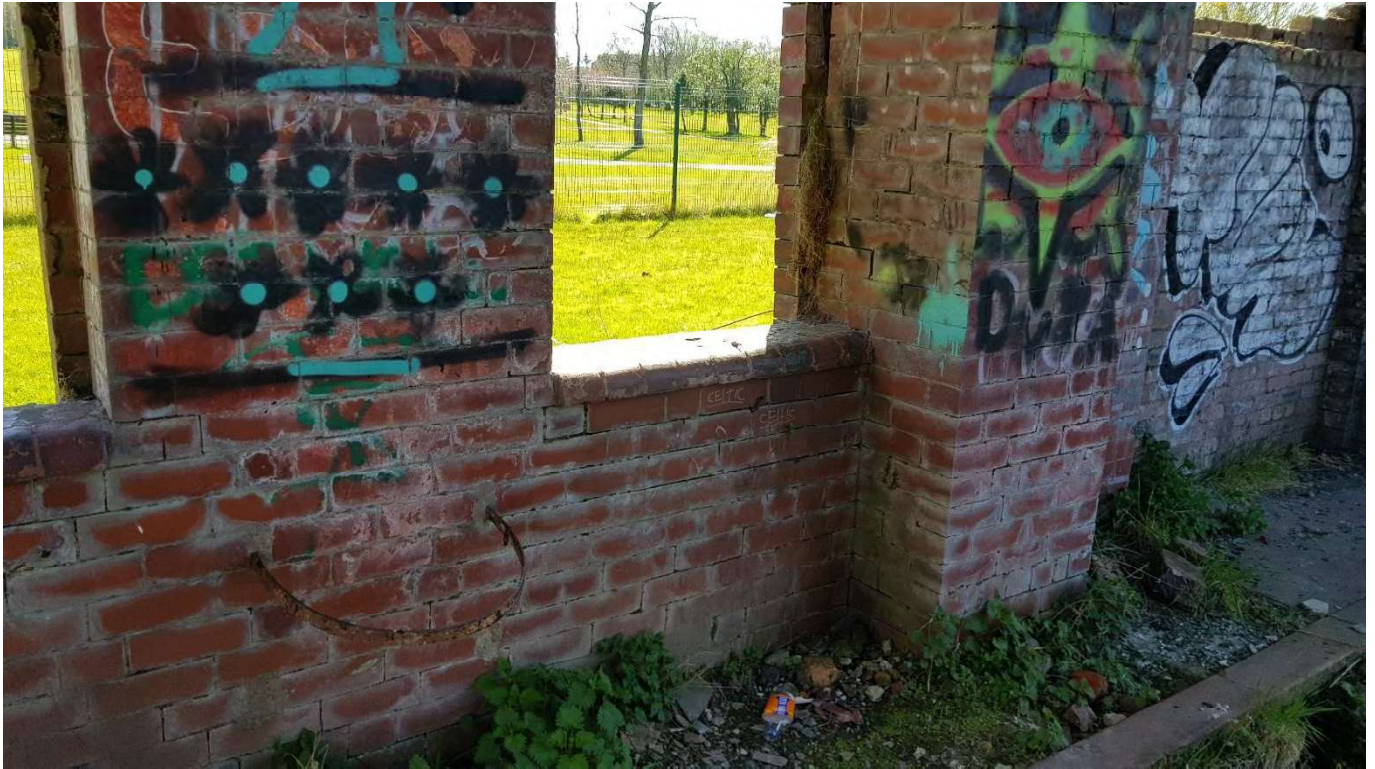
48 – Masonry panels on the east elevation which are in reasonable condition structurally

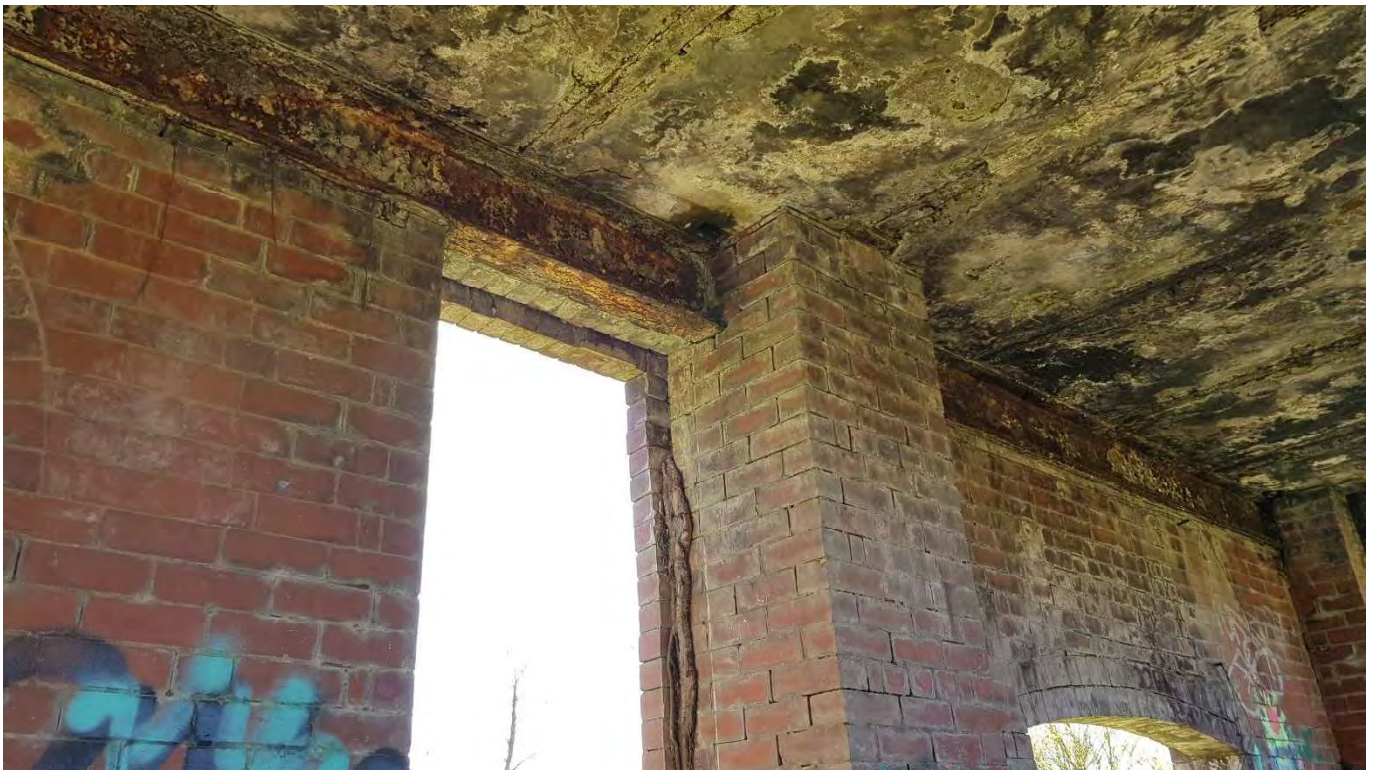
49 – Root growth at window jamb has caused outwards movement of the outer pier masonry

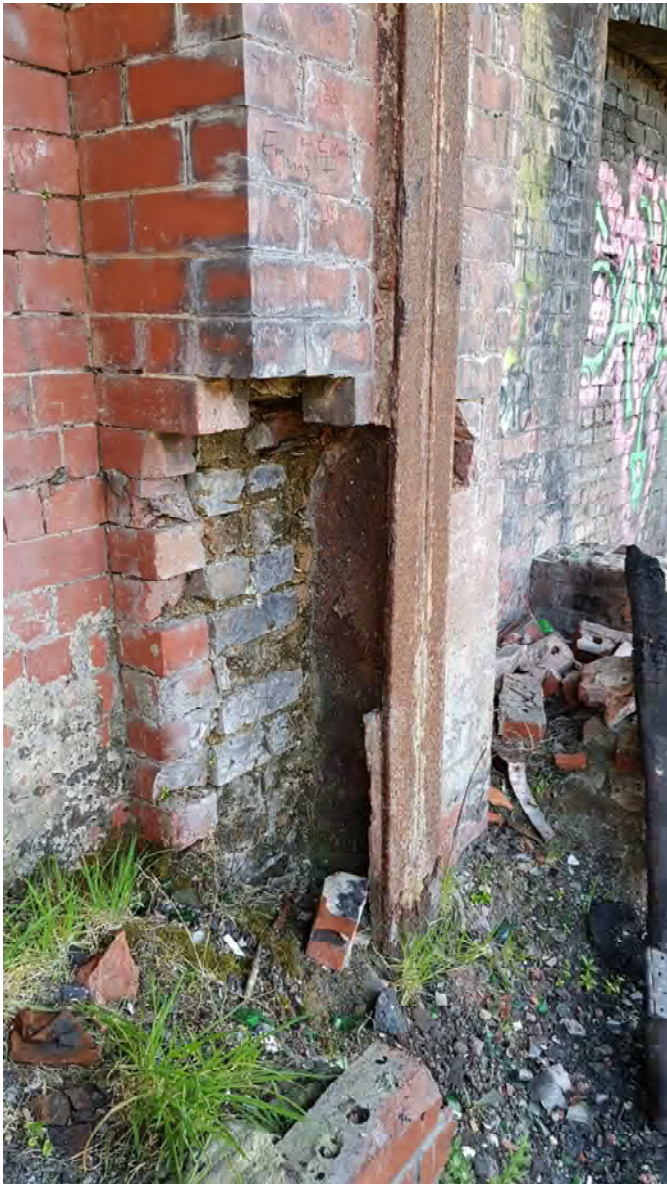
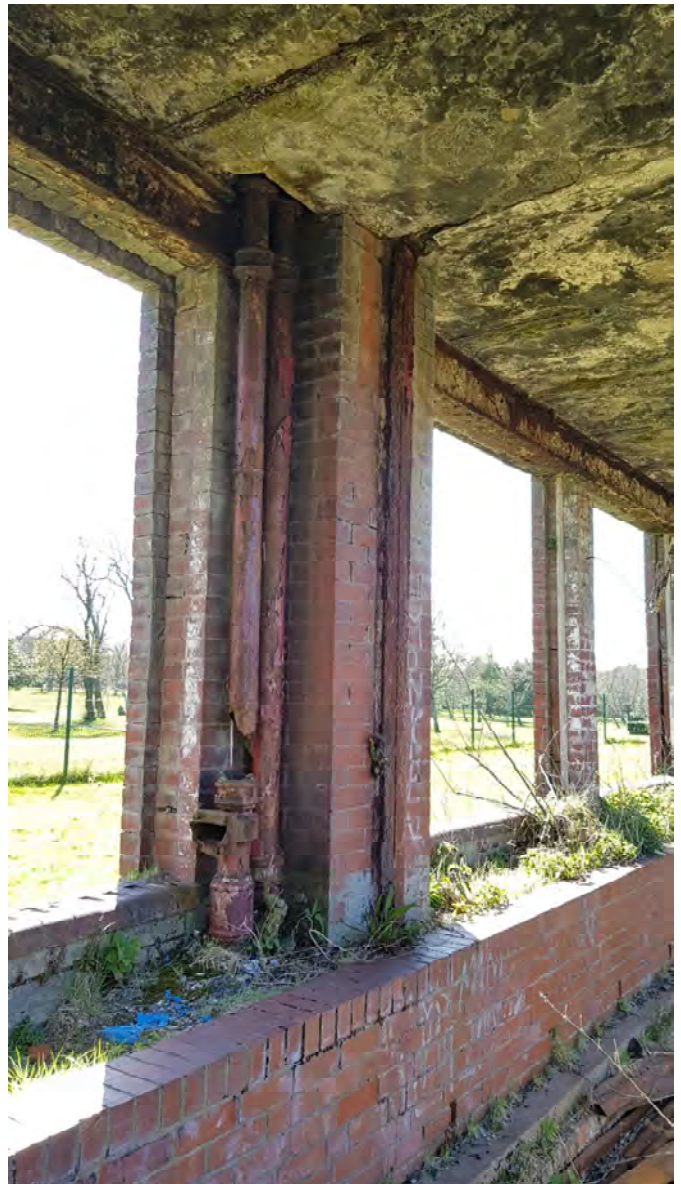
50 & 51 Deterioration or opening-up at internal stanchion base showing corroded but serviceable steelwork in the temporary case. Masonry deterioration to be repaired at main pier

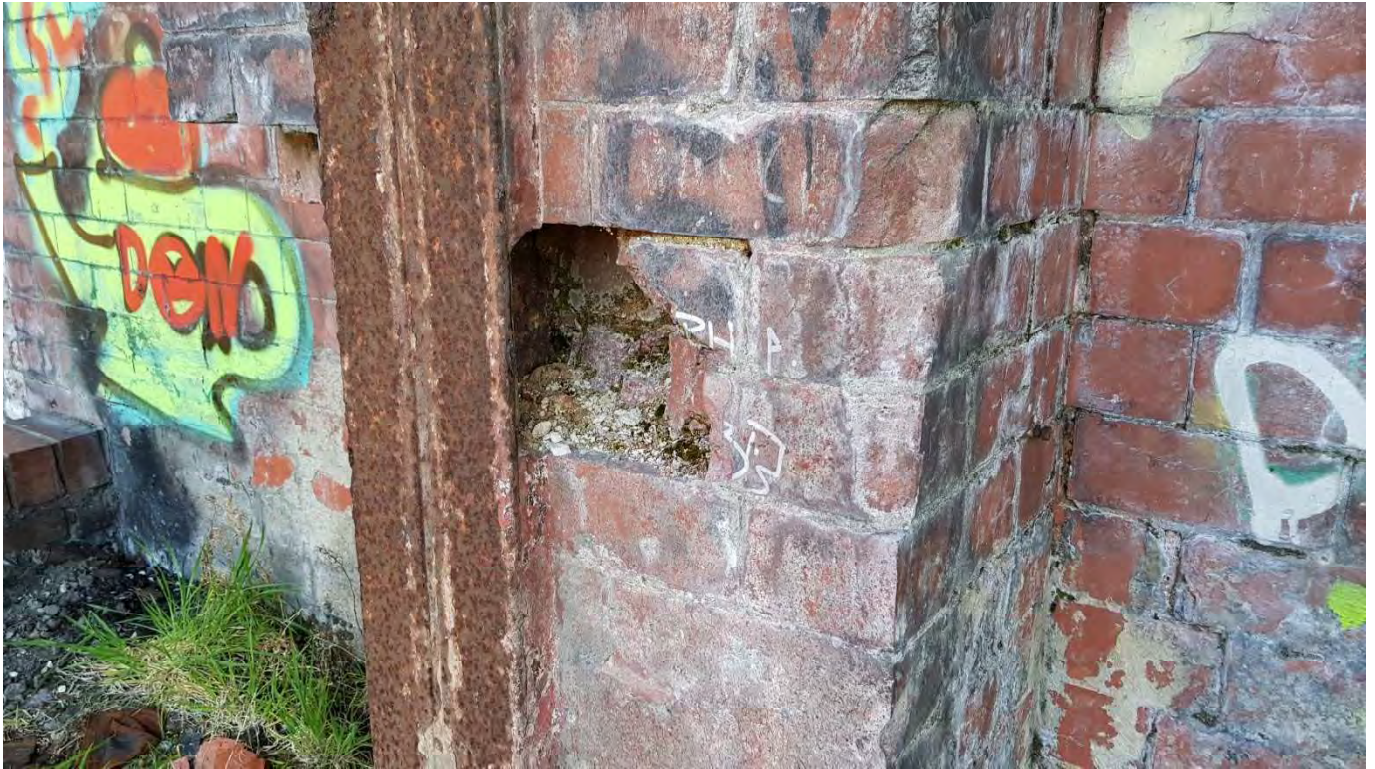
52 – Localised opening-up at stanchion showing surface corrosion

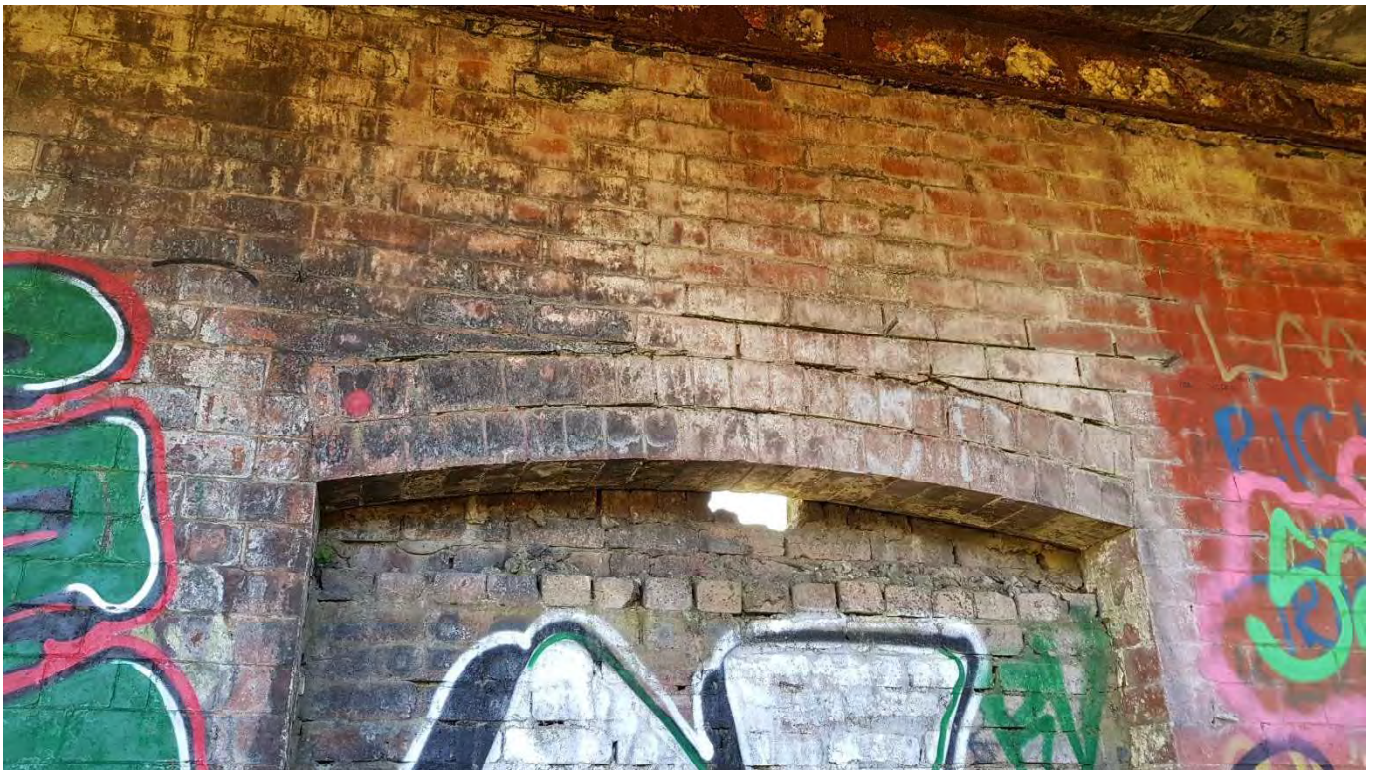
53 – Arch over opening appears to be intact and aligned properly

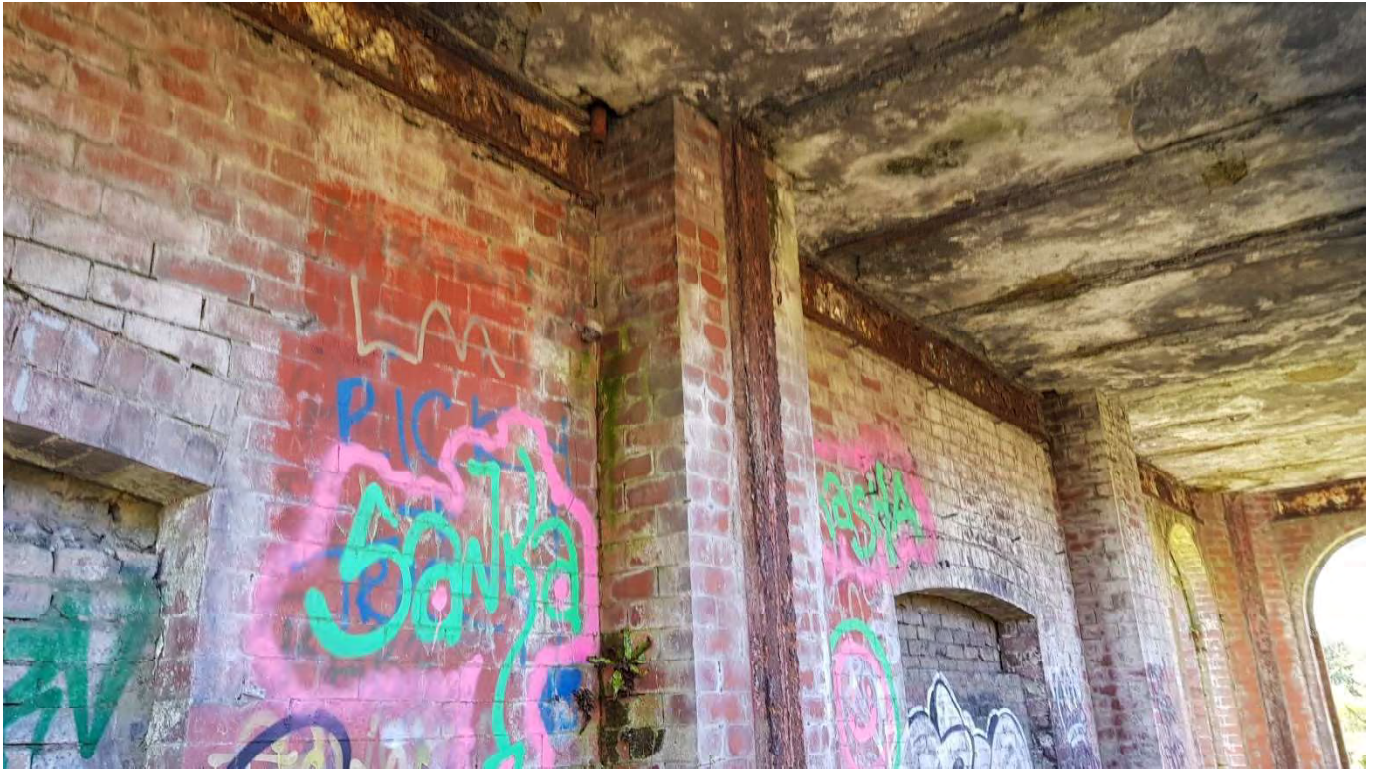
54 – View of internal surface corrosion of embedded stanchion – all steelwork embedded will need to be assessed in due course to determine final repair detail

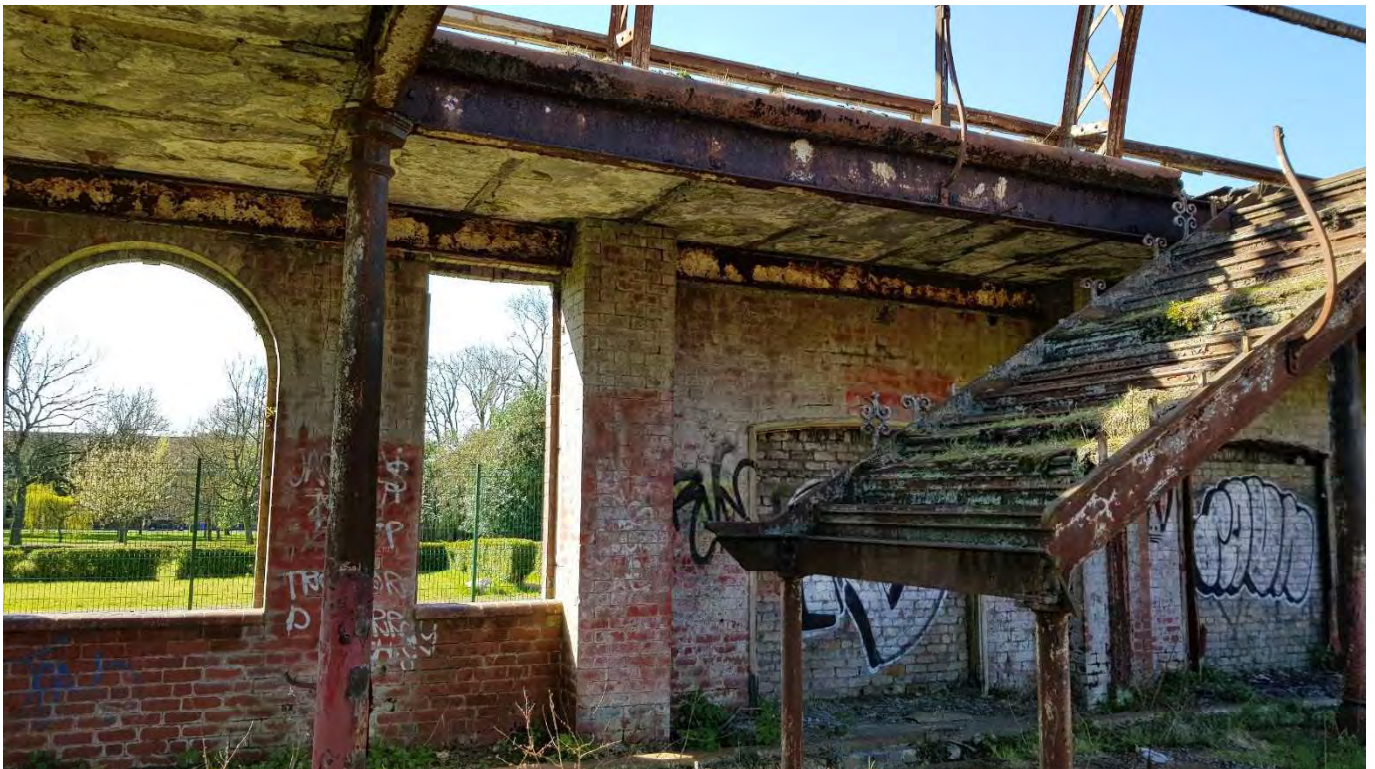
55 – View of stair at south end and cast iron column/steel ring beam around balcony

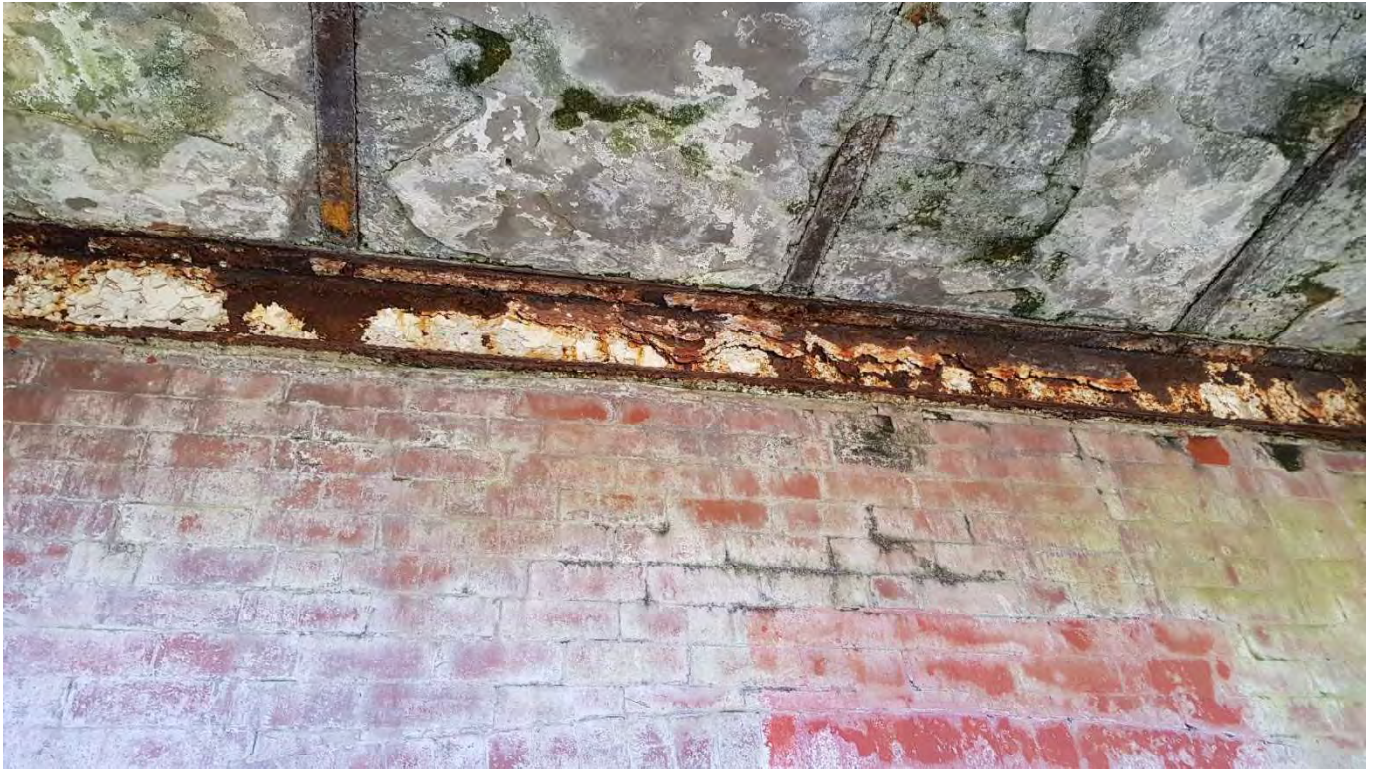
56 – Corroded edge beam with filler joists and main beam needing repainted and potentially repaired

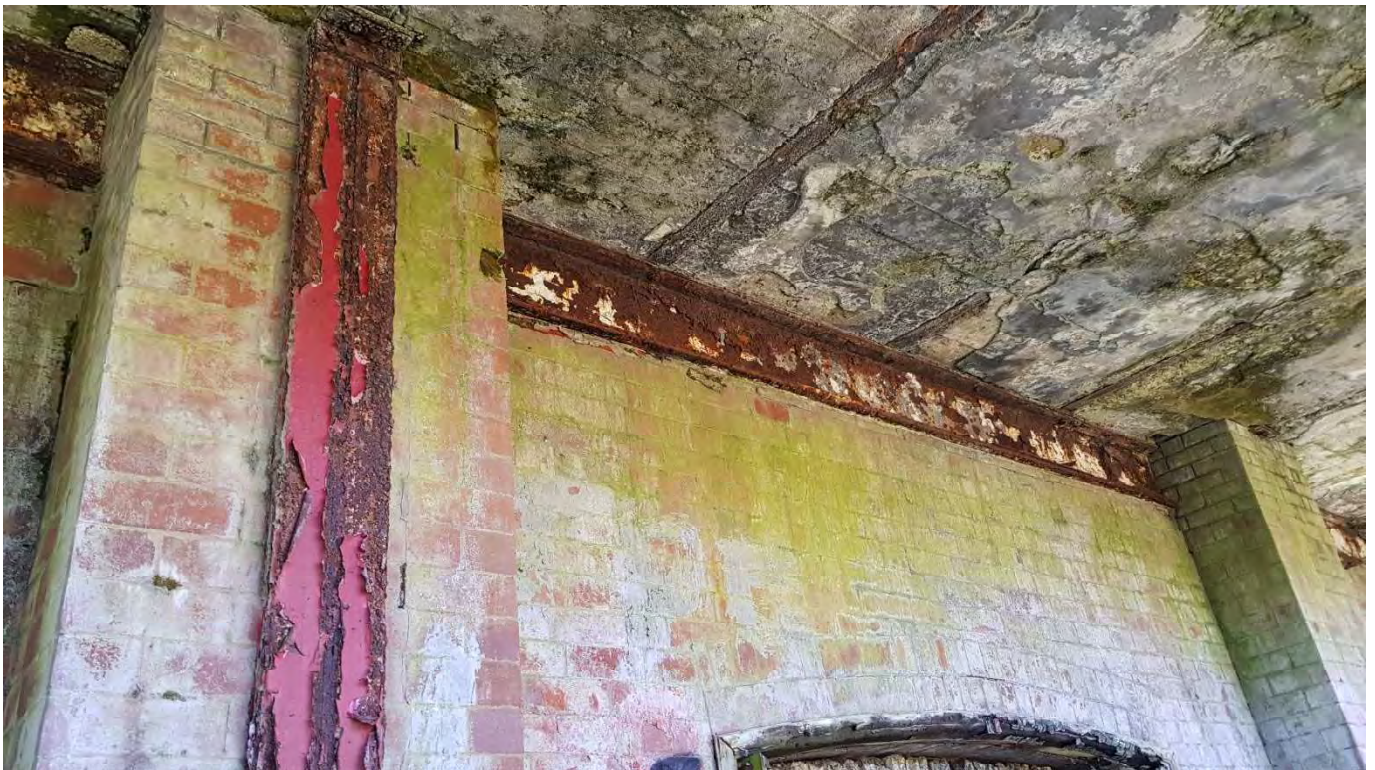
57 – Embedded stanchion with paint still visible

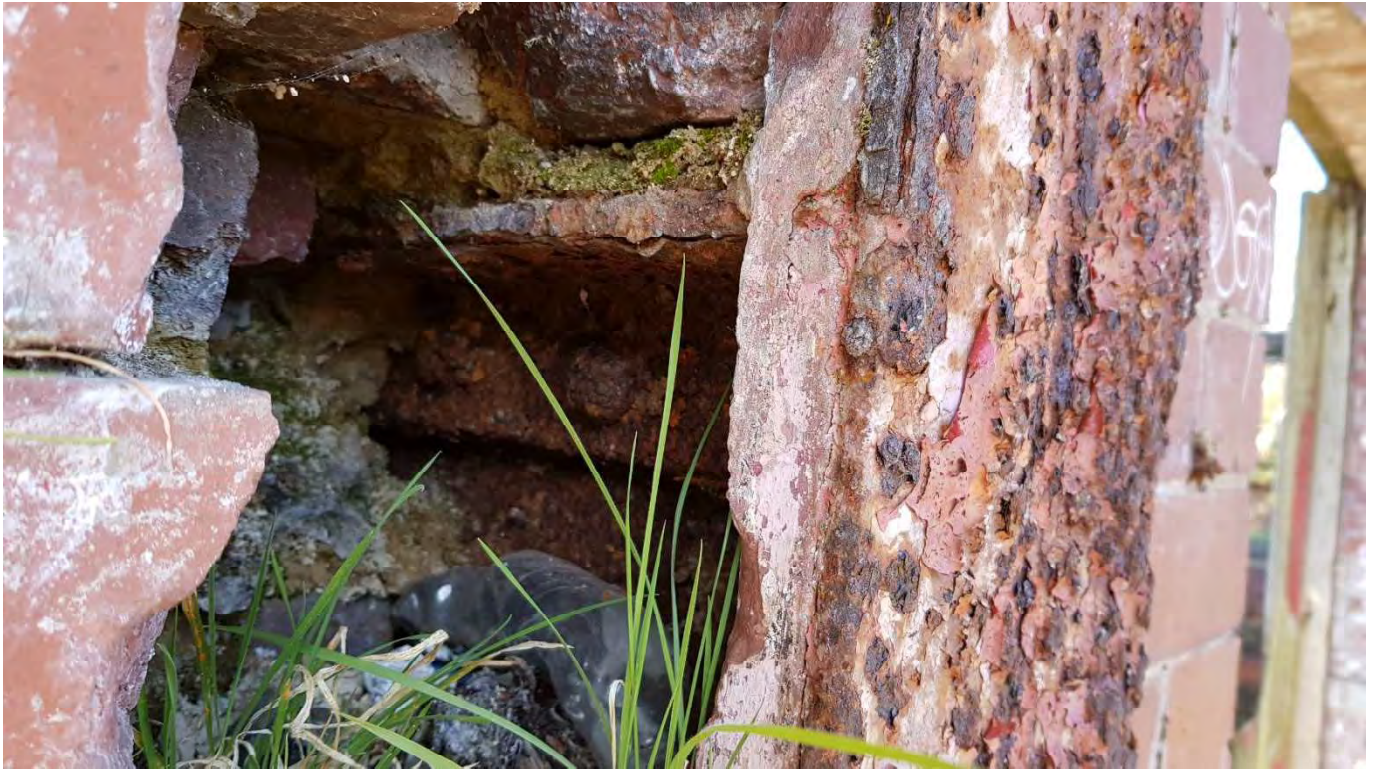
58 – Detail view of embedded steelwork showing some deterioration

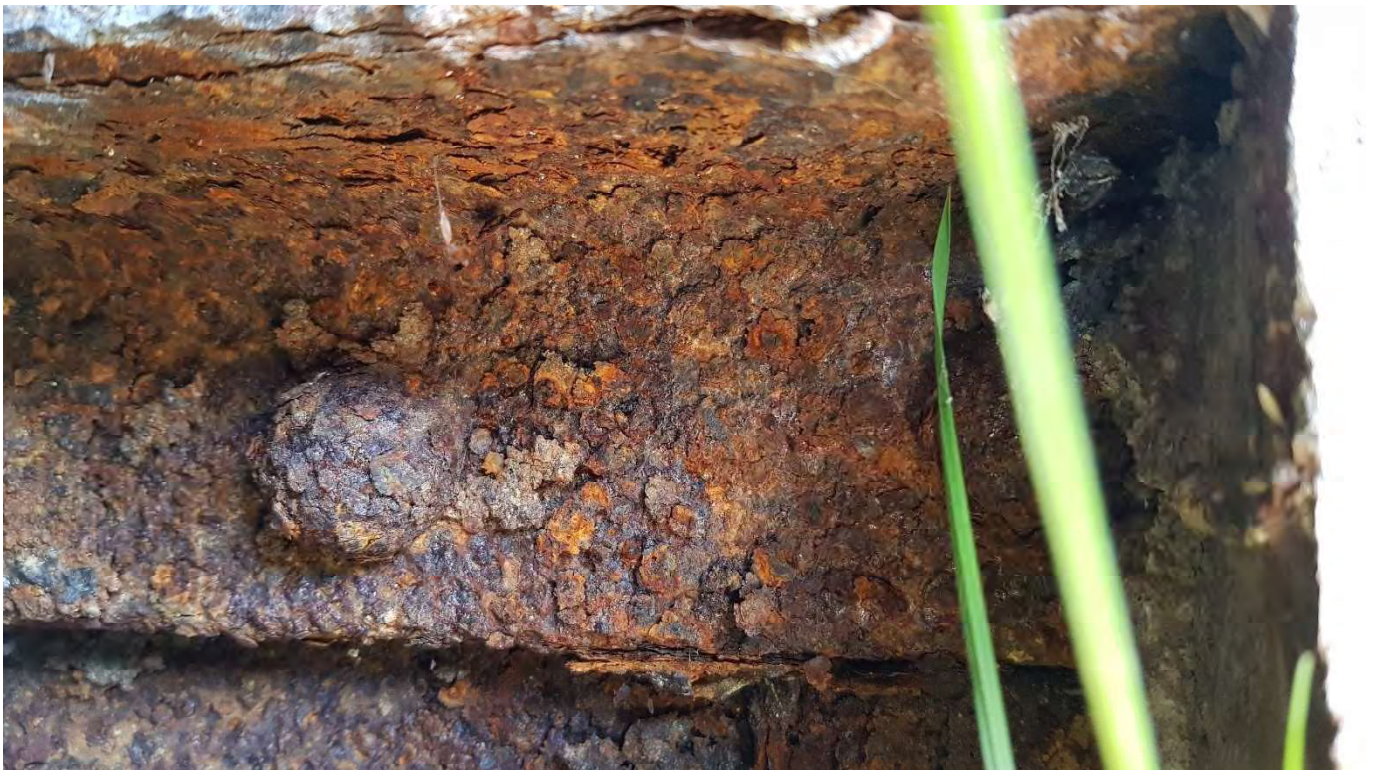
59 – Heavier corrosion including rivet heads which may need direct steel repairs for the longer term project

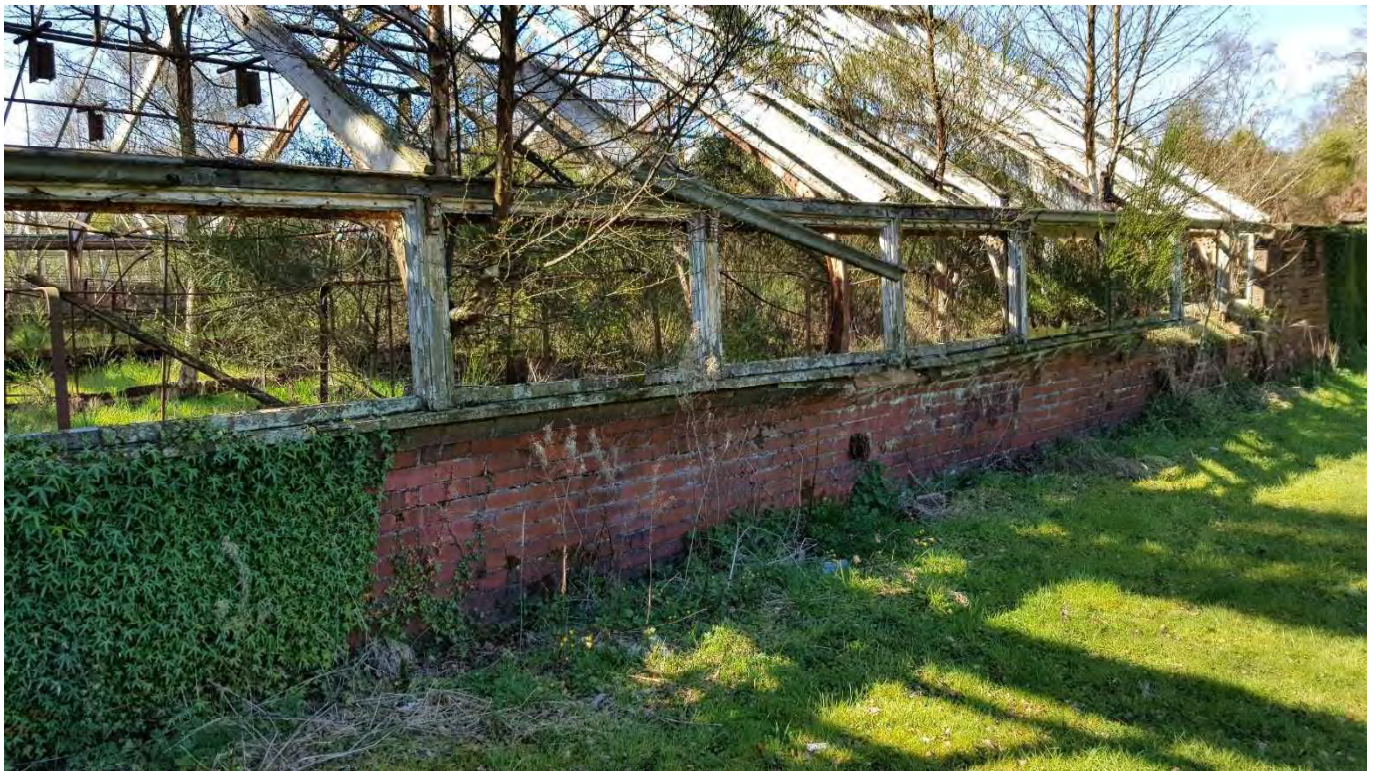
60 – View of partially-collapsed north wall which will need to be rebuilt

The northern Glasshouse requires the north walling to be largely rebuilt due to extensive root damage, although most of the material can be reused. The main original hardwood timber sections could be re-used as part of a more sensitive refurbishment but will require some augmentation and re-setting of the bracketry and infill timberwork.

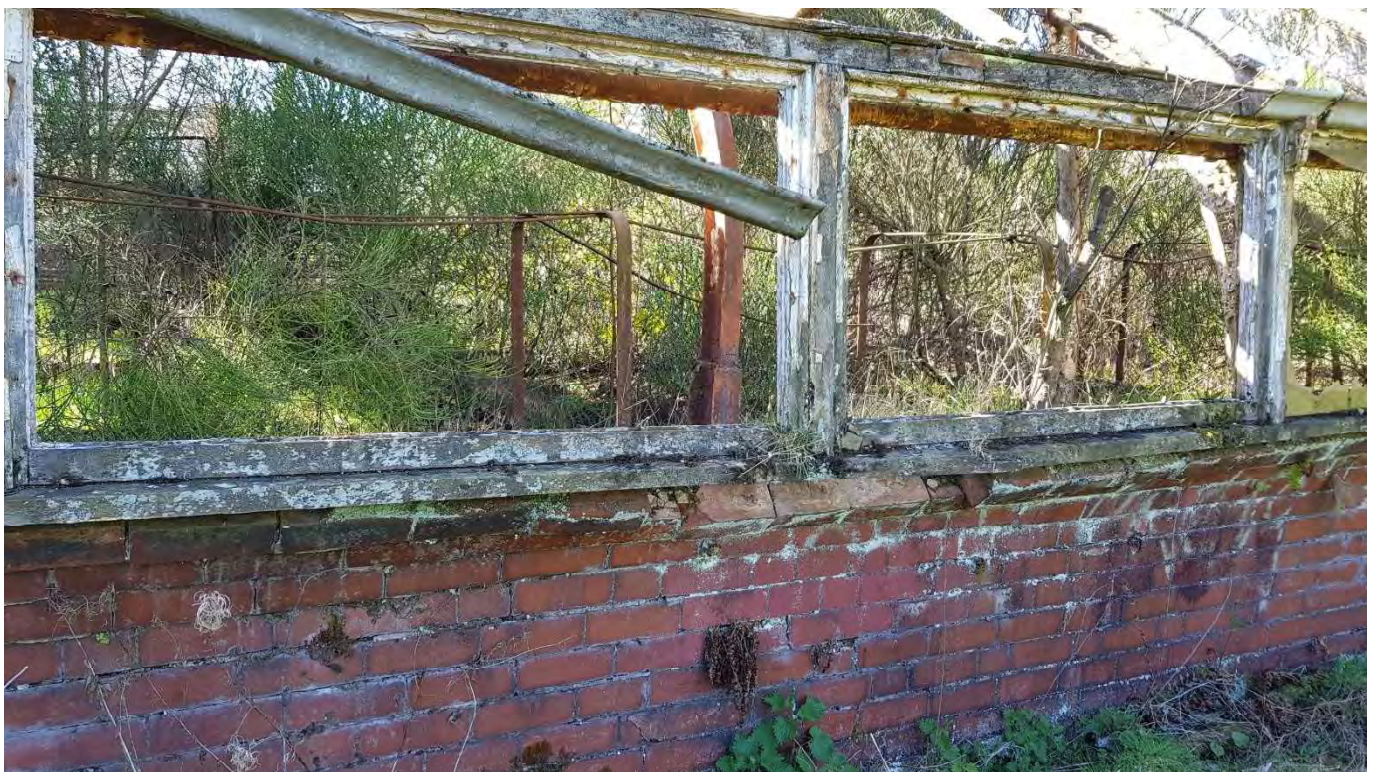
61 – Close-up view of failed wall section with the upper brickwork rotated outwards dramatically. Note the steel 'hoop' within the glasshouse is intact with minor surface corrosion

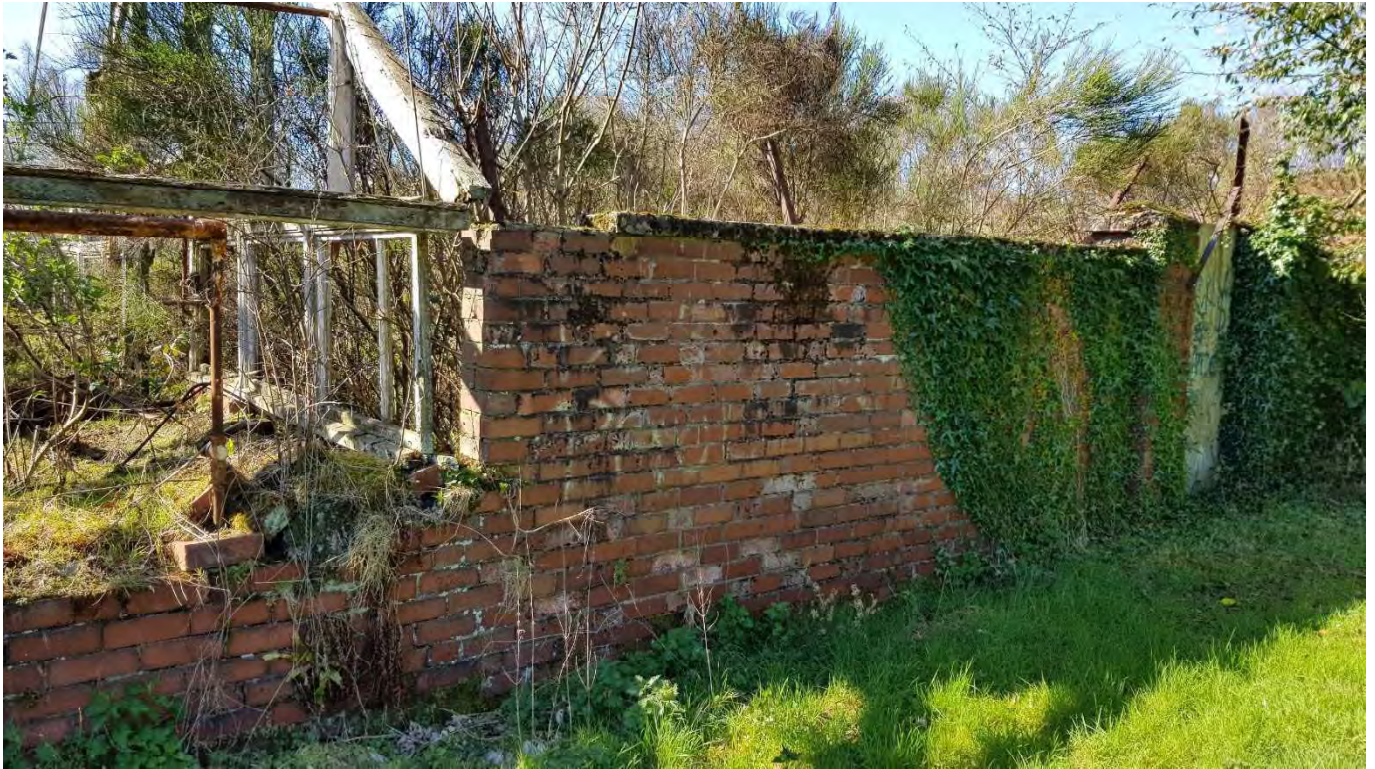
62 – View of west end of north wall where it becomes a freestanding boundary wall. Ivy growth and water ingress through the cope has caused deterioration in the brickwork

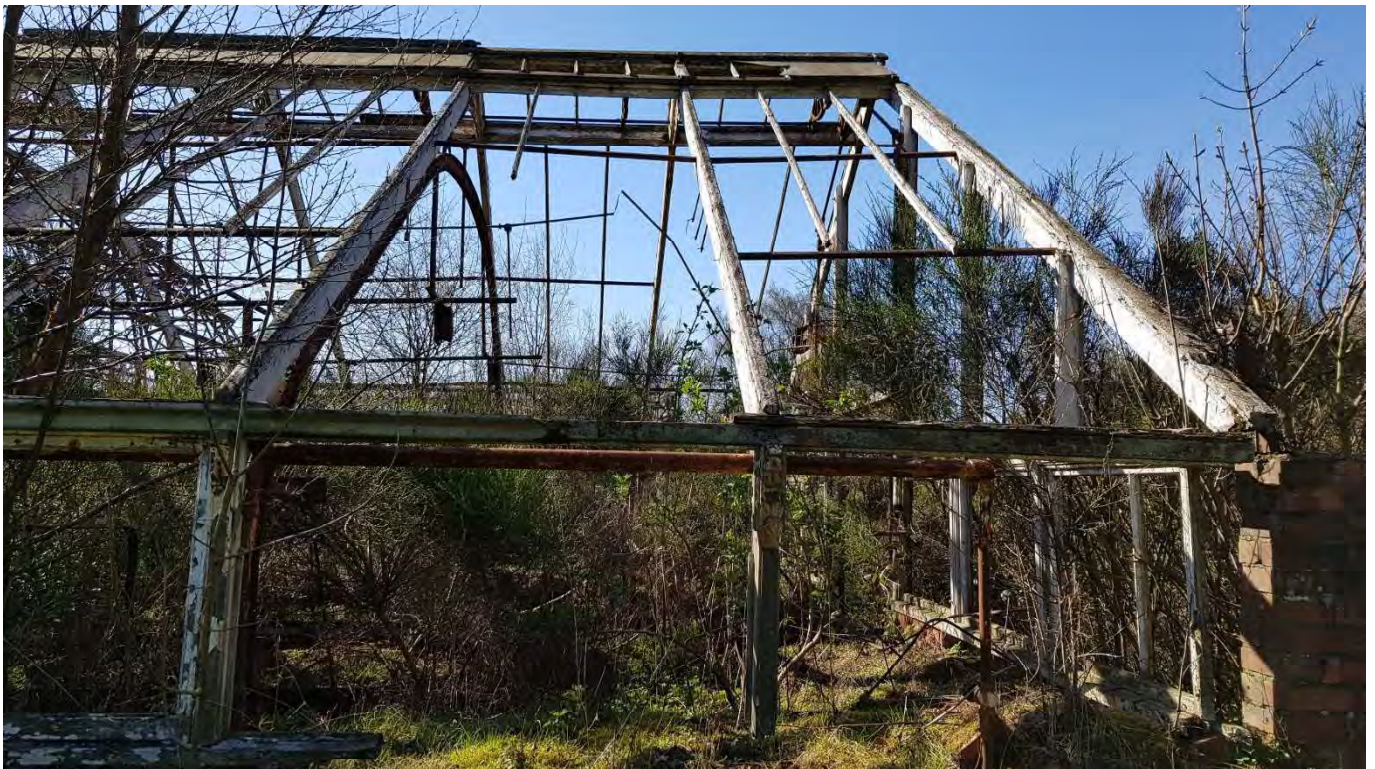
63 – View of west end of the glasshouse showing missing roof mullions and deflection in the upper purlins

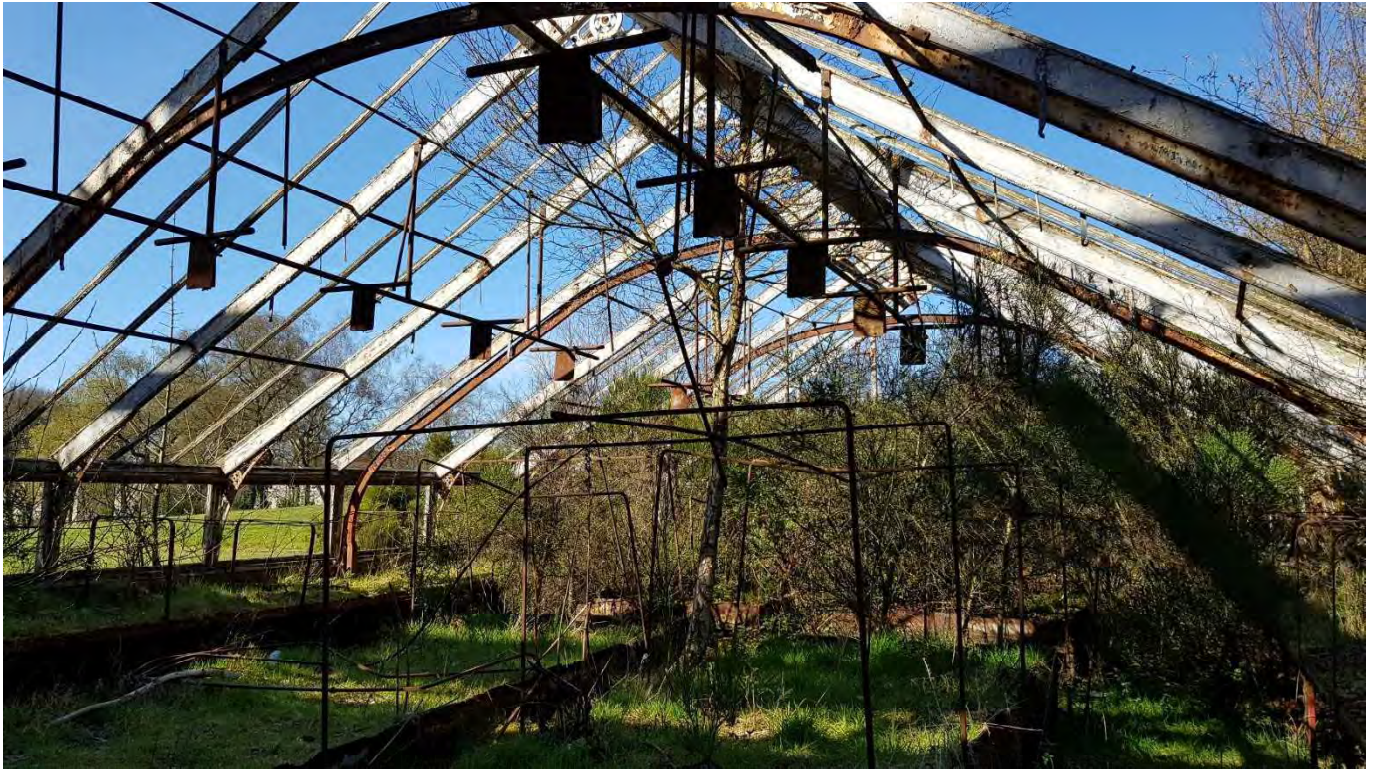
64 – View along glasshouse showing general geometry has been maintained but needing re-set

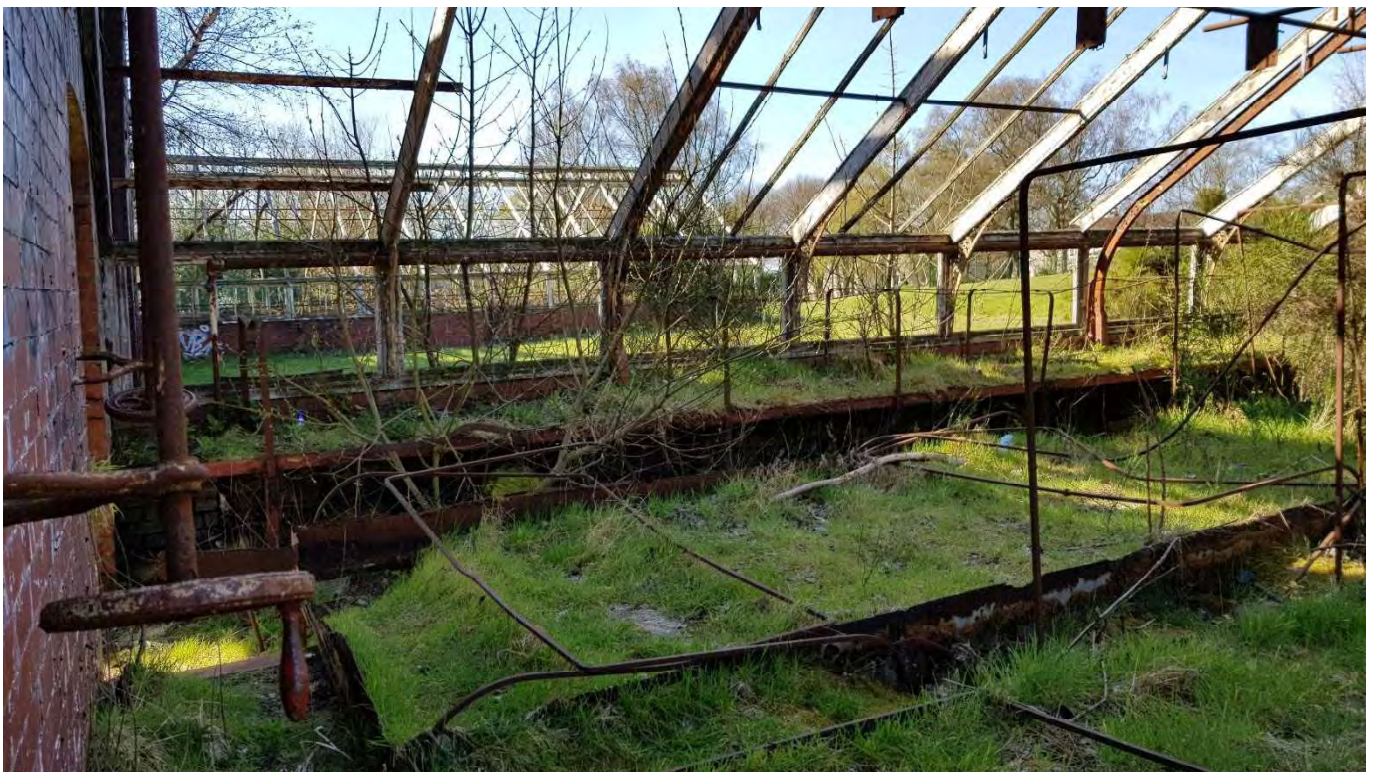
65 – View to south showing heavily vegetated benches and self-seeded bushes

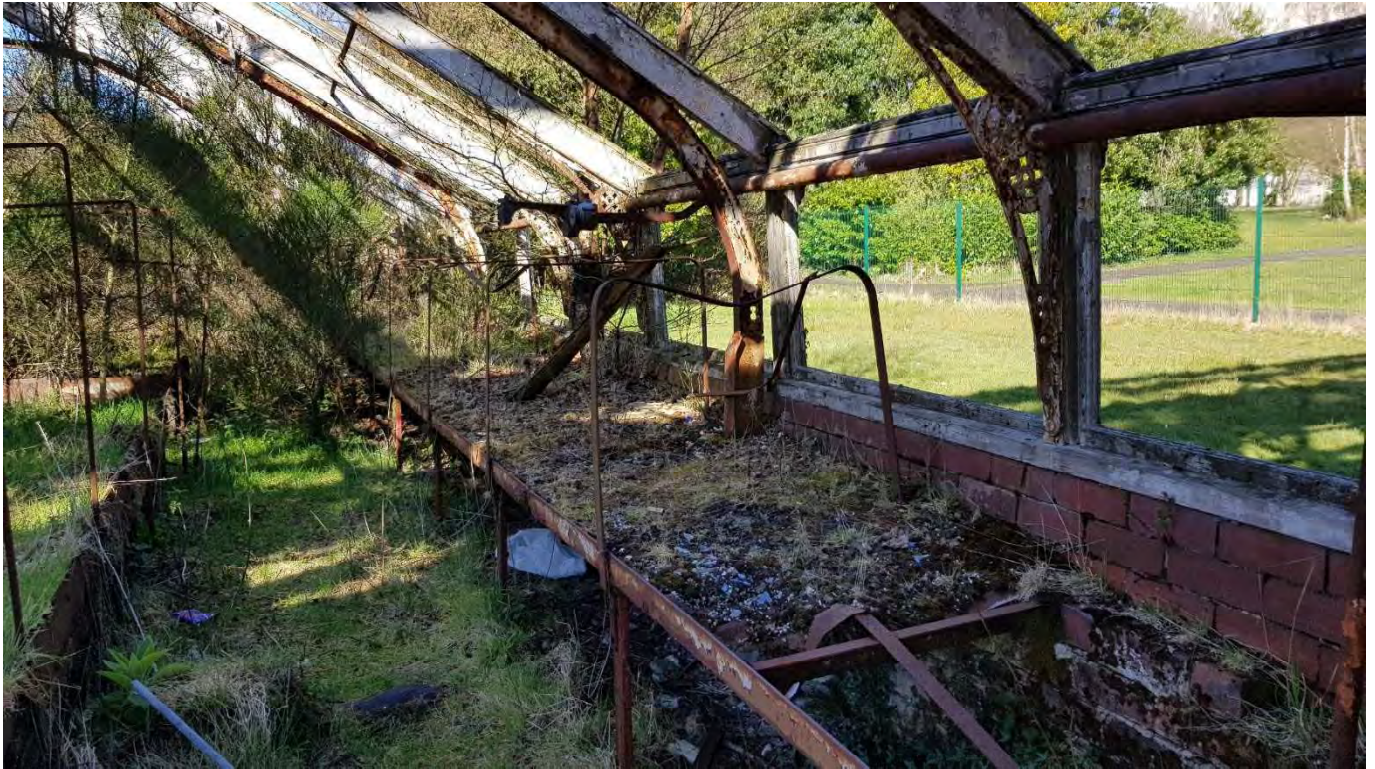
66 – View to north showing the condition of the timberwork which might be able to be re-used and saved

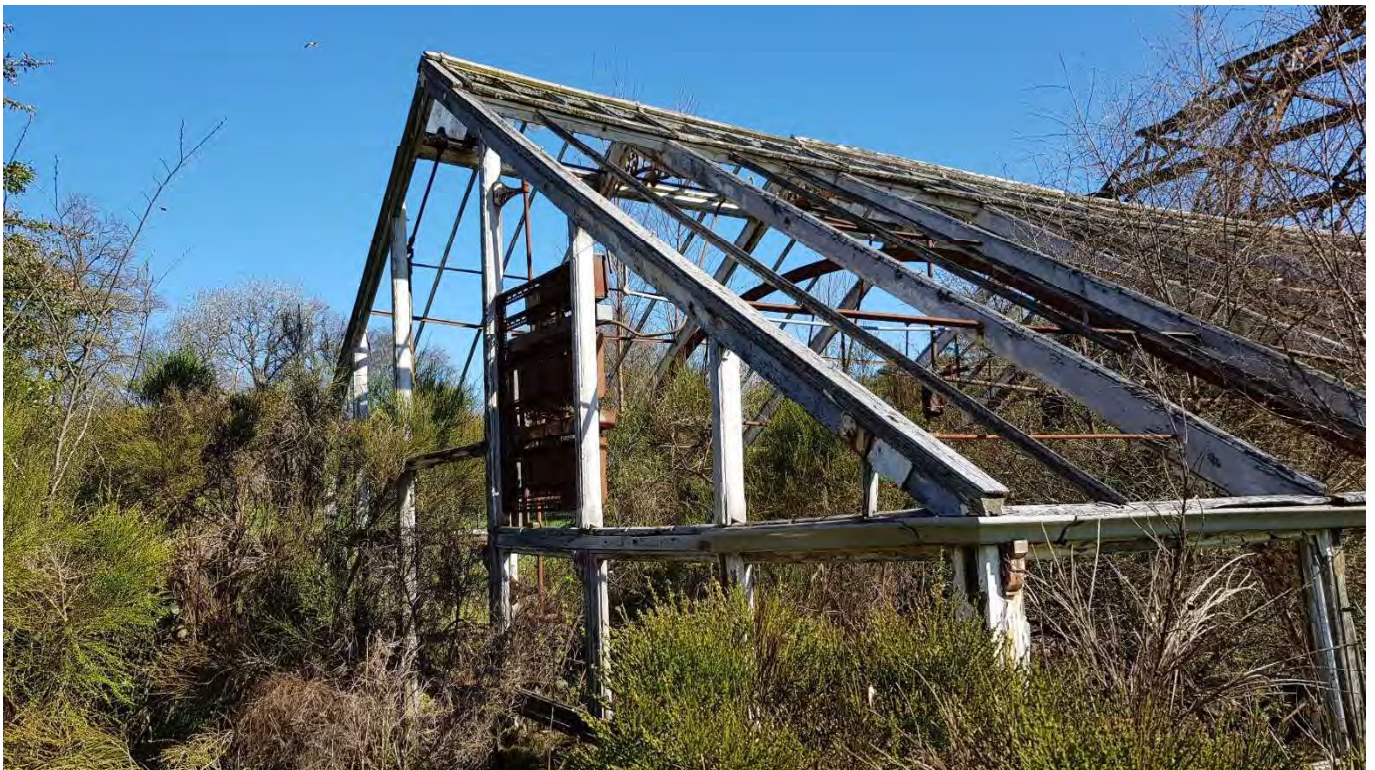
67 – End frame with timber uprights in place and some movement in the eaves beams

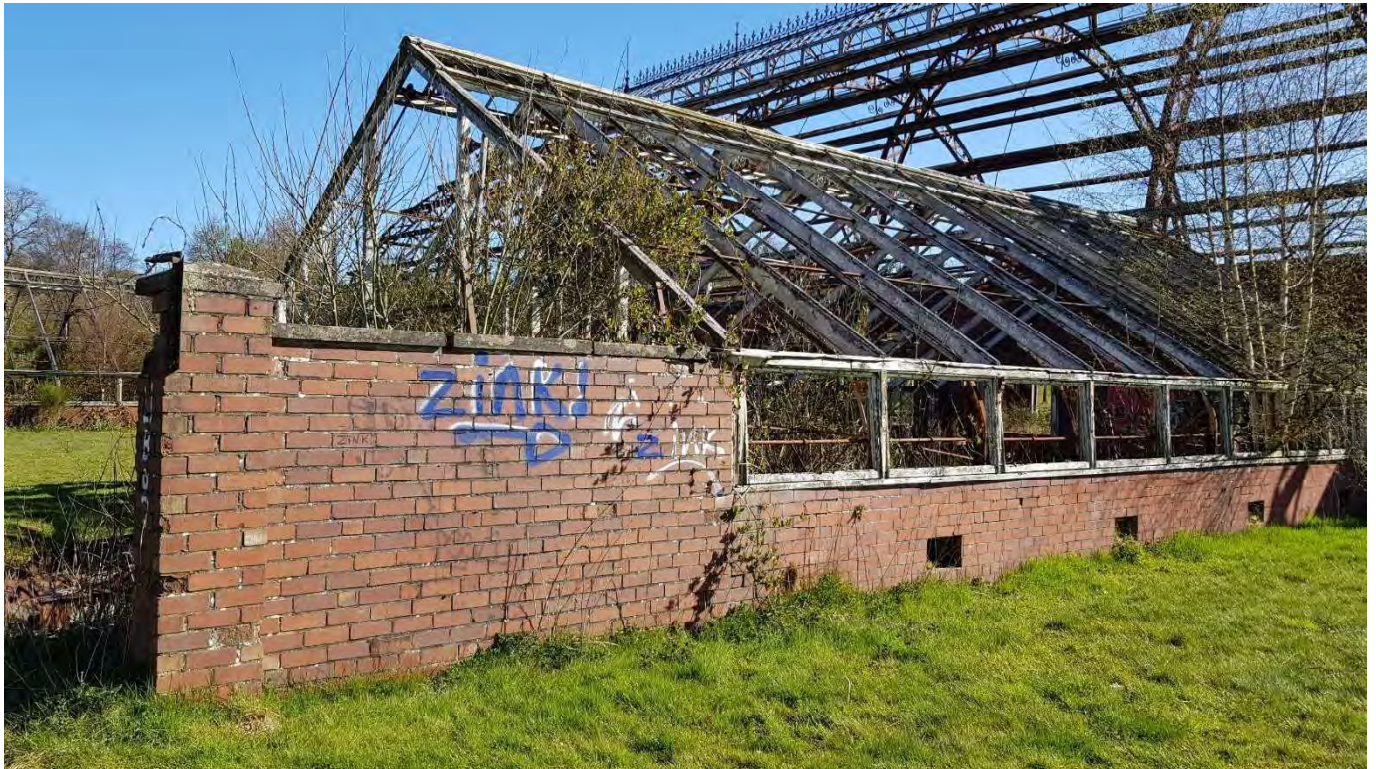
68 – South elevation with freestanding boundary wall and gate pier. This glasshouse is in better condition and alignment compared with the north glasshouse

The southern Glasshouse only requires minor repairs in situ to remove loose debris and stabilise the remaining timberwork to make it safe to access. Removal of embedded roots in the walling can be carried out on a localised basis with rebuilding of the walling using the same bricks. Again, the quality of the timber has meant that many sections can be re-used as part of a refurbishment for 'making safe', and could also be used as part of a full refurbishment.
