## **Springburn Winter Gardens**

## **Structural Appraisal and Condition Report**

For:  
**Glasgow City Council**

**June 2021**

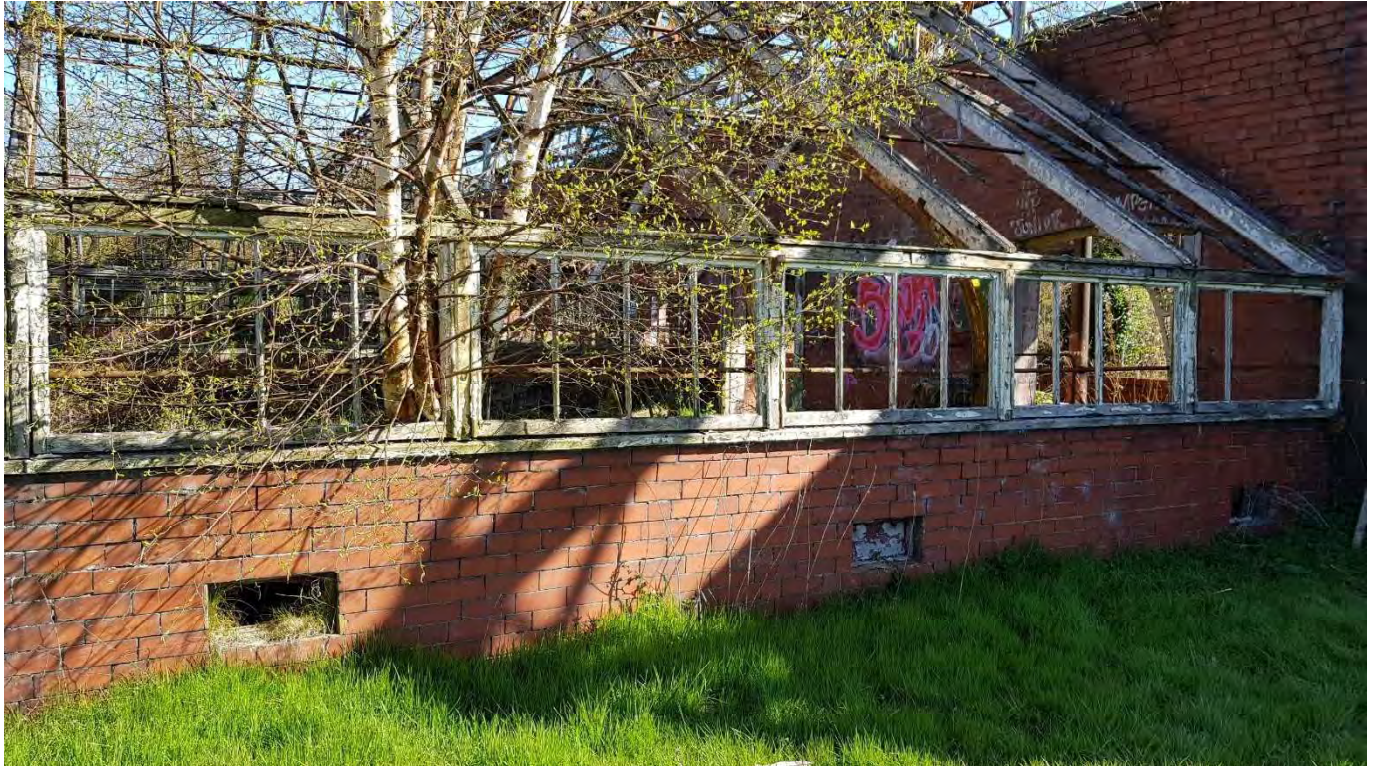
69 – Vegetation growth through the structure needs to be removed and the existing framing re-used

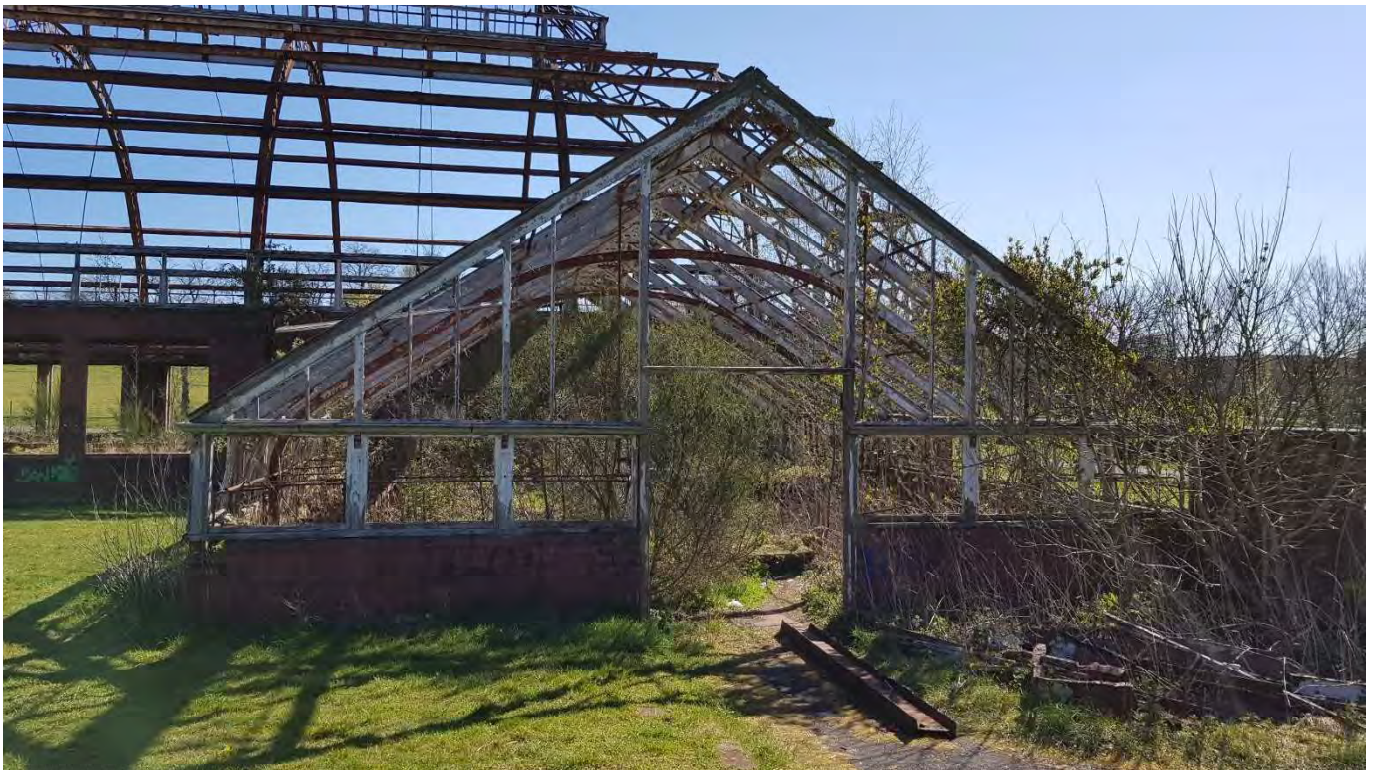
71 – West wall of South Glasshouse showing the internal steel 'hoops' and intact timberwork

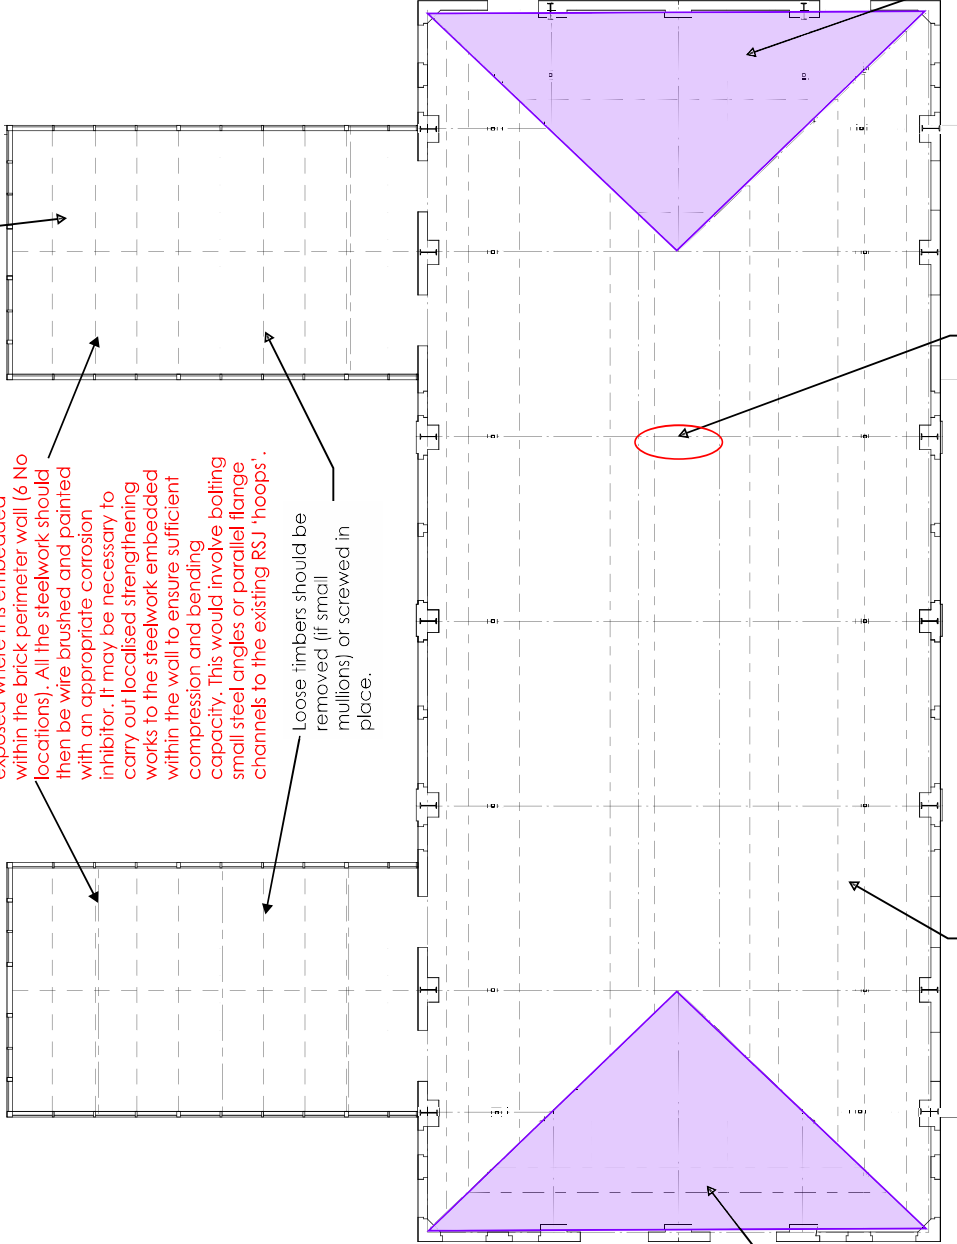
Roof Level  
Structural Repair Notes

All purlins to east and west sides should be investigated further by crane basket to confirm condition and fixity prior to any further works being confirmed to allow public opening. These purlins appear to be 82x4" RSJs with 8" RSC bolted through and appear more robust than the north/south roof purlins

'Hanging' partially collapsed bracket below lantern to be removed immediately

Loose timbers should be removed (if small mullions) or screwed in place.

Cordon off existing north glashouse
