## **Springburn Winter Gardens**

## **Structural Appraisal and Condition Report**

For:  
**Glasgow City Council**

**June 2021**

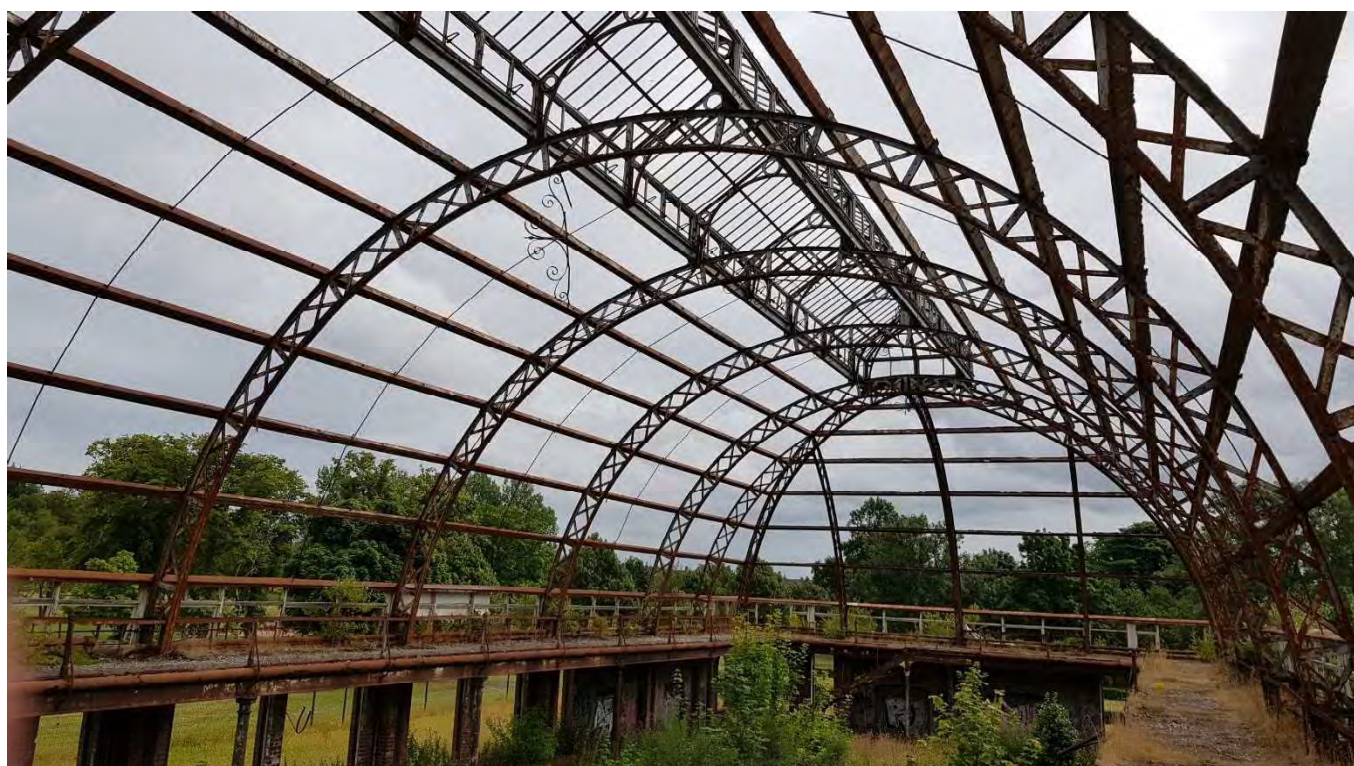
2 – View to south-east showing the regularity of the main lattice frames and the 'hanging' steel bracket

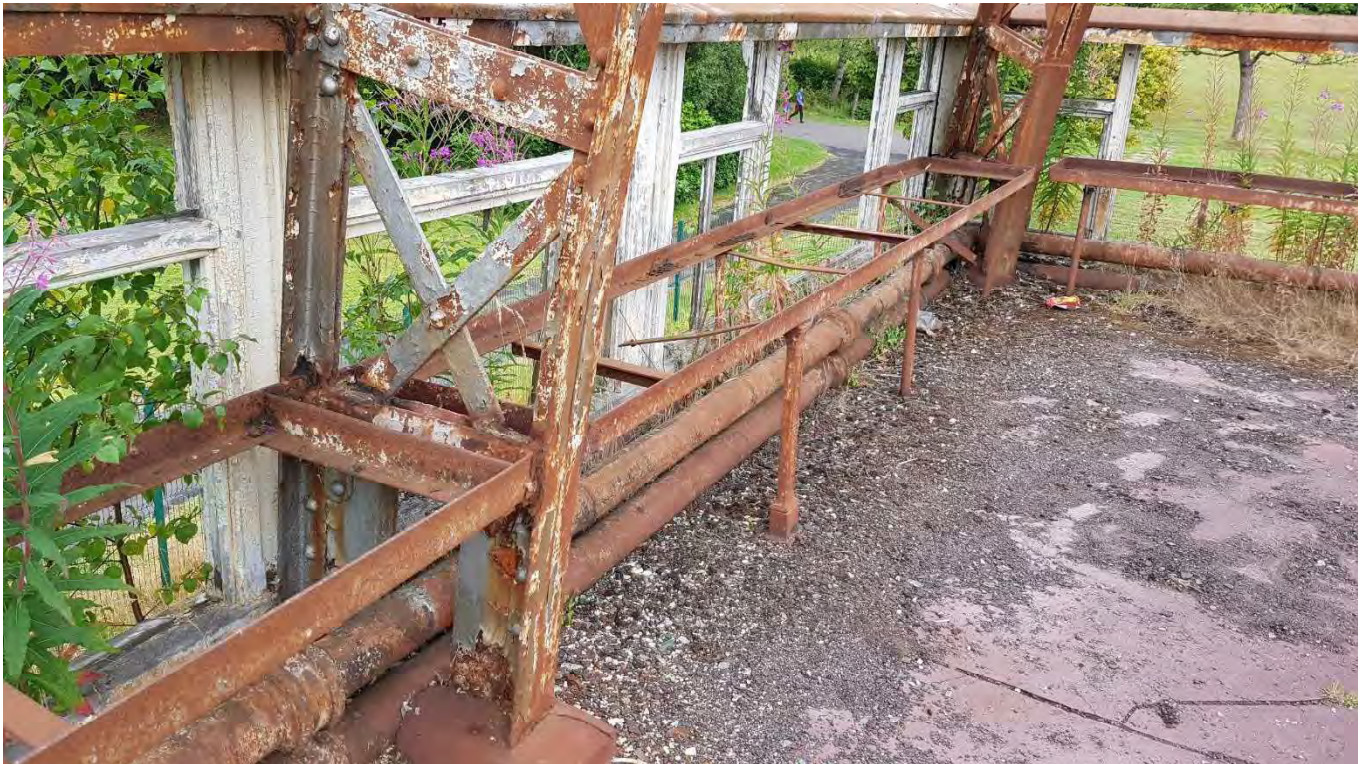
16 – View of north-east corner showing window frames and lower level steelwork

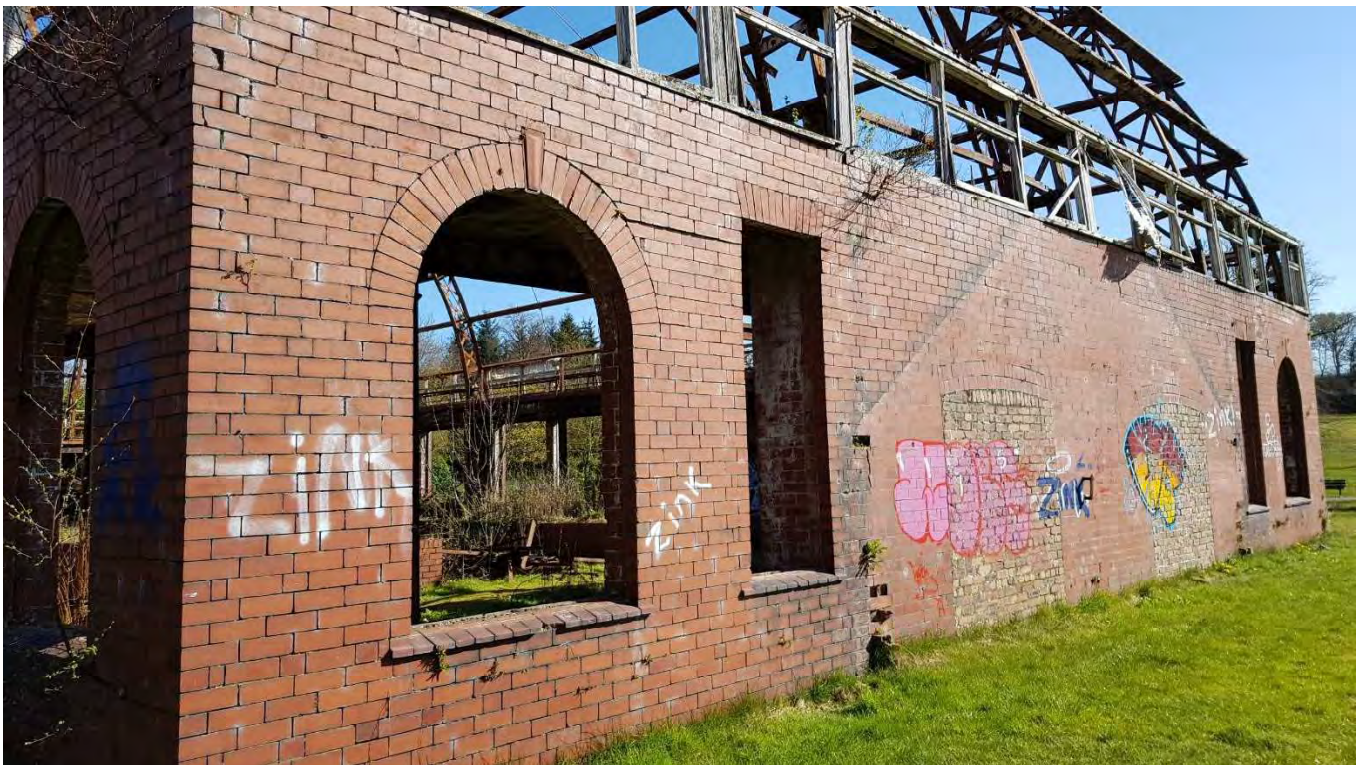
30 - View of north elevation showing the vestige of a northern glasshouse and bricked-up openings. Vegetation growth has rooted in the masonry mortar joints and will need to be removed

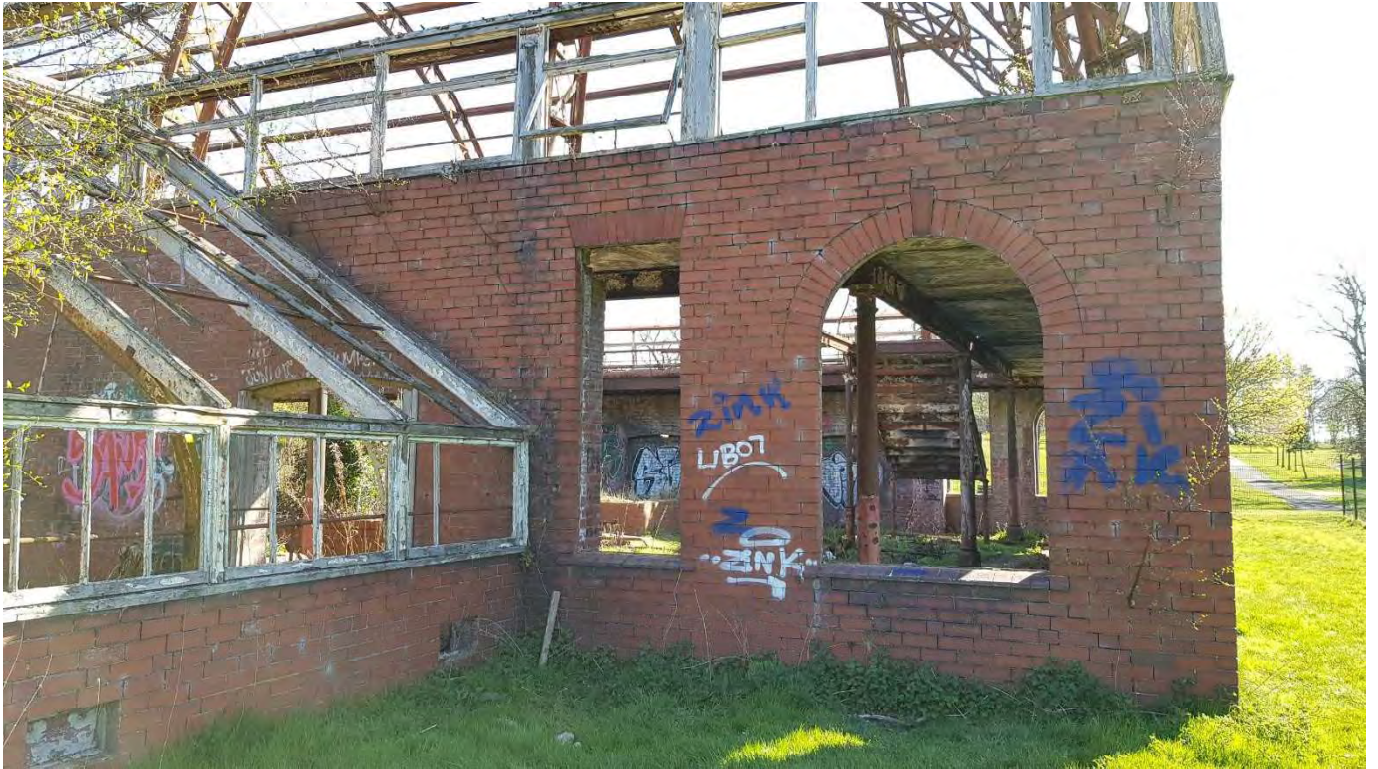
70 – South-east end of the glasshouse showing the relationship with the Main Hall

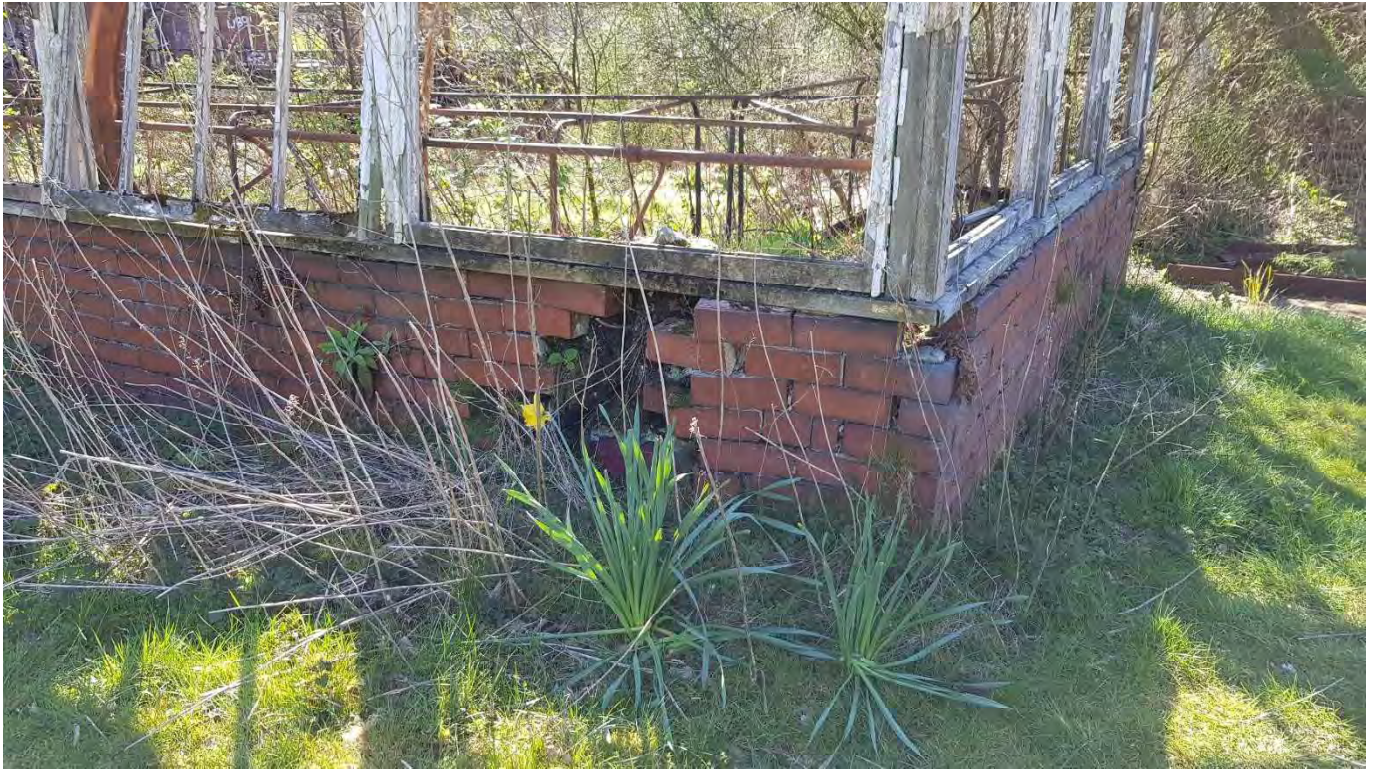
72 – Partial collapse of masonry at north-west corner which will need to be rebuilt

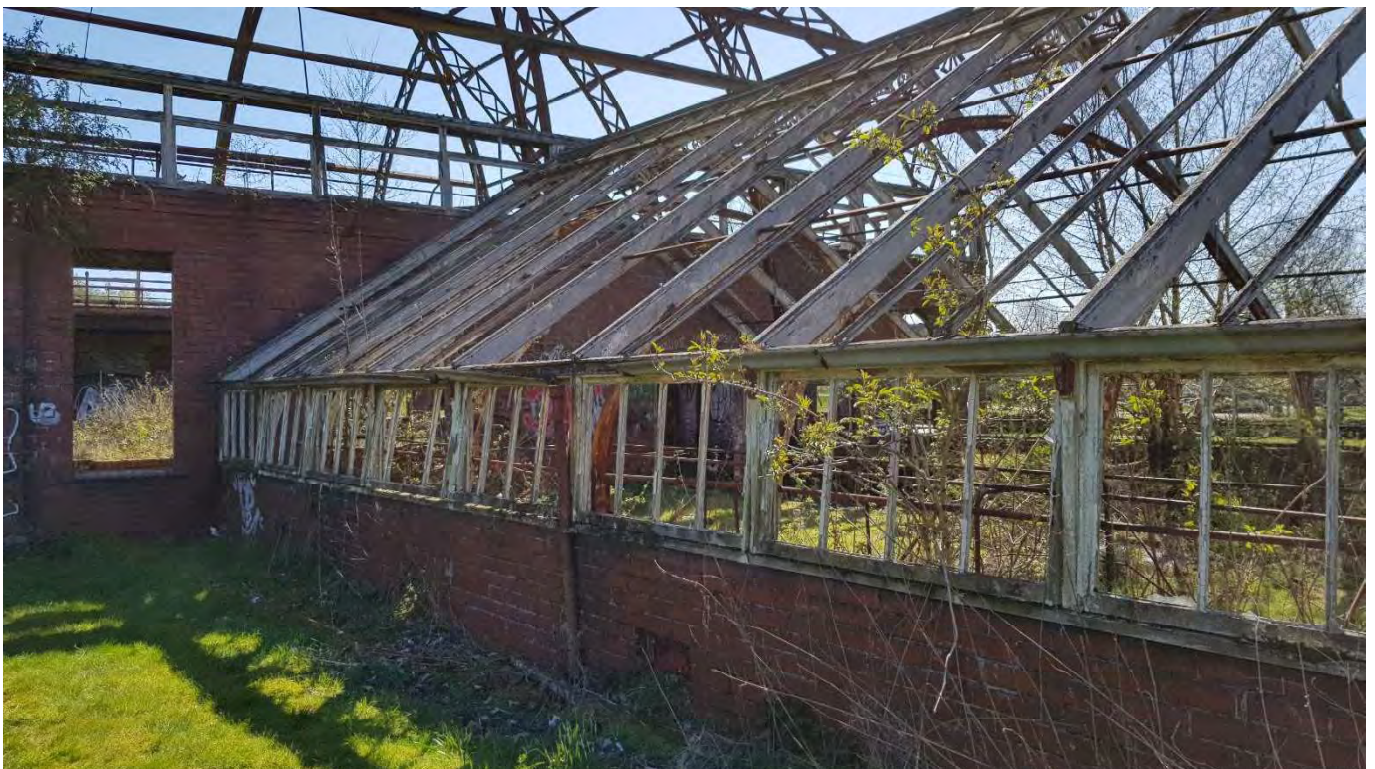
73 – Some movement of wing glazing frames on existing masonry walling

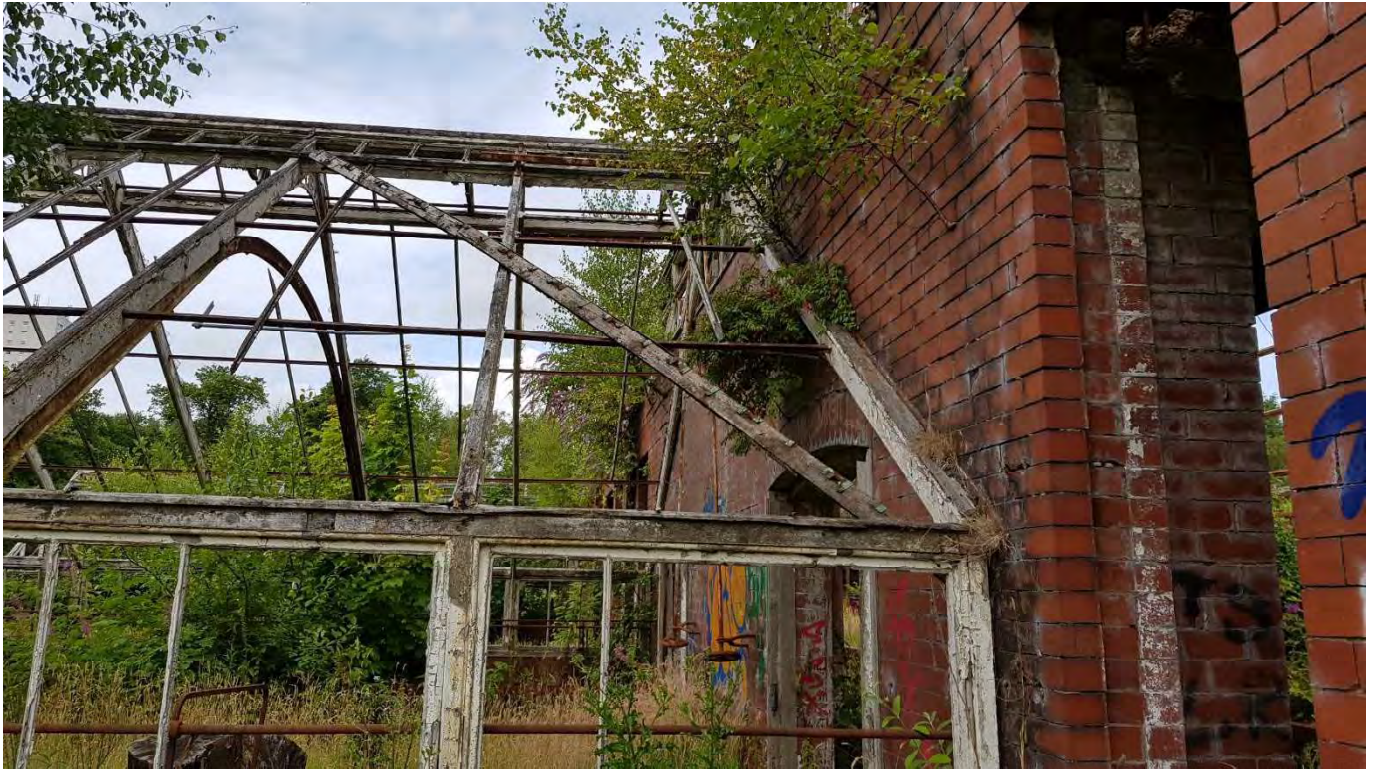
74 – Connection of south glasshouse to Main Hall walling with vegetation in the masonry jointing and some poor connections of the original rafters
